Evaluation of Corrosion in Steel Reinforced Concrete with Brick Waste

Julieta D. Chelaru, Maria Gorea

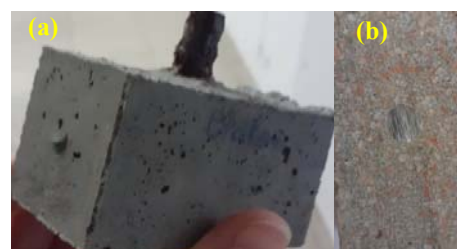
Fig. 1 The mortar samples: (a) generally view; (b) cross section

The raw mortar samples were poured into metallic molds with 40 mm × 40 mm × 160 mm in size. The steel rebar with 6 mm diameter was embedded in middle of mortar samples (Fig. 1). The samples molds with mortar were maintained in RH 95% during 24 hours. For the corrosion tests, the samples were removed from the mold and cured in humidity atmosphere.

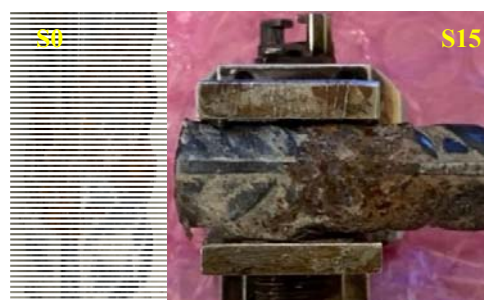
SEM-EDX analysis was used for illustrating the intermediary layer between steel rebar and mortar matrix (S0 and S15). The steel rebar samples are presented in Fig. 4. Visual examination on the surface of the rebar embedded in mortar does not show corroded areas. However, the area directly exposed to the external conditions presents a severe corrosion. The results of the SEM-EDX analysis are presented in Figs. 5 and 6.

Fig. 4 Rebar samples for SEM-EDX analysis
