Effect of Non-Metallic Inclusion from the Continuous Casting Process on the Multi-Stage Forging Process and the Tensile Strength of the Bolt: A Case Study

Tomasz Dubiel, Tadeusz Balawender, Mirosław Osetek

Abstract—The paper presents the influence of non-metallic inclusions on the multi-stage forging process and the mechanical properties of the dodecagon socket bolt used in the automotive industry. The detected metallurgical defect was so large that it directly influenced the mechanical properties of the bolt and resulted in failure to meet the requirements of the mechanical property class. In order to assess the defect, an X-ray examination and metallographic examination of the defective bolt were performed, showing exogenous non-metallic inclusion. The size of the defect on the cross section was 0.531 mm in width and 1.523 mm in length; the defect was continuous along the entire axis of the bolt. In analysis, a finite element method (FEM) simulation of the multi-stage forging process was designed, taking into account a non-metallic inclusion parallel to the sample axis, reflecting the studied case. The process of defect propagation due to material upset in the head area was ana

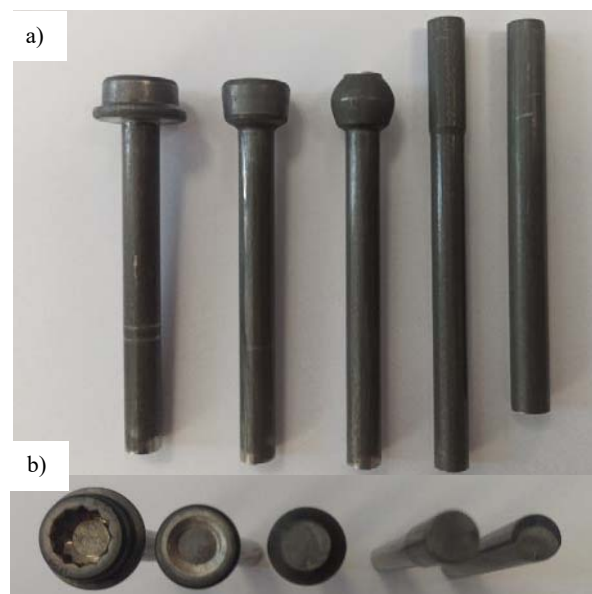
Fig. 1 Successive steps of multi-stage forging a bolt, (a) side view in the Z axis, (b) upper view in the Y axis

The tested objects are M8 x65 bolts with the entire thread and dodecagon socket. The bolts meet the requirements of mechanical property class 8.8 according to ISO 898-1 and are made of the material 20MnB4 [16]. The products are made of wire rod produced in the continuous casting process. The supply of wire rod was verified according to the requirements of EN 10263-1 [17]. Before the forging process, the wire rod was subjected to the processes of pickling, annealing, zinc phosphate coating and wire drawing. The forging process takes place in a multi-stage forging machine, in this case, it is a four-stage forging machine presented in Fig. 1. After forging, the product was heat treated in order to obtain the required mechanical properties, and from there to a coating ensuring appropriate corrosion resistance and friction
