Analysis of Incidences of Collapsed Buildings in the City of Douala, Cameroon from 2011-2020

T. G. L. J. Bikoko, J. C. Tchamba, S. Amziane

Keywords—Collapse buildings, Douala, structural collapse, Cameroon.

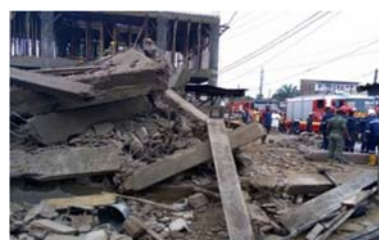
Fig. 1 Collapse of four- storeys building in the Ndogbat suburb

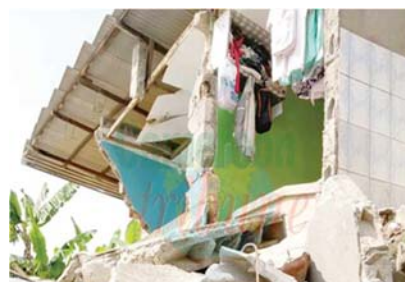
On January 13, 2020, in Ndogbong suburb, there was a partial collapse of one storey building, causing extensive material damage (see Fig. 2). In fact, it was the first floor of the building that had collapsed and had fallen onto a nearby student hostel destroying about five rooms including their contents. Again, the cause of this was attributed to poor quality construction. The latest in these series of collapses took place in Beedi suburb, in front of the Douala General Hospital, on May 30, 2020, where a four-storey building collapsed, partially destroying a house nearby as well as a parked vehicle.

Fig. 2 Collapse of one storey building in the Ndogbong suburb
