Analysis of Incidences of Collapsed Buildings in the City of Douala, Cameroon from 2011-2020

T. G. L. J. Bikoko, J. C. Tchamba, S. Amziane

Keywords—Collapse buildings, Douala, structural collapse, Cameroon.

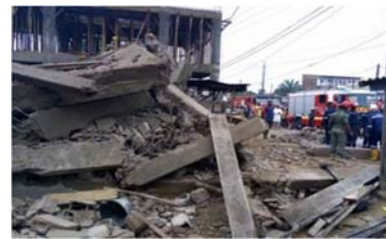
Fig. 1 Collapse of four-storeys building in the Ndogbat suburb

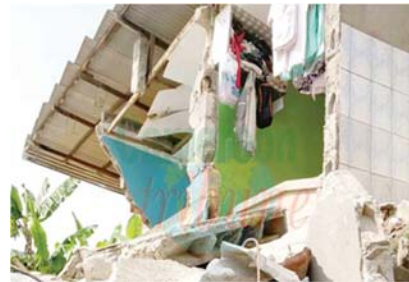
On January 13, 2020, in Ndogbong suburb, there was a partial collapse of one storey building, causing extensive material damage (see Fig. 2). In fact, it was the first floor of the building that had collapsed and had fallen onto a nearby student hostel destroying about five rooms including their contents. Again, the cause of this was attributed to poor quality construction. The latest in these series of collapses took place in Beedi suburb, in front of the Douala General Hospital, on May 30, 2020, where a four-storey building collapsed, partially destroying a house nearby as well as a parked vehicle.

Fig. 2 Collapse of one storey building in the Ndogbong suburb
