Comparison and Characterization of Dyneema™ HB-210 and HB-212 for Accelerated UV Aging

Jonmichael A. Weaver, David A. Miller

Abstract—Ultra High Molecular Weight Polyethylene (UHMWPE) presents several distinct advantages as a material with a high strength to weight ratio, durability, and neutron stability. Understanding the change in the mechanical performance of UHMWPE due to environmental exposure is key to safety for future applications. Dyneema® HB-210, a 15 μm diameter UHMWPE multifilament fiber laid up in a polyurethane matrix in $[0/90]_2$, with a thickness of 0.17 mm is compared to the same fiber and orientation system, HB-212, with a rubber-based matrix under UV aging conditions. UV aging tests according to ASTM-G154 were performed on both HB-210 and HB-212 to interrogate the change in mechanical properties, as measured through dynamic mechanical analysis and imaged using a scanning electron microscope. These results showed a decrease in both the storage modulus and loss modulus of the aged material compared to the unaged, even though the $\tan \delta$ slightly increased. Material degradation occurred at a higher rate in Dyneema® HB-212 compared to HB-210. The HB-210 was

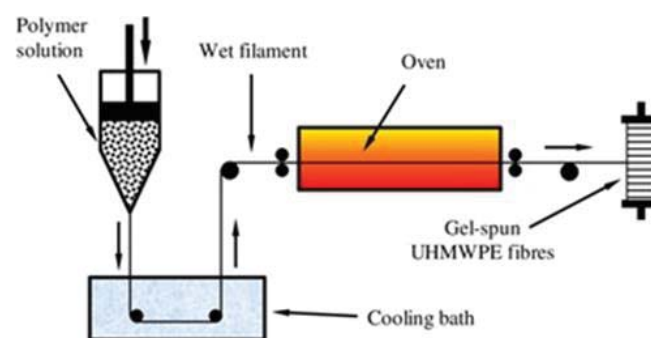
Fig. 1 Gel Spinning Process for Manufacturing UHMWPE Fibers [1]

UHMWPE, sold by DSM as Dyneema®, is used in a broad range of applications. The unique material properties rank this multifilament fiber as a high-performance material. The base monomer ethylene, $-\text{CH}_2-$, is structured into long aligned molecular chains through a gel-spinning process as seen in Fig. 1, that creates a fiber with a high tensile strength while maintaining a lightweight hydrophobic structure approximately 15 μm in diameter. The ultra high molecular weight classification comes from the long length of the polymer chains, a distinguishing feature from other forms of thermoplastic polyethylene.

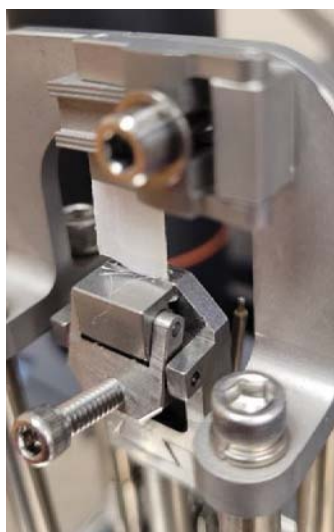
Fig. 3 DMA Film Tension Clamp with a Dyneema® HB-210 Sample Mounted

A TA Instruments – DMA Q800 characterized the dynamic mechanical response of the UHMWPE under a temperature ramp. The samples were loaded, with consistent orientation, into a film tension clamp as shown in Fig. 3. The exposed 90° ply was placed towards the front of the machine with the 0° towards the back.

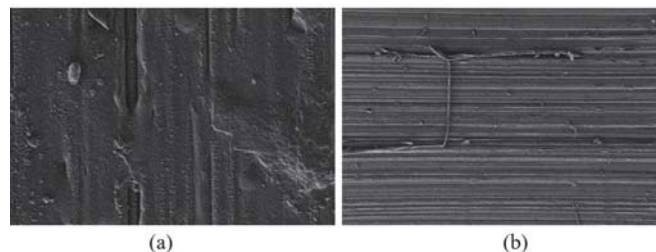
The unaged samples were imaged to show a baseline for reference on how the material ages with UV exposure. In Fig. 4, comparing baseline (a) HB-210 and (b) HB-212, both samples have a full matrix intact and do not show any spalling, pitting, or matrix cracking.

Fig. 4 Unaged single-ply Dyneema® HB-210 (a) and HB-212 (b) before UV exposure

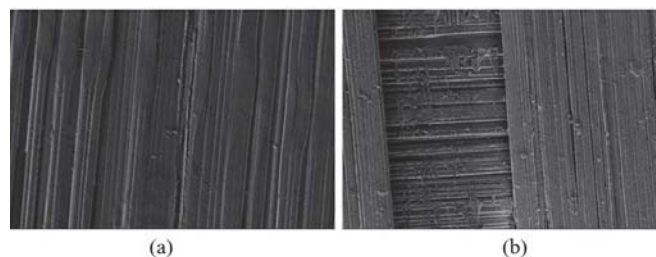
As shown in Fig. 5, after 100 hours in the UV chamber the HB-210 (a) does not appear to show matrix degradation, while the rubber-based matrix in HB-212 (b) begins to show signs of spall. In the center of the images, a section of the top layer of

the ply is removed and the matrix in the HB-212 (b) is damaged and begins to degrade compared to the HB-210 (a) sample where the fibers are exposed while the matrix seems to be intact. This partial delamination occurred when mounting the HB-212 sample into the SEM.

Fig. 5 SEM image of 100 Hour UV Exposure on Dyneema® HB-210 (a) and HB-212 (b)

The unaged HB-210 appears to have a rough texture in Fig. 5, while the 100-hour UV sample appears to have a smooth texture on the matrix in Fig. 6, this could have occurred from the temperature cycling causing the matrix to flow, along with some erosion from the dew/humidity in the ASTM-G154 test.

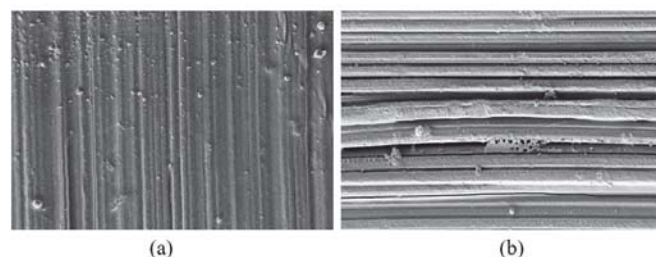
As the aging of the samples increased to 200 hours of UV exposure, in Fig. 6 (b) the HB-212 begins exhibiting pitting and matrix loss. Most of the matrix has eroded away except for the small, pitted portion in the center of Fig. 6 (b) of the HB-212 sample. The HB-210 sample in Fig. 6 (a) appears to have most of the matrix intact and appears largely unaffected compared to the unaged sample.

Fig. 6 SEM image of 200 Hour UV Exposure on Dyneema® HB-210 (a) and HB-212 (b)

In Fig. 8 (a) the HB-210 sample after 800 hours of UV exposure shows pitting and matrix degradation similar to the 200-hour aging of the HB-212 sample in Fig. 6 (b), revealing that the polyurethane matrix is more resilient to UV damage compared to the rubber-based matrix but not completely immune to UV damage.

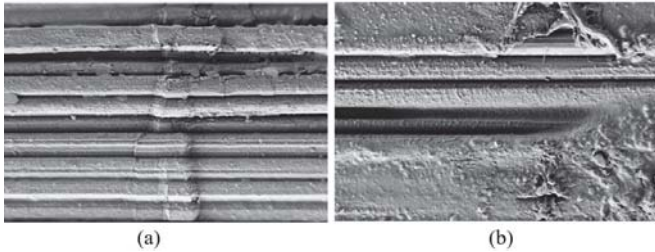
The difference between the front side and backside of the coupons aged in the QUV machine is shown in Fig. 7, where the matrix of the HB-212 appears to erode faster on the UV

exposed side. Erosion may have occurred from the humidity and condensation that was present as part of the testing parameters and accelerated the matrix degradation on Fig. 7 (a) compared to Fig. 7 (b). Fig. 7 (b) shows a small amount of matrix torn away as the backside of the coupon had some areas that adhered to the mounting fixture. The HB-210 did not have a detectable difference between the exposed and backside faces.

Fig. 7 HB-212 UV exposed face (a) vs backside face (b) for 200 Hour Exposure

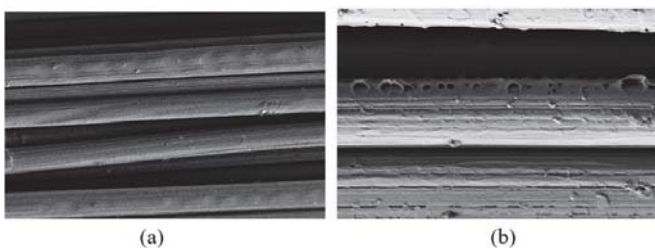
Fig. 8 Comparison of 800 Hour UV Exposure on Dyneema® HB-210 (a) and HB-212 (b)

After 800 hours with the UV bulbs on the HB-212 matrix had completely dissolved, the fibers became brittle. This sample was difficult to mount as the fibers had nothing holding them together. This made imaging difficult as the fibers did not easily adhere in a planar manner on the SEM sample holders. The fibers are lightweight and the slightest bit of wind or breath will disturb the fibers and cause them to fly off the sample holder. The HB-212 samples were not able to be measured in the DMA after 800 hours of aging. The HB-212 fibers became brittle compared to the unaged sample and would break during handling and removal from the QUV machine.

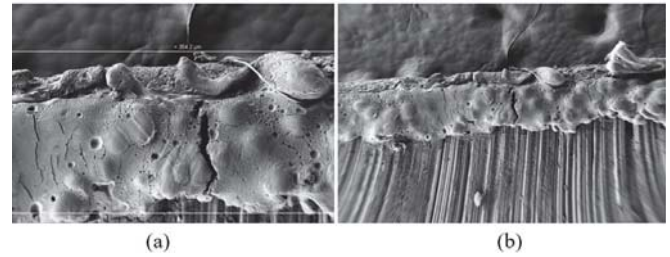
The heat affected zone of HB-210 in Figs. 9 (a) and (b) is approximately 350 μm in width. This melted zone ends up impacting the DMA results through noise and grip slippage, rendering the DMA tests on laser cut HB-210 and HB-212 indiscernible.

Fig. 9 Heat Affected Zone on Laser cut HB-210 210 Enlarged (a) and standard view (b) of the HB-210 Melted Edge

It was discovered that the heat-affected zone from the laser on the edges of each DMA coupon induced noise into the data making the results invalid and inconclusive. Additionally, many of the tests done on the laser cut coupons slipped out of the DMA grips before the test had concluded the temperature ramp. Cutting the HB-210 with a blade by hand allowed for accurate

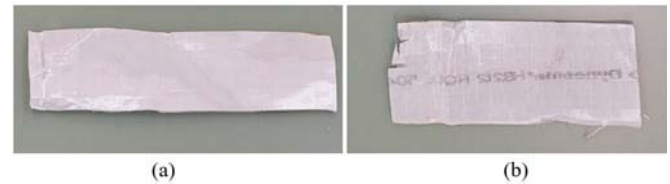
Fig. 10 depicts the unaged HB-210 (a), and the unaged HB-212 (b) respectively as a reference for optical changes as the material ages.

Fig. 10 Reference Image for Unaged HB-210 (a) the Unaged HB-212 (b)

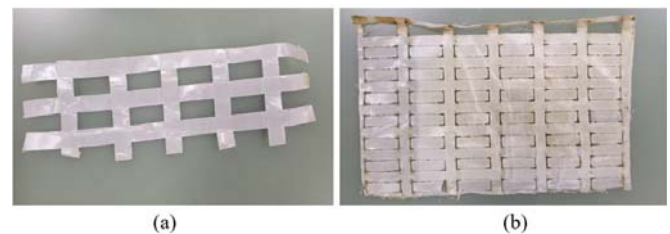
In Fig. 11 (a) the HB-210 after 100 hours of UV exposure remains unchanged in appearance; the DMA coupons had already been removed before photographing resulting in the rectangular holes shown in Fig. 11 (a). Fig. 11 (b) shows the HB-212. After 100 hours of UV aging, the material appearance of HB-212 has changed, with a vertical line in the second column of DMA coupon perforations showing the edge of the window where the UV shines into the coupon. The HB-212 appeared to lighten and become opaquer with UV aging as seen to the right of the vertical delineation.

Fig. 11 100 Hour UV aged HB-210 (a) and HB-212 (b)

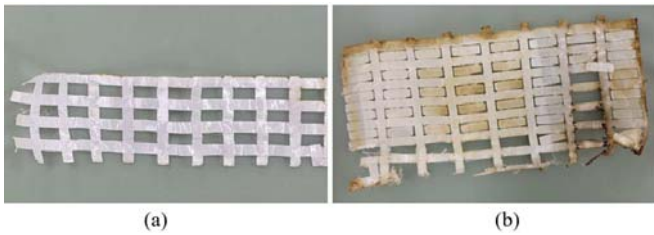
After 200 hours of UV exposure the HB-210 had no visible change, as seen in Fig. 12 (a). However, the material became stiffer and less malleable compared to the unaged HB-210. In the HB-212, Fig. 12 (b), the effect of UV became more apparent than the 100-hour sample. The window of UV exposure is more pronounced, with the left edge of the window bisecting the left most column of DMA samples, and the right edge bisecting the third from the right edge column. The DMA samples in the second column from the right were removed before aging due to damage from the laser engraver which was used to perforate the DMA shaped coupons from the larger sample. Discoloration appears most intensely in the center of the sample shown in Fig. 12 (b) in the center 3x3 perforated coupons after 200 hours of UV exposure. This darkening of the normally white composite was accompanied by embrittlement to the point of hold shape under its own weight in a cantilevered position, where the

unaged coupon appears limp and droops under the material weight in the same position.

Fig. 12 200 Hour UV aged HB-210 (a) and HB-212 (b)

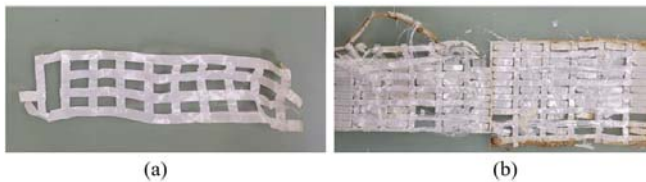
At 800 hours of UV aging, the HB-210 sample in Fig. 13 (a) began to change opacity in the exposure window, but not to the same degree as the HB-212 in Fig. 12 (b). Fig. 13 (b) depicts the HB-212 after 800 hours of UV exposure, the yellowing disappeared as the matrix eroded away and the fibers debonded. The 800-hour HB-212 sample could not be handled without damaging the composite as the fibers were weak and brittle without the presence of the matrix.

Fig. 13 800 Hour UV aged HB-210 (a) and HB-212 (b)

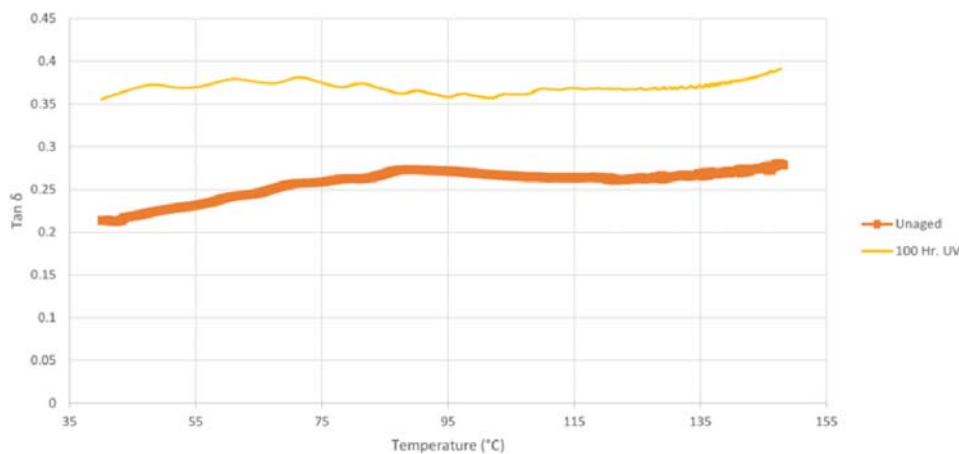
Fig. 14 compares the $\tan \delta$ of unaged and 100-hour UV-exposed HB-210. The overall $\tan \delta$ increased with the UV aging by an average of 0.15 over the temperature range of the DMA experiment, possibly from molecular weight changes or alterations in the matrix properties. This is consistent with what is seen in tests of UV aged Dyneema® yarn, where the irradiated samples increase in $\tan \delta$ [7]. The relative stability of the $\tan \delta$ parameter throughout the DMA test suggests that as the temperature increases both the storage and loss modulus decrease at a constant rate, likely due to the cross-ply orientation of the composite.

Fig. 14 Tan Delta vs Temperature of HB-210 for Unaged and 100 Hour UV

With the increase in $\tan \delta$ during UV aging, the HB-210 slightly increases the ratio of the tensile loss modulus compared to the tensile storage modulus. However, this does not indicate that UV aging increases the material dampening potential, only the ratio between the two moduli that make up the complex modulus. The complex modulus decreases with UV exposure, shown in Fig. 15 which compares the storage and loss modulus of the unaged to the 100-hour UV aged HB-210. Both storage and loss modulus of the unaged sample are greater than that of the aged sample for temperatures less than 125 °C. At 125 °C, the unaged and 100-hour UV loss modulus reach the same temperature and remain nearly identical for the duration of the test up to 150 °C. The unaged storage modulus remained higher than the UV aged storage modulus for the entire experiment.

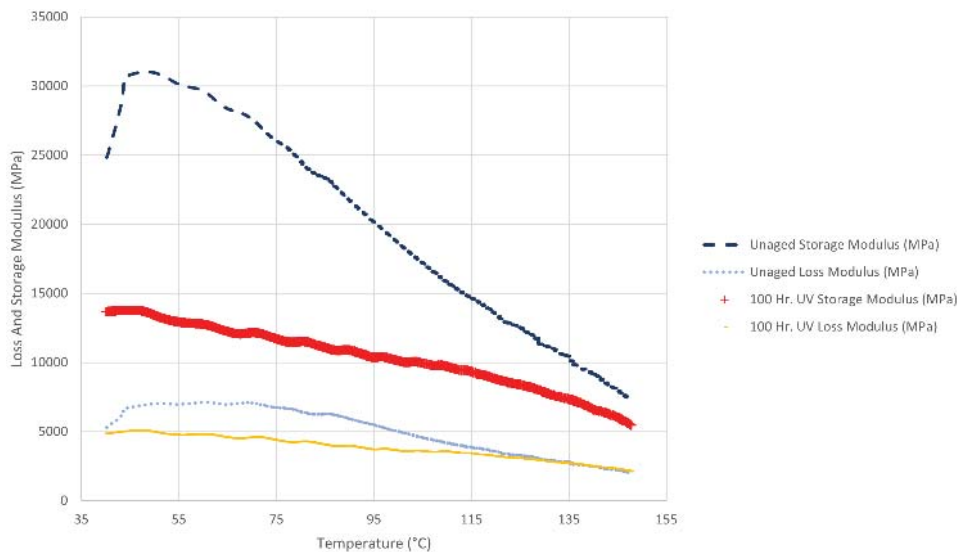
The decrease in both the loss and storage modulus for the UV aging sample could have occurred from chain scissioning and cross-linking due to photolysis. Additionally, these scission processes can accelerate the effects of hydrolysis and oxidation at the defect and scission sites, further decreasing the storage moduli. The decrease in both storage modulus and loss modulus of the HB-210 after UV aging reduces the potential for this material to dampen and dissipate energy, which will result in diminished utility as a high-performance ballistics protection system.

Fig. 15 HB-210 Storage and Loss Modulus vs Temperature for Both Unaged and 100 Hour UV
