The Shifting Urban Role of Buildings' Facades: A Diachronic Analysis of El Korba

Virginia Bassily, Sherif Goubran

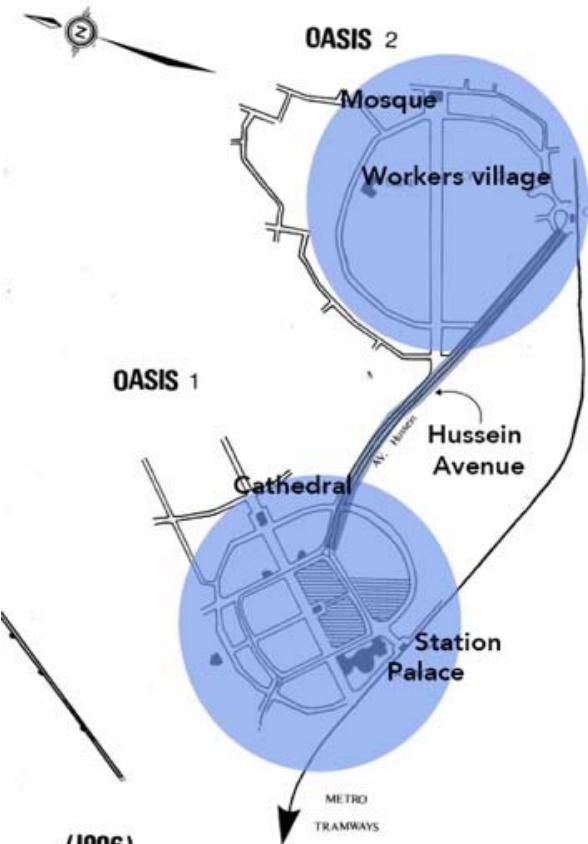
El Korba has always been noted for its strong architectural character that stimulates social life. This is due to a few factors present in El Korba and not in other places in Cairo. As Fig. 1 shows, Heliopolis was initially designed in 1906 as two 'oases' that were to be connected through a big avenue. The first oasis (where El Korba is now) was a residential area for the high-income class and foreigners, while the second oasis, much farther from Cairo, was for the lower-income classes [1, p.7]. Later, during 50's and 60's, the old part of Heliopolis became its center, which is now known as El Korba. This part still included the commercial functions; all the newly developed parts following this were mainly residential [1, p.33]. Later, specifically during the Infitah (globalization) era, Heliopolis went through uncontrollable changes and expansions that were clearly manifested in the buildings' changed facade designs. Despite all that, the district is still one of Egypt's most popular areas for socialization [2, p.69]. However, it is essential to

Fig. 1 Original Heliopolis Design in [3, p.61] (annotated by author)

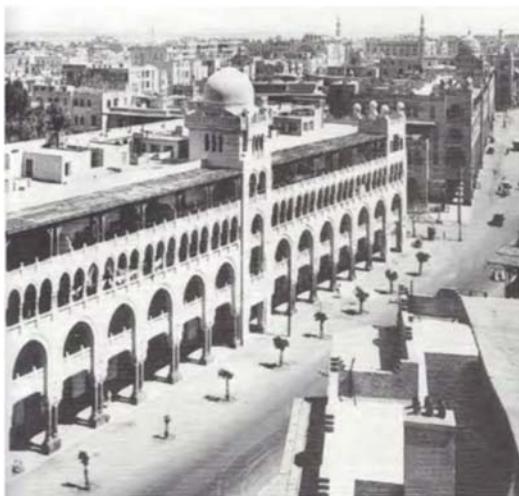
Fig. 2 Baghdad Street 1930's [1, p.20].

As Dobrowolski stated, "One thing that remains certain: the original Heliopolis was, and still is, a very powerful architectural statement" [8, p.73]. Going from Cairo to Heliopolis, the train passes first through the entertainment area, the hippodrome, the Luna Park, the cinemas, and the shopping area, and then it will reach the more residential parts [1, p.11]. As Fig. 2 shows, everything in Heliopolis was planned and regulated. This includes the height of the buildings, the number of floors, the percentage of built area, and the width of the roads, which even in the 60's considered the traffic [1, p.14]. Egyptian and European specialists also helped give Heliopolis its strength and originality [1, p.17]. The designers also considered the effect of the climate. Because Heliopolis was built before air-conditioners, loggias and arcades were placed in a way to protect from the sun [1, p.19]. One researcher, Elokda, also confirms that the communities and neighborhoods designed in the 1900's were designed for better walkability and to provide for a more active street life [8, p.41].

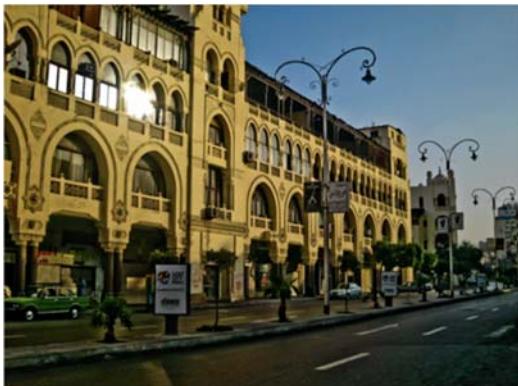
Fig. 3 Baghdad Street 21st century [2, p.41]

It was found in the research done using these parameters on Baghdad and Ibrahim Streets in El Korba that the parts of the street that were characterized as being highly social were the parts of the street where the below parameters were met, and the parts of the street that were characterized as being less social were when the parameters were lacking or not present altogether. These parameters are:

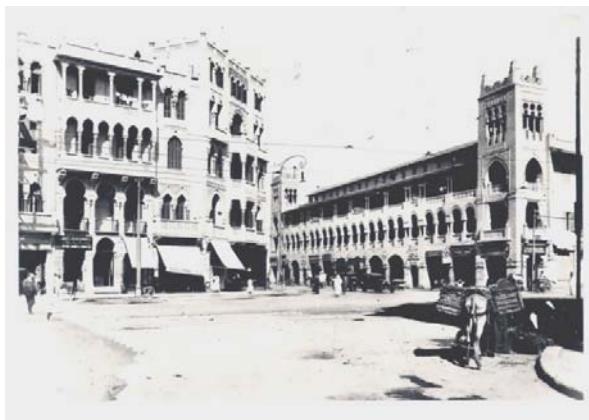
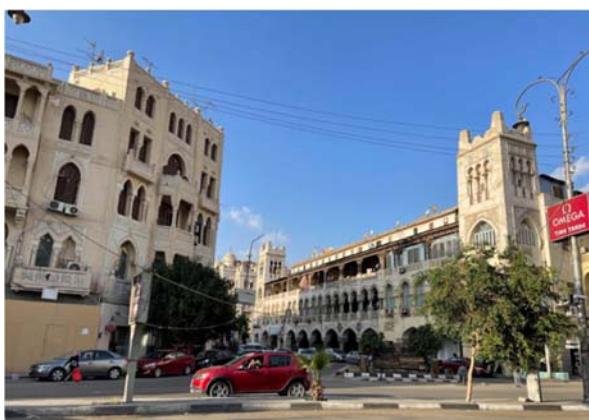
Fig. 4 Boulevard Ibrahim El-Lakkani. (a) 1920's [13, p. 58], (b) 2020 (taken by author)

Ibrahim El-Lakkani Boulevard in the El Korba area. Each parameter will be assessed separately in a general analysis of the Ibrahim El-Lakkani Boulevard from Fig. 4. Then each is explicitly assessed in two selected buildings. This is to acquire a general view of the presence and performance of the parameters in the Boulevard as a whole and a detailed analysis of the specific buildings.

- *Interventions (Size)*: The size of interventions (fabric shades) in Fig. 4 (a) is large in comparison with the portion of the facade that pedestrians interact with.

- *Environmental (shading)*: It seems from Fig. 4 that shading was well taken care of. The shades that were added in front of the storefronts would make it more comfortable for users to linger under them and interact with them.
- *Environmental (greenery)*: Greenery is not very evident in Ibrahim El-Lakkani Street as observed from Fig. 4 (a).
- *Seating Options (safety)*: Seating was well-designed in the original design of Heliopolis and that is evident in Ibrahim El-Lakkani Street where no seating is exposed directly to the street.
- *Seating Options (quality)*: The quality of seating also was very good because they were always considered in the design.

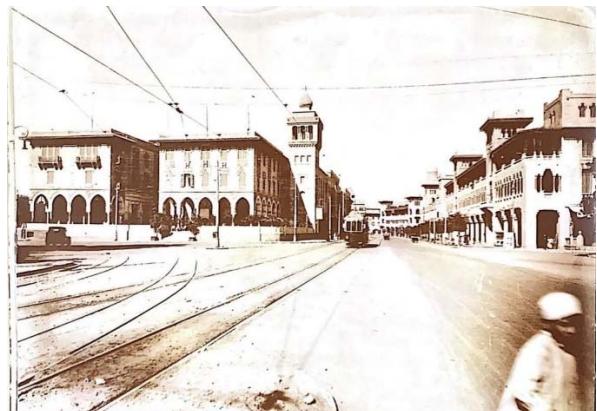
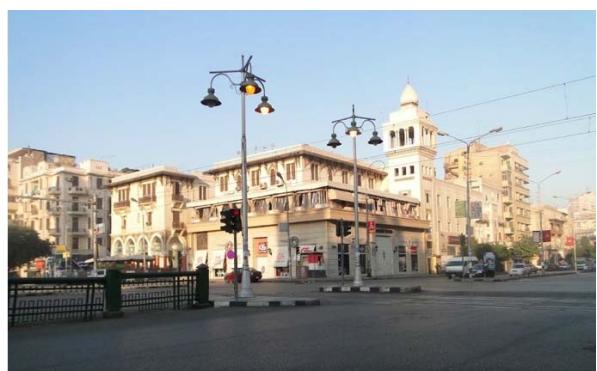
Fig. 5 Building 1 (Heliopolis House Hotel)- Boulevard Ibrahim El-Lakkani. (a) 1920's [13, p. 58], (b) 2021 (Courtesy of Sherif Aboul Gadayel)

Much has changed in this specific building over the years. The complexity has increased in this building with the articulation of the different levels through protrusions and recesses in the facade. However, the architectural character has become less defined because of removing the arches on the ground floor. The side tower has been left relatively the same over the years with minimal changes.

The windows have changed in the new form of this building; they now add depth to the facade that was not articulated in the original design. However, the permeability level itself has decreased. The new windows are blocked with *shish* (or wooden shades), making the visual permeability through them impossible. The level of physical permeability on the ground floor also has suffered after removing the arches, which previously made it easy to access the ground floor spaces and interact with them.

The level of territoriality has decreased due to the removal of the arches. Removing the arches deletes the buffer zone left for each store owner near their shops. The level of personalization also has suffered because although the stores may be personalized, this is not visible due to the overwhelming number of advertisements that hinder the view of the building.

The removal of the ground floor arches decreases the level of enclosure significantly. The addition of big shading trees and the division of the street adjacent to the building have partially made up for this.

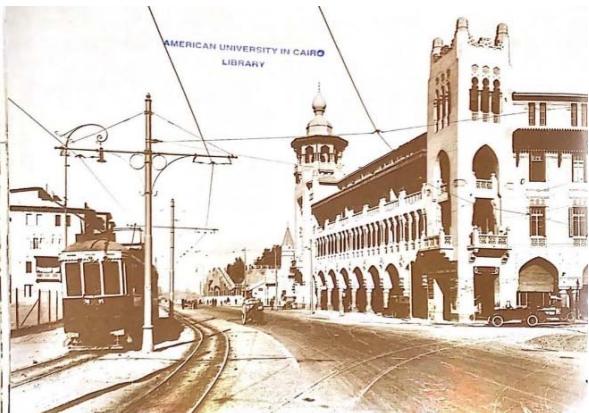
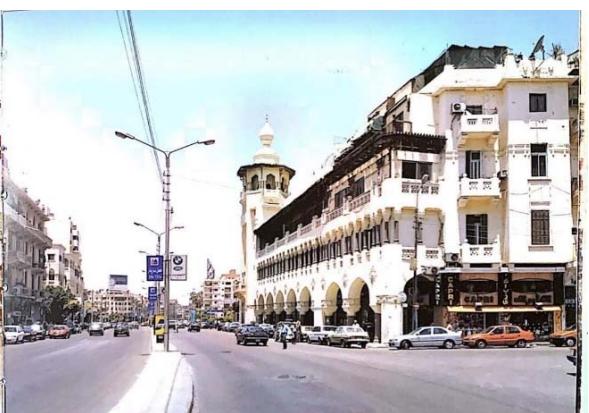
Fig. 6 Building 2 (Luna Park) - Boulevard Ibrahim El-Lakkani. (a) 1930's [13, p. 56], (b) 2006 [13, p.57]

The level of complexity has not changed much for this building over the years. However, the architectural character has. It has decreased due to a few factors; the first is the removal of the front-most tower in Fig. 6 (a); this is a significant change made to the building that alters its character considerably and breaks its balance -especially when considering the other tower on the other side of the building. The second is the replacement of some of the openings with square openings that do not resemble the geometry that was initially in that same place when the tower was still there. Lastly, various components such as the air conditioning units, satellite dish plates and shading elements obstruct the building's architectural character as observed from the facade.

parameter, the solid downwards arrow (\blacktriangledown) indicates a general decrease or deterioration of the parameter, and the solid square (\blacksquare) indicates that the parameter has not changed over the years. Furthermore, two buildings have been specifically used to conduct a more detailed comparison of the six parameters to understand the impact of the changes on the adjacent street life in this area on a more nuanced level. Building 1 is the Heliopolis House Hotel with Groppi's Terrace (Fig. 5) and Building 2 is the Luna Park amusement center (where Roxy Square is today) (Fig. 6).

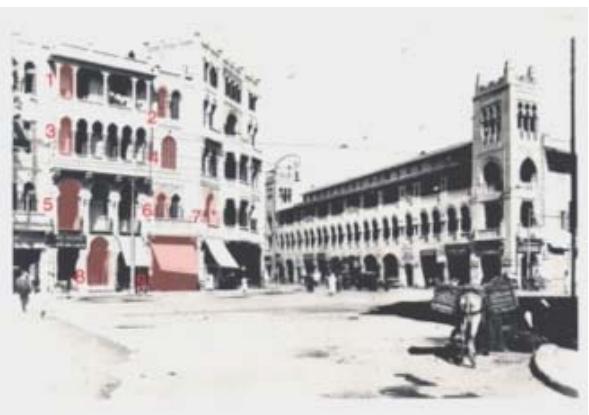
Fig. 7 Boulevard Ibrahim El-Lakkani 1920's [13, p.58] (adapted by author)

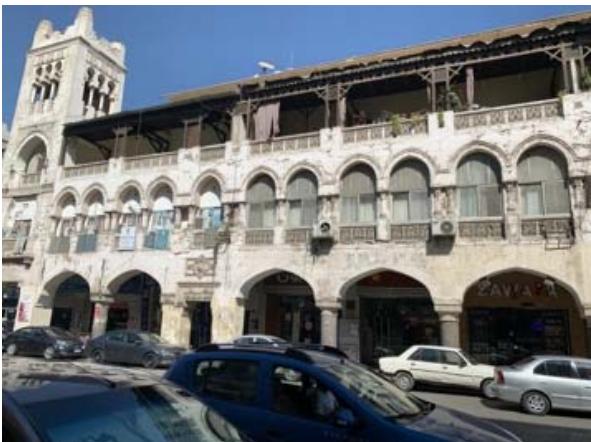
Fig. 9 Ibrahim El-Lakkani Boulevard 2020 (taken by author)

- *Openings (Types)*: The types of openings have not changed. The majority are still either windows, doors, arcades, or balconies. On that note, however, the number of balconies decreased significantly because users blocked them, so the space no longer functions as a balcony.

- *Openings (Number)*: The number of openings also has decreased due to the blocking of various openings.
- *Openings (Depth)*: There are deteriorations in the concept of depth between openings and the actual livable space of a building. The blocking of balconies affected the aspect of different layers and depths to a facade.

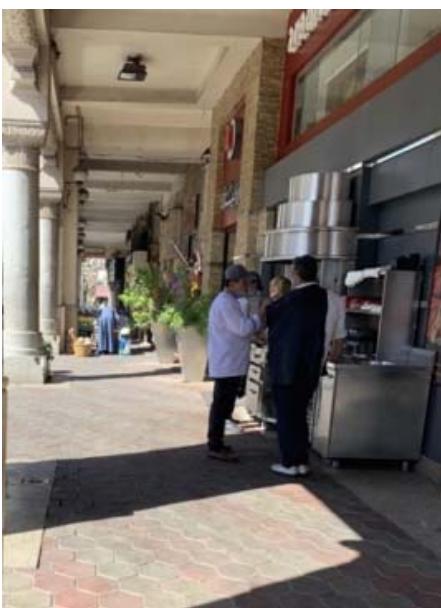
Fig. 10 Ibrahim El-Lakkani Boulevard 2020 (taken by author)

While there were interventions made in both the original design and the current situation, and both were of relatively big

size, the old design rendered better with regards to this parameter because of the strict local identity and the policing of the interventions to make sure they abide by this identity.

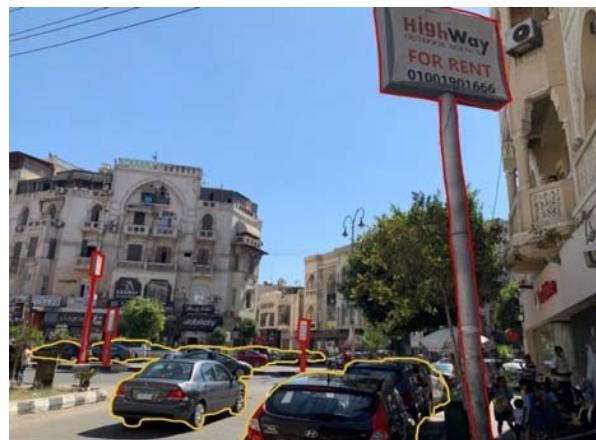
Fig. 11 Intersection between Ibrahim El-Lakkani Street and Baghdad Street (taken by author – adapted by the author): Annotations in red point out the signs that hinder the view, Annotations in yellow point out the cars that hinder the view

In the original design, the streets were wide enough so that vehicles did not hinder the view of the buildings' facades. Now, however, the facade cannot be seen clearly due to many obstacles that come in the way. These include an overload of parked cars in one and sometimes two rows by the sidewalk, therefore creating an indirect barrier between the pedestrians and the building facade. Another factor is an overload of advertisements along the middle island between two lanes; it also hinders the view down the street and prevents pedestrians from clearly seeing the building ground-floor shops. These obstacles result in a lowered sense of the area's architectural character, as opposed to in the original design where the

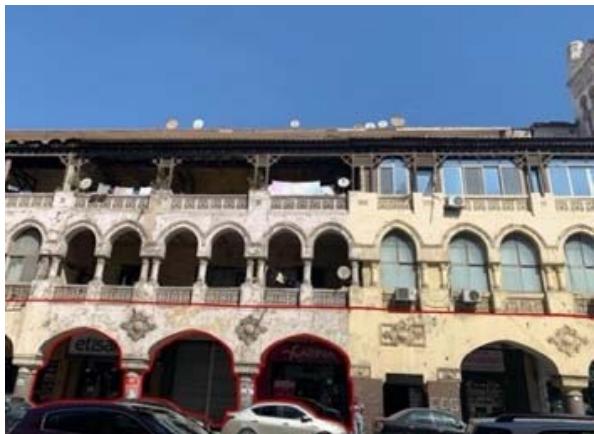
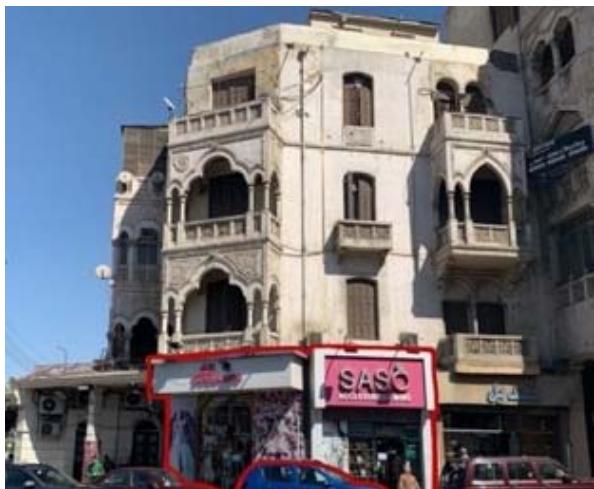
designers were careful to exhibit the beauty of the buildings in a wide street where no obstacles hinder the view. In areas with arcades, this can be seen nowadays too. The shops are somewhat hidden in the grand scheme, but they are still very accessible to those who want to reach them. However, this was not the case in other building parts, like building corners. And so, when the store owner changed their storefront, the overall building identity was affected as is clear in Fig.12.

Fig. 12 Building in Ibrahim El-Lakkani Street: (a) annotations point out the arcades to mask interventions made behind them in the stores, taken by author – adapted by author; (b) annotations point out a corner shop where the absence of the arcade had a negative impact on the overall architectural character of the building, taken by author – adapted by author

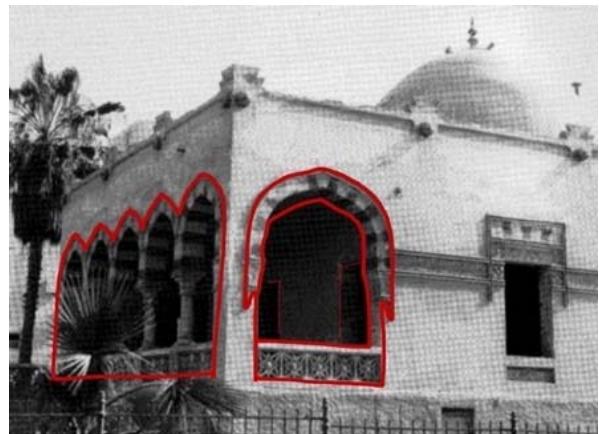
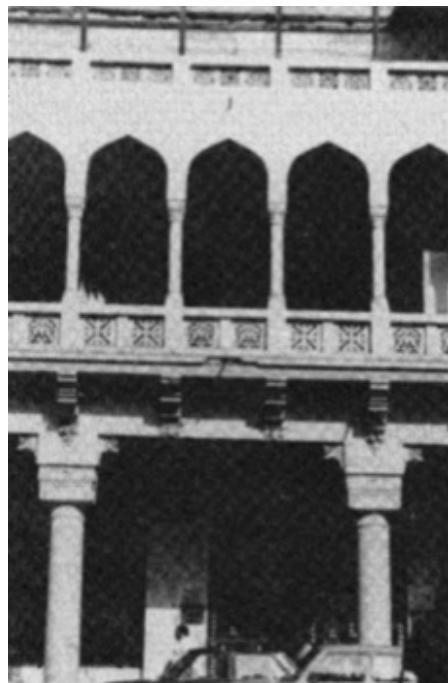
In the original design of El Korba, a lot of the balconies were left open and made for an outdoor terrace area for the residents and so the level on which the glass was fixed was not noticeable from the street as seen in Fig. 13. This created a much higher sense of permeability without compromising the residents' privacy. As seen in Fig. 14, one would have come really close to these spaces between the indoor spaces and the openings to

Fig. 13 Facades in the 19th Century; (a) [14, p.2], (b) [14, p.1]; annotations point out the ability of the outside openings to create visual permeability by hiding the fixed glass behind them

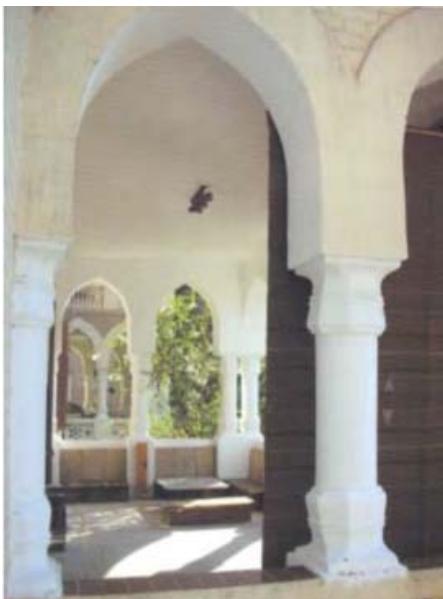
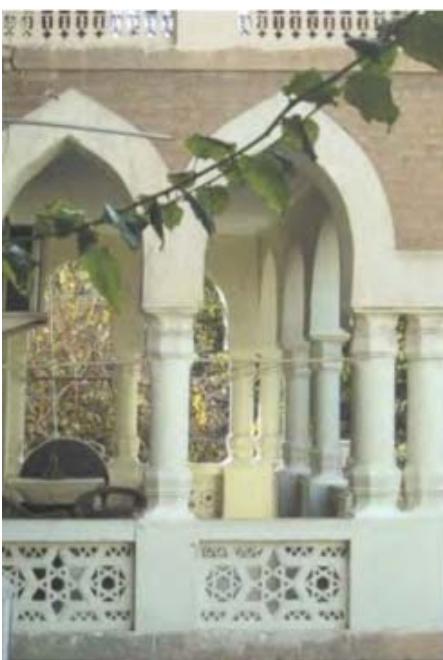
In areas where total visual permeability could not be met, the original designers added glass panels that were identical across the facade for all units and that abided by the local identity code of the El Korba area. However, in present-day El Korba, many of the buildings' facades have changed, and visual permeability is now blocked in many places where the original design intended for transparency. This can be easily seen when comparing the original and current state of the building in Fig. 15.

Fig. 14 Arcade balconies, late 20th century: (a), (b) [13, p.1]

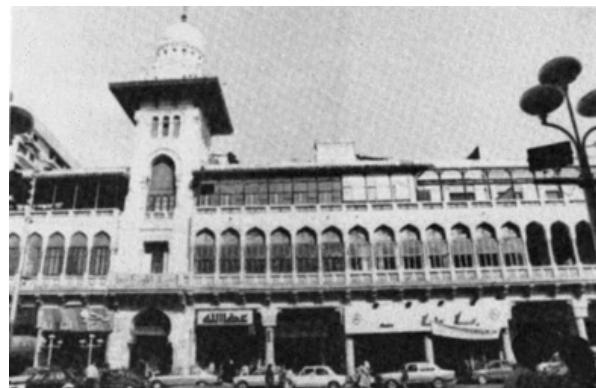
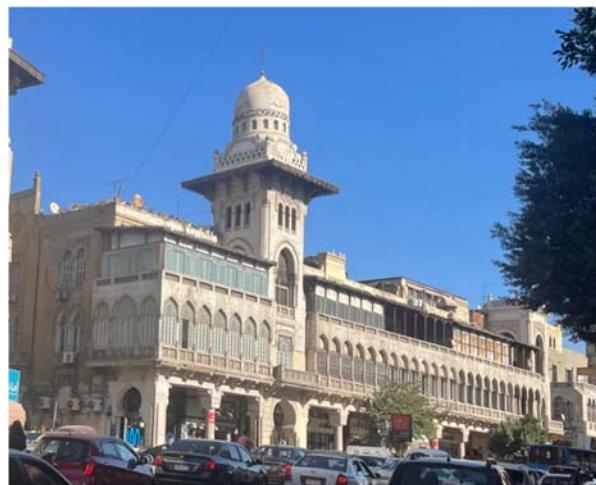
Fig. 15 Buildings in Ibrahim El-Lakkani Boulevard: (a) 19th century [14, p.1], (b) 2022 (taken by author)

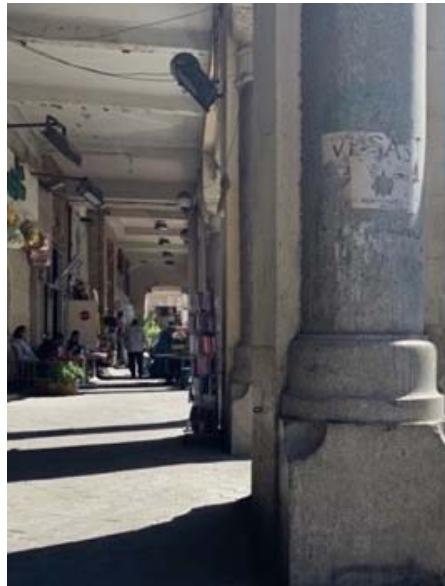
Fig. 16 Baghdad Street arcade, 2021 (taken by author)

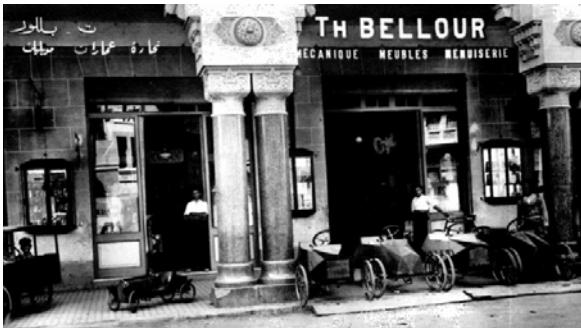
Fig. 17 Heliopolis House Gallery 20th Century [15, p.68]

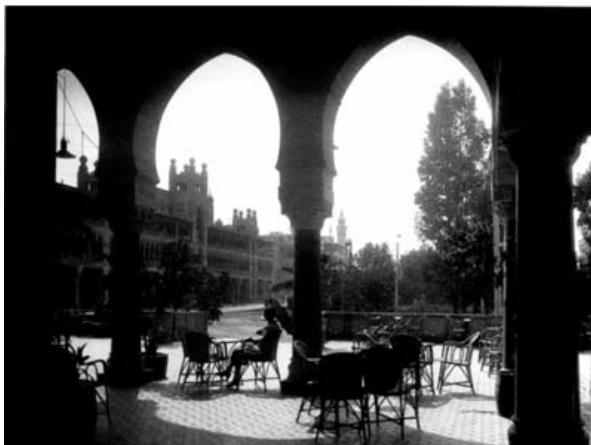
Fig. 18 Heliopolis House Gallery 20th century [15, p.109]

In the original design, seating was added in well-shaded and well-protected areas which were accessible to whoever needed them. Now however, seating areas are not as well-shaded or protected as can be seen when comparing Figs. 18 and 19.

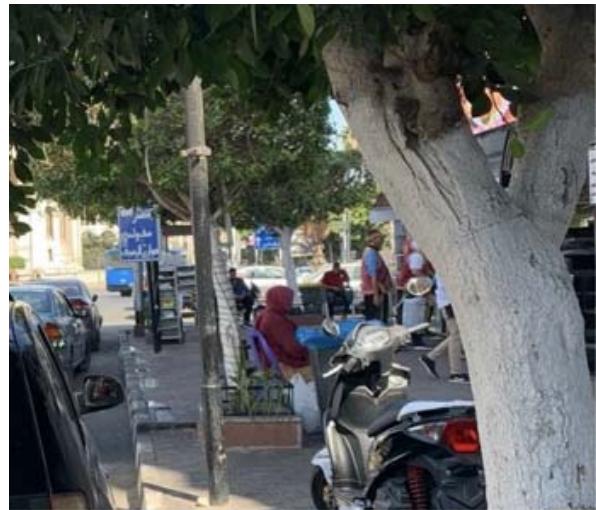
Fig. 19 Restaurant along el-Ahram Street (taken by author)
