# Prediction Study of a Corroded Pressure Vessel Using Evaluation Measurements and Finite Element Analysis

**Abstract**—The steel structures of the Oyu-Tolgoi mining Concentrator plant are corroded during operation, which raises doubts about the continued use of some important structures of the plant, which is one of the problems facing the plant's regular operation. As a part of the main operation of the plant, the bottom part of the pressure vessel, which plays an important role in the reliable operation of the concentrate filter-drying unit, was heavily corroded, so it was necessary to study by engineering calculations, modeling, and simulation using modern advanced engineering programs and methods. The purpose of this research is to investigate whether the corroded part of the pressure vessel can be used normally in the future using advanced engineering software and to predetermine the remaining life of the time of the pressure vessel based on engineering calculations. When the thickness of the bottom part of the pressure vessel was thinned by 0.5 mm due to corrosion detected by non-destructive testing, finite element analysis using ANSYS WorkBench software was used to determi

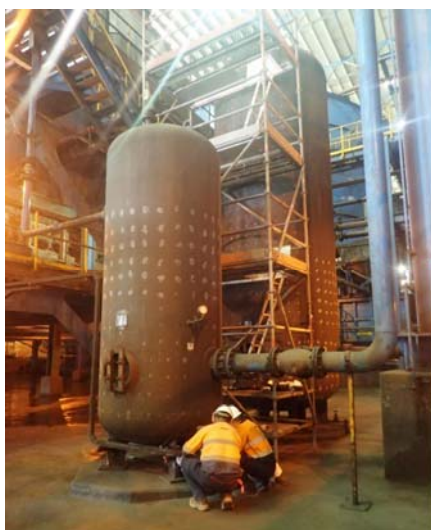
Selected as a research object the pressure vessel number 3820-REC-009 is used in the filtration system of the filter-drying section and also serves as a power source for air-powered equipment (Fig. 2).

Fig. 2 Research object - 3820-REC-009 pressure vessel

Due to regular water cleaning in the area where the pressure vessel was located, the entire steel structure of that area was affected by corrosion. The protective coatings and paint of some steel structures have been deteriorated by rust and are no longer able to perform their primary functions and insufficient air circulation in that area, the humidity level was high compared

to other areas. The safety relief valve located at the top of the pressure vessel was heavily corroded. It can be seen by visual inspection that the inlet and outlet air pipelines of the pressure vessel were heavily corroded.

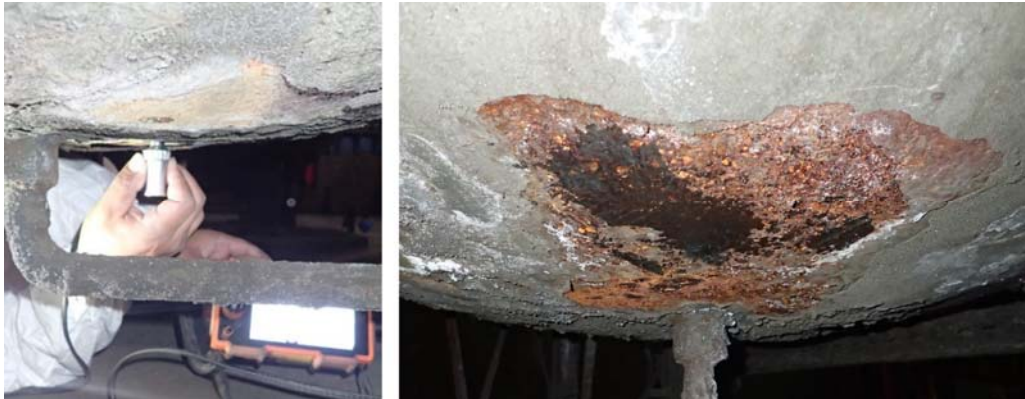
Wall thickness measurements have been performed on pressure vessel steel structures by scheduled non-destructive testing using an ultrasonic instrument, Fig. 3, as per visual inspection report. By creating a unified database of measurements, it will be possible to prevent future risks, as well as monitor how the pressure vessel changes during operation.

A thickness measurement conducted and revealed that the thickness of the bottom part of the pressure vessel was originally 14 mm, as stated in the manufacturer's documentation, but it has been thinned by 0.5 mm. The wall thickness measuring instrument should be calibrated and verified, and the better results will be obtained by measuring as many points as possible on the measuring surface.

Fig. 3 Measurements with the DMS Go instrument used in non-destructive testing

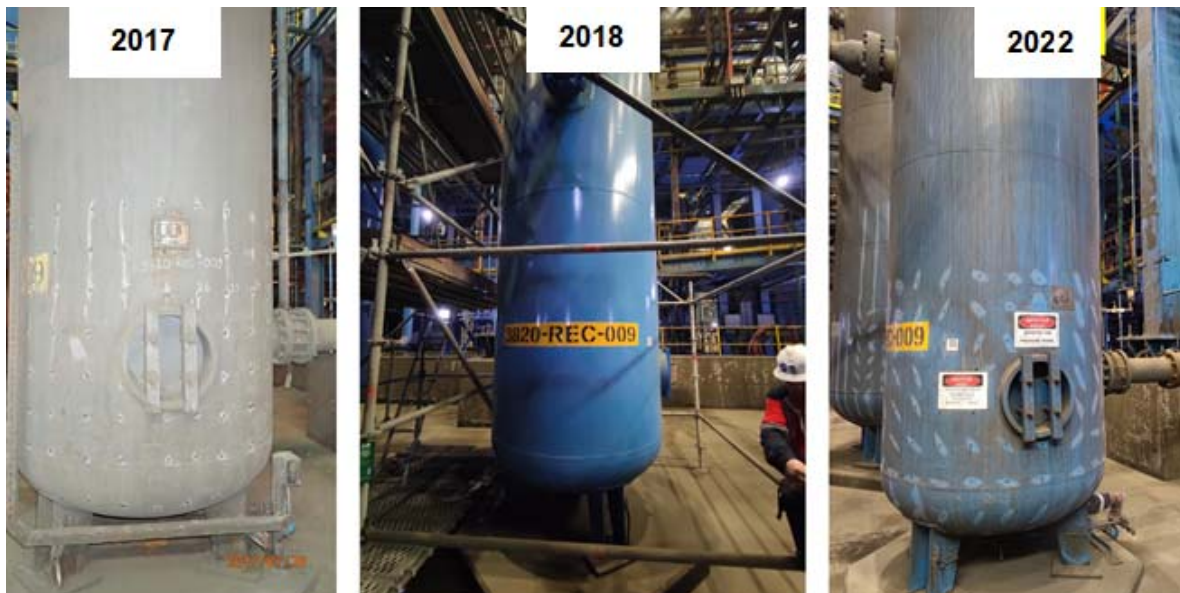
using (1) and (2). In this case, the change in wall thickness and the time used are important (Fig. 4). As an example, the

Fig. 4 Pictures of the view during the measurement
