FRC – A New Sustainable Option for Construction to Mitigate Earthquakes

Abstract—Ten simply supported grossly underreinforced tapered concrete beams of full size were tested upto complete collapse under flexural effect. Out of 10 beams, 5 beams were nonfibrous and the remaining beams contained fibres. The beams had a variation in the tapered angle as 2°, 4°, 6°, 8° and 10°. The concrete mix, conventional steel and the type of fibre used were held constant. Flat corrugated steel fibres were utilized as secondary reinforcement. The strength and stability parameters were measured. It is established that the fibrous tapered beams can be used economically in earthquake prone areas.

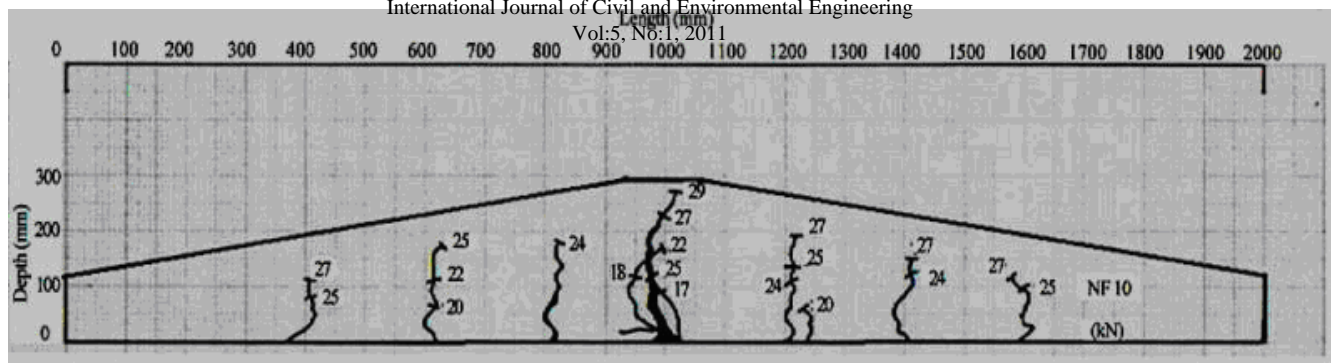
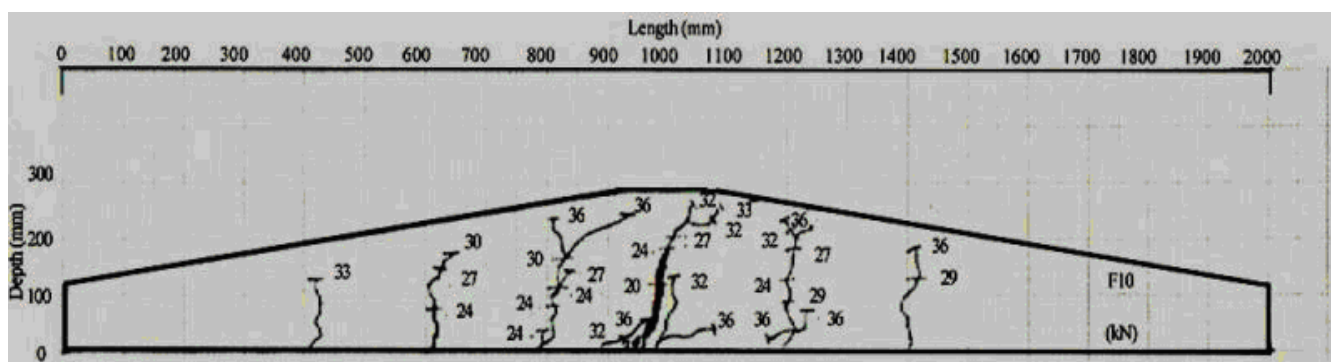
Fig. 11 and Fig. 12 show the cracking patterns of typical beams.

In general, it was observed that all the beams with and without fibres failed in flexural mode only. Most of the cracks were developed in the middle one-third zone of the beam. The structural characteristic property of developing reasonably large number of cracks in the fibrous sets of beams confirmed the law of fracture mechanics.
