# Beating Phenomenon of Multi-Harmonics Defect Frequencies in a Rolling Element Bearing: Case Study from Water Pumping Station

Fathi N. Mayoof

Author is with Department of Mechanical Maintenance, Water Transmission Directorate, Electricity and Water Authority, Kingdom of Bahrain.

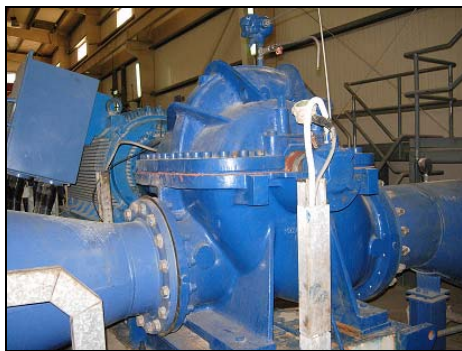
Fig. 2 West Riffa centrifugal pump

A double suction centrifugal pump running at 1480 rpm (24.67 Hz) is installed in West Riffa II water blending station in Bahrain water transmission network as shown in Fig. 2. The main duty of the pump is to pump water from a ground storage tanks to an elevated service reservoir (ESR). The last overhauling of the pump was on May 2008 after which the pump was running smoothly. Fig. 3 shows the vertical frequency spectrum of the Pump-drive end bearing which has an overall vibration of 0.6 mm/s only.

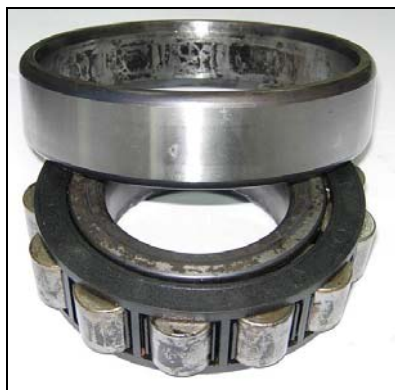
Hence, a recommendation of dismantling the pump and replace the bearings were sent to the maintenance group. Accordingly, the action was taken and the pump overhauled. We inspected the dismantled bearing to confirm the concluded results. Fig. 12 shows the bearing after dismantling. Clearly, dark marks appear inside the outer race and the rollers. A closer view on the roller is shown in Fig. 13. Several rollers were damaged and worn out.

Fig. 12 The bearing after removal. Note the marks in the rollers and the outer race

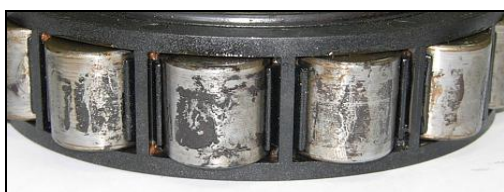
Fig. 13 The defects (dark marks) in the rolling elements of the bearing

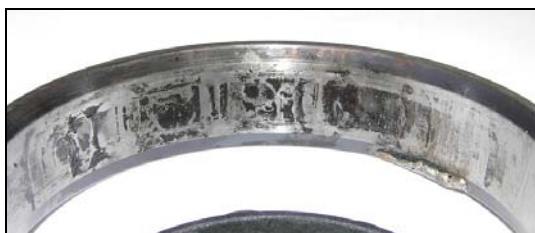
Both outer and inner races were defective as shown in Fig. 14 and Fig. 15. The outer race has a lot of scratches and wear. The same thing could be said about the inner race.

Fig. 14 The defects (dark marks) in the outer race of the bearing

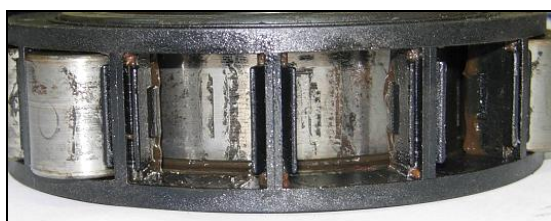
Fig. 15 The defects (dark marks) in the inner race of the bearing
