# Structural Monitoring and Control During Support System Replacement of a Historical Gate

Ahmet Turer

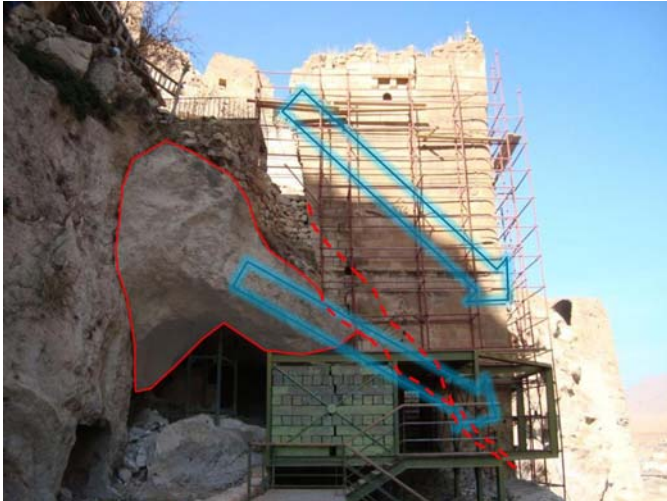
Fig. 1 Middle Gate general view, cracked rock & force paths, and crack pattern

MIDDLE-GATE is located in Hasankeyf, Batman dating back to 1800 BC [1] and is one of the important historical structures in Turkey. The gate is located on a path leading to the upper city which is protected by steep cliffs on all sides and two other gates. The ancient structure has suffered major structural cracks due to aging as well as lateral pressure of a cracked rock which is predicted to be about 100 tons (Figure 1). The existing support system was found to be inadequate to support the load especially after a recent rock fall in the vicinity. Concerns were increased since a large rock block has fallen within close proximity of the middle gate and an existing support system that is integral with a damaged and cracked gate wall was inadequate (Figure 2) and needed to be replaced by a new support system. The support system replacement was a very risky process since the wall and existing support system were in a balance state, removing the existing system would leave the wall vulnerable to immediate damage. Therefore, the cracks needed to be monitored by crackmeters and a control mechanism must be integrated to prevent cracks to expand. Following the replacement of the support system, the new system should maintain similar level of crack on all important locations. Closing the cracks too much relative to their original states should also be prevented since such an action would generate additional stresses and deformations at other places. The monitoring and control system would ensure post replacement condition to be similar to the original state as well.

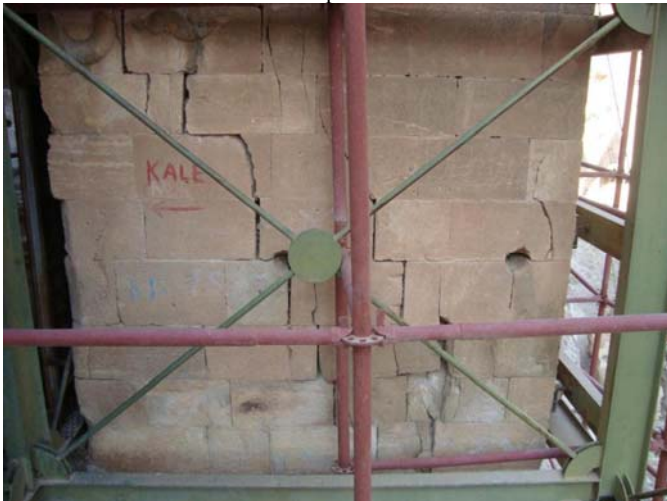
Fig. 2 Close view of the middle gate entrance wall on the valley side

A simple and efficient monitoring system was implemented focusing on the major cracks on the middle gate. The most significant crack was located at the entrance wall on the valley side (Figure 2). The diagonal cracks were clear indication of shear loading exceeding the load carrying capacity of the gate wall. Four crackmeters were placed on the visible cracks of the wall, one at the bottom right corner, two crackmeters at the mid-height of the wall, and fourth gage located on the crack at the top of the wall. The crackmeters were placed in horizontal direction measuring the lateral movement of the upper side of the wall relative to the lower side of the wall separated by a series of diagonal cracks. Two additional crackmeters were located at the cracked rock block behind the middle gate observing movement in the vertical and horizontal directions. The datalogger used for monitoring and control was Campbell CR800 [2] with 6 single ended channels. The system can read 5000mV with 1333 $\mu$ V resolution about 3750 resolution lines or close to 212 which corresponds to 12 bit ADC. Although 16, 18, and 24 bit ADC systems are setting the current standards, 3750 divisions on a 100mm measurement system would provide 0.026667mm resolution. The datalogger programming was made such that each measurement is repeated 500 times with 50 Hz integration frequency to improve the resolution up to 0.0003 mm taking advantage of the random noise on the measurement data vibrating around the actual data. The crackmeters used in the study were potentiometric kind having practically infinite resolution. Therefore, the CR800 system with 6 single ended input channels was the optimum solution for the monitoring project of middle gate. An additional temperature and relative humidity sensor was also integrated to the measurement system to compare, correlate, and compensate temperature induced movement components in the measured long term monitoring data. Temperature and Relative Humidity Probe Model CS215 from Campbell was used which uses SDI-12 protocol to communicate with the datalogger. SDI-12 is a digital communication between the sensor and the datalogger, which permits utilizing digital channels leaving space for the analog sensor channels. Since collected temperature and humidity data is digitized at the sensor, the data can be transmitted over long distances. The sensor can read temperature data between -40° to +70°C with  $\pm 0.4^\circ\text{C}$  ( $+5^\circ$  to  $+40^\circ\text{C}$ ),  $\pm 0.9^\circ\text{C}$  ( $-40^\circ$  to  $+70^\circ\text{C}$ ) accuracy as well as 0 to 100% RH ( $-20^\circ$  to  $+60^\circ\text{C}$ ) with (at 25°C):  $\pm 2.0\%$  (10-90% range),  $\pm 4.0\%$  (0-100% range) accuracy.

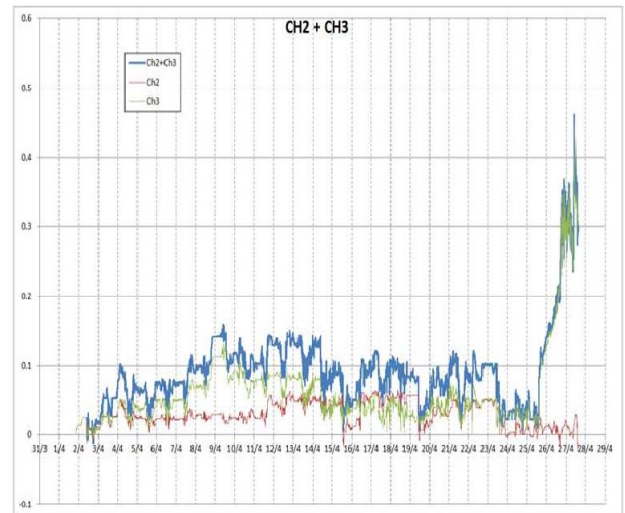
Fig. 3 Monitoring data of the wall crack for about first 25 days

The execution work needed to start with careful considerations and contingency plans if the main planned action would fail. However, the monitoring system gave silent alarms before the actual replacement work has started as a subgroup of workers responsible of the cleaning work unwillingly damaged the existing support system. As the SMS alarm automatically sent by the datalogger was received, a warning was given on site and the new support system had to be rapidly completed as the crack was quickly opening (Figure 3). The new system was completed in less than a day by extra shifts and post-tensioning was applied on the new support system by turning bolts at the end of the new anchors. The system was tightened by hand, and the actual load level existed neither in the old nor in the new support system was known. As the crack width monitoring was continued, the crack width that was rapidly opening before the intervention was observed to be quickly recovering. However, the recovery seemed to be progressing far beyond the original crack width (Figure 4). The over tightening in the new anchorage system was evident from the measured data. The crack was monitored to be closed about 0.2mm more than the original crack width. In order to restore the crack to its original width, the anchor's bolt was rotated backwards. Bolt teeth had about 20 rotations in 73mm distance. The bolt had to be untightened about 1/20 rotation to bring back to original width [3]. The leverage to untighten the bolt had 1m radius. The operator was asked to revolve the end of the leverage about 0.32m to achieve 0.2mm release [3]. The measured data indicates the untightening process bringing the crack width back to its original value (Figure 4).

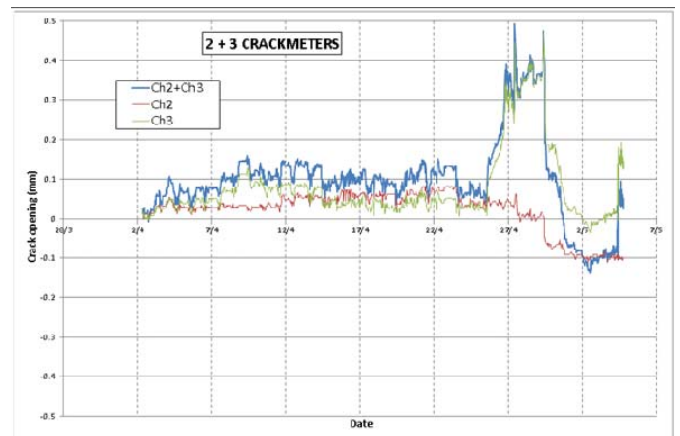
Fig. 4 Crack control by bolt rotation adjustment

Furthermore, the crack width was adjusted back to its original state using the control system maintained by the crackmeters.
