Role of Oxide Scale Thickness Measurements in Boiler Conditions Assessment

M. Alardhi, A. Almazrouee, S. Alsaleh

Keywords—Superheater tubes; Oxide scale measurements; Overheating

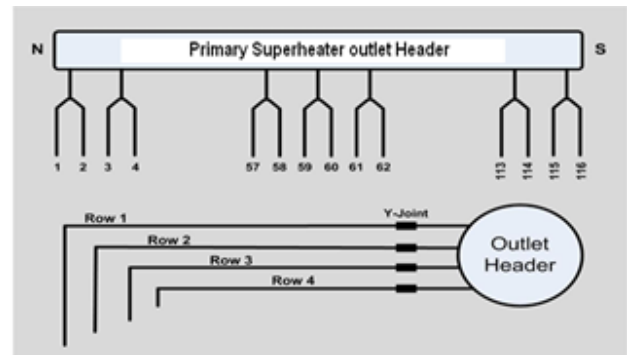
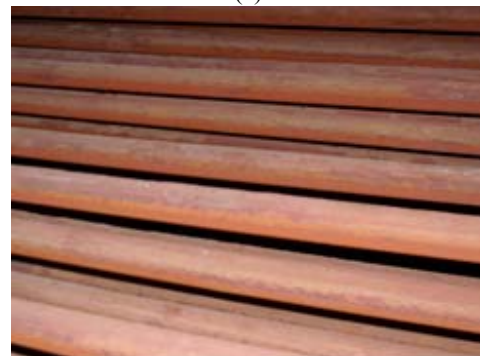
Fig. 1 (a) Schematic illustration of the primary superheater setup and (b) the tube bank

Chromium-molybdenum steels are used extensively in the manufacturing of piping, heat exchangers, pressure vessels and several other high temperature components in process and power plants, due to their creep and oxidation resistance [12-14]. They are used in Kuwaiti power plants in primary and secondary superheaters for long times. However, in one of Kuwaiti power plants, a number of failures were encountered mainly in the first row of the primary superheater tubes. As a results, the specialized engineer decide to replace them during the annual shutdown. The primary superheater, in the studied boiler, consists of four rows of tubes, each row having 116 tubes that are connected to the outlet header (Fig. 1). The design operating temperature for the outlet of the primary superheater is 436 °C.

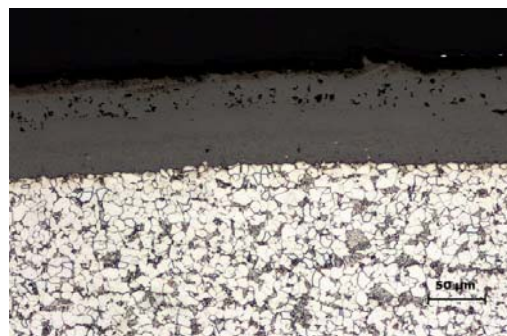
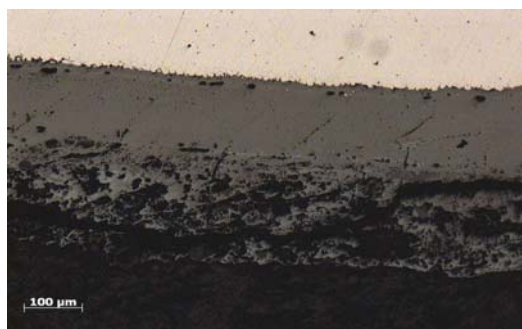
Fig. 2 Optical micrograph of (a) Fireside oxide scale showing thick layer with some spallation and (b) intact steam side oxide scale

The repeated failure in the boiler can be caused by several reasons such as overheating, fireside corrosion, fatigue, and creep. The temperature of the boiler firing and the steam temperature play significant role in these failures. Therefore, the metal temperature which can be approximated by the oxide scale measurements should show whether the design conditions are met or not. The oxide scale were thicker in fireside when compared to steam side. Spallation were noticed in fireside oxide scales and as a result they are not considered in oxide scale measurements.

The temperatures of all tubes are above the design operating temperature by more than 100 °C. This is a clear indication of overheating suffered by these tubes which can explain the repeated failures in this boiler. This overheating can reduce the life of these tubes as a result of creep in less than design time. Also, localized oxidation can be encountered which lead to localized overheating that reduce wall thickness and lead to tube burst. Another interesting remark, is the microstructural degradation that was found in some of these tubes. Some of these tubes suffer from spheroidization as a result of this overheating. Moreover, one of the tubes showed a clear decarburization zone of 150 µm. These microstructural alteration need more analysis to find the root cause of this degradation. However, one clear cause is the long term overheating of as a result of improper boiler firing. The temperature seems to raise gradually as the number of tube increases. This is an indication that a part of the boiler is overheated more than the other. Firing procedure should be reviewed to find out the reason for this overheating and the non-uniformity of the heating for boiler tubes.
