Various Information Obtained from Acoustic Emissions Owing to Discharges in XLPE Cable

Tatsuya Sakoda, Yuta Nakamura, Junichiro Kitajima, Masaki Sugiura, Satoshi Kurihara, Kenji Baba, Koichiro Kaneko, Takayoshi Yarimitsu

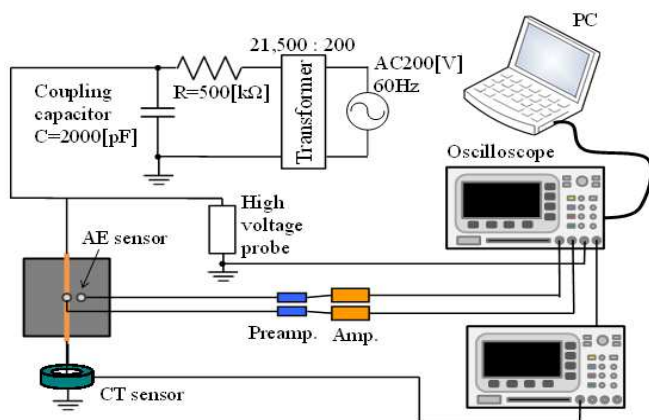
Fig. 1 Experimental setup for AE measurement

Instead of creeping discharge occurred outside a XLPE cable, we here generated discharges at the surface of a plate-like EPR and inside a sandwiched EPR plates. Figure 1 shows the experimental setup for measurements of AE signal and PD current, and Fig. 2 shows electrode arrangements for generation of discharges at the surface of a plate-like EPR and inside a sandwiched EPR plates. A plate-like EPR (200 mm × 200 mm) with thickness of 10 mm, density of 1.19 g/cm³, dielectric constant of 3.0 and volume resistivity of $5 \times 10^{15} \Omega \cdot \text{cm}$ was used here. A couple of copper needle-like electrodes 10 mm in width was arranged on the surface of an EPR plate with length of 110 mm. The gap length of the electrode system was 3 mm. When discharges were generated in EPR, a couple of copper needle-like electrodes was sandwiched by a 20 mm-thick-EPR plate and two EPR plates with a total thickness of 40 mm. AC voltage with frequency of 60 Hz was applied until discharges were generated, and its range was 2 - 4 kV.

A piezoelectric AE sensor with a diameter of 10 mm and the wide frequency sensitivity in the range of 20 kHz to 1000 kHz was arranged at the surface of a CV cable. In the case when AE signals owing to outside discharges were measured, an AE sensor was arranged on the surface of an EPR plate. The distance between the AE sensor and the center of the gap axis of an electrode system was 20 mm. The AE signal detected by the AE sensor was amplified by a preamplifier of 30 dB (Maximum gain: 40 dB) with a frequency band of 2 kHz - 1.2 MHz and a main amplifier of 50 dB (Maximum gain: 40dB) with a low pass filter of 500 kHz, i.e., a total amplification was 80 dB. The signal from the amplifier system was sent to a digital oscilloscope with a sampling frequency of 1 MHz or 50 MHz and then recorded with a computer for further analyses including a fast Fourier transform (FFT).

PD current with a pulse width of several tens ns was detected with a CT sensor and was sent to a digital oscilloscope with a sampling frequency of 100 MHz, which triggered a digital oscilloscope used for recording AE signals. The measurements of the AE signal and the PD current against time (t) elapsed from the voltage application were continuously carried out.

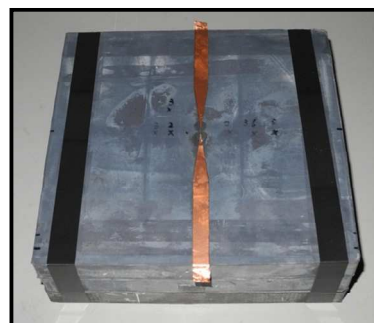
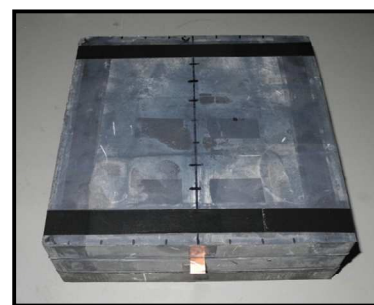
(a) Electrode arrangement for outside discharge

(b) Electrode arrangement for inside discharge

Fig. 2 Electrode arrangement for generation of discharges

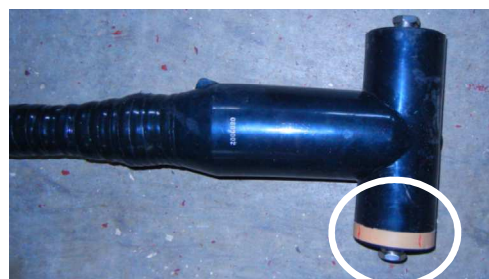
Fig. 3 T-branch joint for a 22 kV distribution system

Figure 3 shows our used T-branch joint of XLPE cable for a 22 kV distribution system. Figure 4 shows the experimental setup for measurements of AE signal and PD current, and Fig. 5 shows the arrangement of AE sensors on the surface of a T-branch joint with outer diameter of 86 mm. The insulation taps were connected to the T-branch joint, and two copper needle-like electrodes mentioned in Sec. A were arranged on the surface of the connected insulation tap. The distance between the tip of the copper electrode and the tip of the conductor of T-branch joint was 20 mm. AC voltage with 60 Hz was applied to conductor of the T-branch joint in order to generate discharges and its range was 5 - 10 kV.

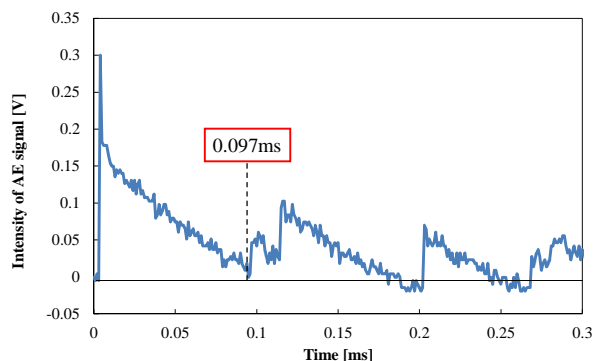
(a) AE signal in the case of outside discharge

(b) AE signal in the case of inside discharge

Fig. 7 AE signals obtained when outside and inside discharges were generated

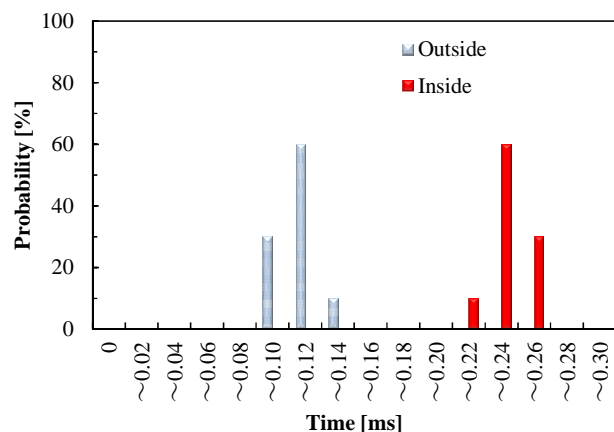
Fig. 8 Distribution of decay time for the cases of outside and inside discharges

Figure 8 shows distribution of decay times for the cases of outside and inside discharges.

The number of measurements was 3 for each discharge. The decay time for the case of outside discharge is in the range of 0.1 to 0.14 ms whereas that for the case of inside discharge is in the range of 0.22 to 0.26 ms. As mentioned before, the leakage currents for both cases were the almost same, i.e., the amounts of energy release owing to discharges might be the almost same. Energy transformed into generation of elastic wave passing EPR may disperses in all directions of EPR in the case of the inside discharge. However, in the case of the outside discharge, energy transformed into generation of elastic wave passing EPR is half. Therefore, the AE signal for the case of the outside discharge is smaller than that for the case of the inside discharge. Additionally, a period which the AE signal is continuously detected is short.

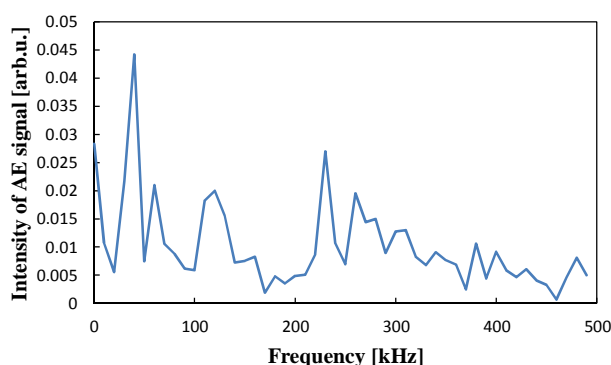
(a) Outside discharge

(b) Inside discharge

Fig. 9 FFT spectra obtained from AE signals for the cases of the outside and inside discharges

Figure 9 shows FFT spectra of AE signals shown in Fig. 6. A frequency component around 60 kHz is extremely larger than other components for the case of the inside discharge (Fig. 9(b)). As shown in Fig. 6, the maximum intensity of AE signal owing to the inside discharge (Fig. 9(a)) is 3 times larger than that owing to the outside discharge. Thus, the large AE signal for the case of the inside discharge is mainly due to a frequency component around 60 kHz. In contrast, the intensity around 60 kHz for the case of the outside discharge is much small (about one-sixth) in comparison with that for the case of the inside discharge. Instead of frequency component of 60 kHz, frequency component around 40 kHz and higher frequency components than 200 kHz are large.

Thus, envelop detection is useful for distinguishing between the inside and the outside discharge, i.e., between PDs or creeping discharge on the surface of a joint / terminal section of a XLPE cable. If adding frequency information obtained from detected AE signal, the distinction accuracy will be higher.

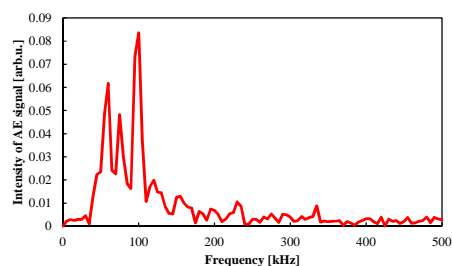
Fig. 11 FFT spectra of AE signals shown in Fig. 10

Next, we show FFT spectra of Fig. 10 in Fig. 11. A frequency component obtained by “Sensor A” is large at around 60 kHz. In contrast, a frequency component at around 100 kHz is larger than at around 100 kHz. This may be due to attenuation of main component of 60 kHz.

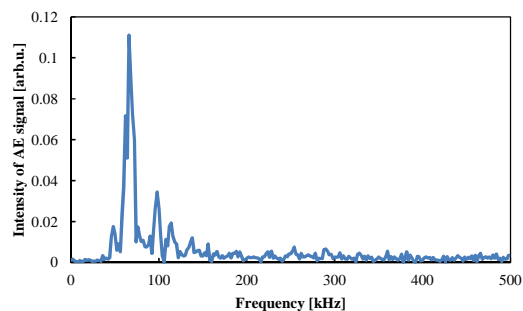
Fig. 15 FFT spectra of AE signal shown in Fig. 14

As can be seen from this figure, two AE waves are continuously detected. Therefore, a period which AE signal was continuously detected becomes long. The period is about 0.5 ms when two discharges were generated and overlapped whereas that when one earth electrode was arranged was about 0.25 ms. However, FFT spectra of Fig. 14 is the almost same as that of Fig. 11(a). Thus, the results indicated that we can distinguish between single and plural discharges by paying attention to a period which AE signal is continuously detected.
