# Microscopic Analysis of Welded Dental Alloys

**Abstract**—Microplasma welding is a less expensive alternative to laser welding in dental technology. The aim of the study was to highlight discontinuities present in the microplasma welded joints of dental base metal alloys by visual analysis. Five base metal alloys designated for fixed prostheses manufacture were selected for the experiments. Using these plates, preliminary tests were conducted by microplasma welding in butt joint configuration, without filler material, bilaterally and with filler material, proper for each base metal. Macroscopic visual inspection was performed to assess carefully the irregularities in the welds. Electron microscopy allowed detection of discontinuities that are not visible to the eye and revealing details regarding location, trajectory, morphology and size of discontinuities. Supplementing visual control with microscopic analysis allows to detect small discontinuities, which escapes the macroscopic control and to make a detailed study of the weld.

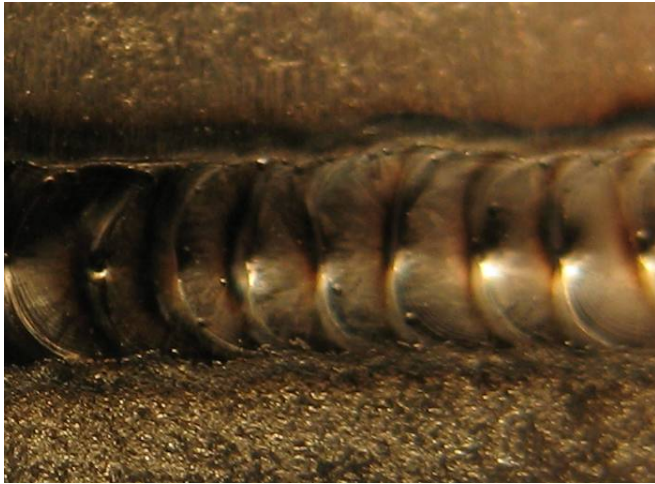
Fig. 1 Macroscopically image of a Heraenium NA alloy welded without filler material: uniform welding ribs, with a proper overlap of the spots and good penetration

Making comparison between Ni-Cr alloys taken in the experiment, the best alloy welds appear at Heraenium NA, both without filler material and with filler material. Macroscopically uniform welding ribs were observed, with a proper overlap of the spots and good penetration (Fig. 1).

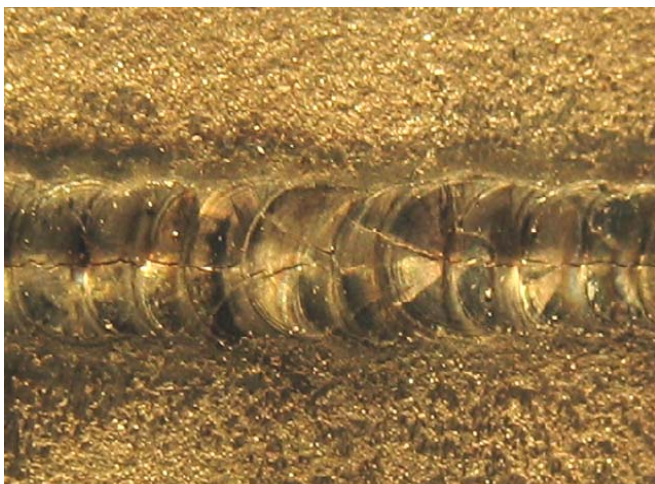
Fig. 2 Macroscopically image of a Wiron 99 alloy welded without filler material: longitudinal discontinuous crack on the weld trajectory

Regarding the other two alloys, welding with filler material is better for NB Wirloy than for Wiron 99, but there are visible defects in both cases. Welding without filler material has fewer discontinuities in Wirloy NB compared to Wiron 99.

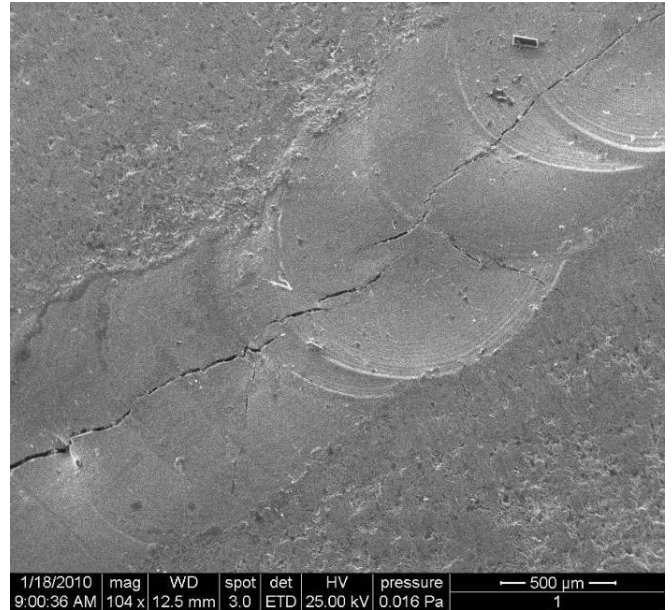
Fig. 3 Electron microscopically image of a Wiron 99 alloy welded without filler material: longitudinal discontinuous crack on the weld trajectory

Electron microscopy allowed detection of discontinuities that are not visible to the eye and revealing details regarding location, trajectory, morphology and size of discontinuities (Fig. 3-7).

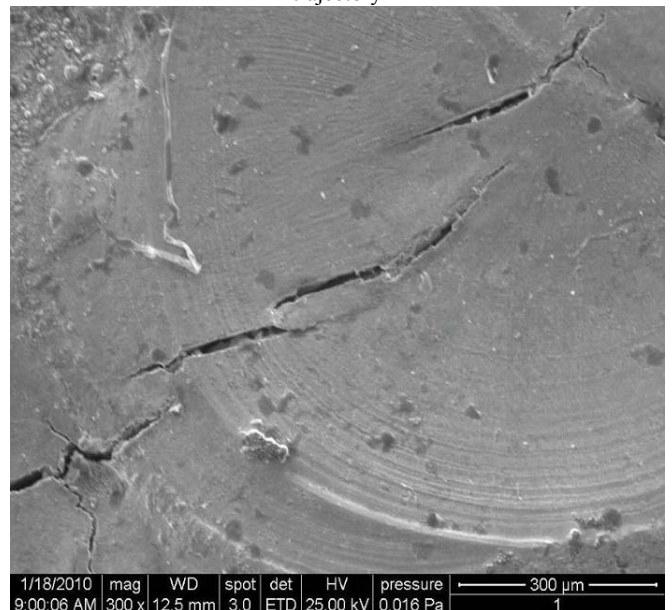
Fig. 4 Electron microscopically image of a Wiron 99 alloy welded without filler material: detail of an interrupted longitudinal crack on the weld trajectory

overlapping, filler material distribution can be seen. Sometimes, by macroscopically visual inspection very small cracks are not noticed. At electron microscopically examined samples very small cracks both longitudinal and transverse or oblique were detected in the welding rib. Some start from the main longitudinal cracks, some from the middle spot, others are completely isolated.

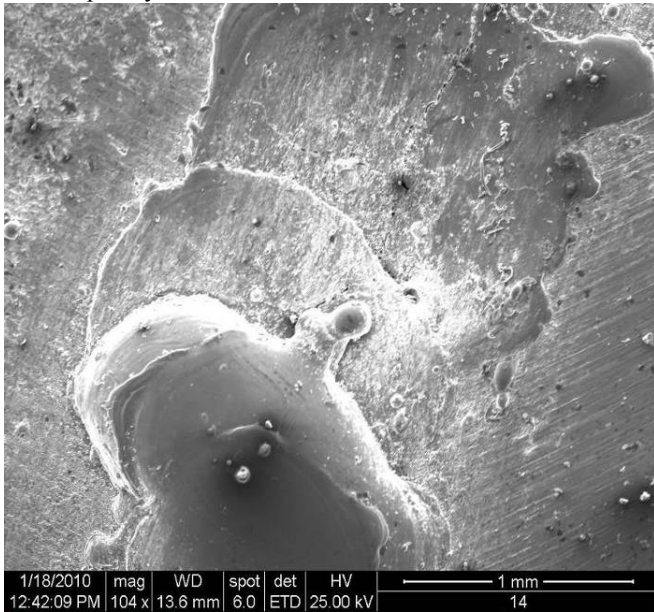
Fig. 5 Electron microscopically image of an SG Wirobond alloy welded with filler material: detail of ununiform distribution of the filler material

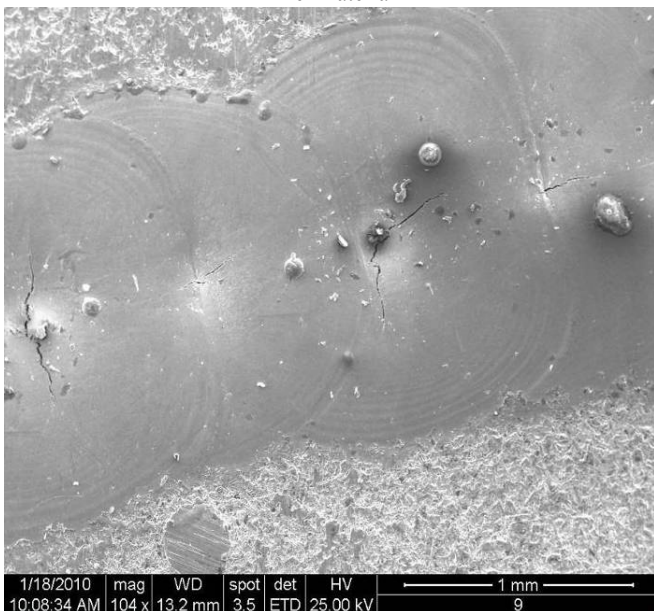
Fig. 6 Electron microscopically image of Heraenium NA alloy welded joints, without filler material: detail of short, radial cracks in the middle of the spot

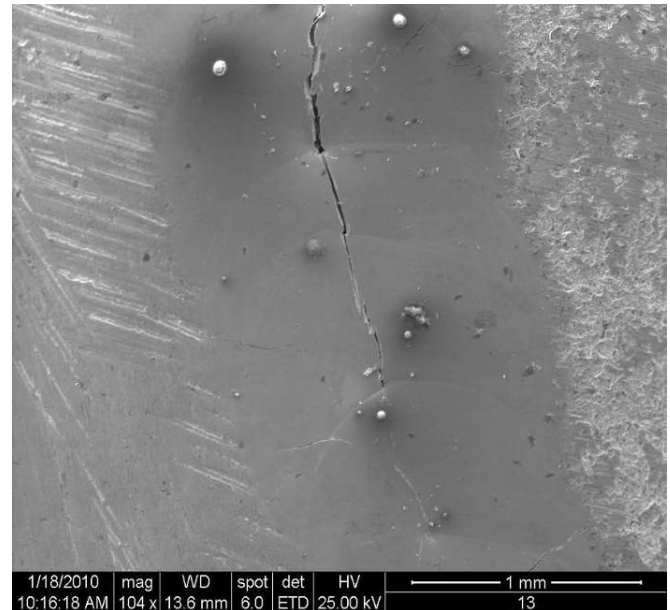
Fig. 7. Electron microscopically image of an SG Wirobond alloy welded without filler material: detail of a continuous longitudinal crack, and isolated oblique cracks in the welding rib.
