The Effect of Micro Tools Fabricated Dent on Alumina/Alumina Oxide Interface

Taposh Roy, Dipankar Choudhury, Belinda Pinguan-Murphy

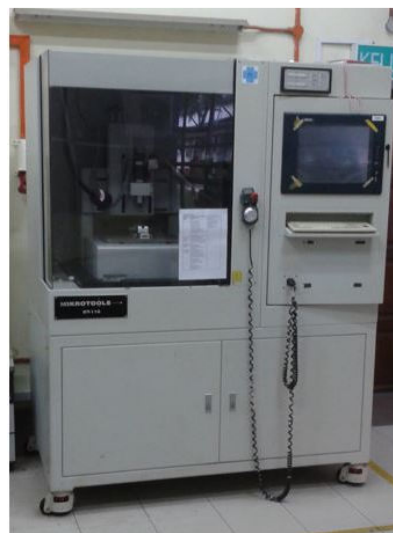
Fig. 1 (a) Mikrottools DT110 and (b) Micro drill tools

There selected three set of dent profiles based on literature — diameter 400µm, depth 20µm and distance between two dents were 2 and 1.5mm. The desired micro-dent surface were prepared by using a Mikrottools DT110 multipurpose micro machine with a set of solid carbide drill bit (0.4mm diameter, n=6). The drill bits were supplied by PrecisetechSdn. Bhd. (Selangor, Malaysia), where the recommended spindle speed was 55,000 rpm and feed rate was 334mm/min for effective drilling on hard ceramic substrate. The CNC Mikrottools DT110 and drill bits are shown in Fig. 1. Based on the recommendation and designed surface geometry, a numerical program (CNC) was prepared and installed in the Mikrottools DT110. To avoid the machining error due to wear of drill bit, every single surface was drilled by a brand new drill bit. Moreover, a further surface polishing was conducted in order to remove the dent burs. Finally an ultrasound cleaner was used to clean so; it was made sure that no foreign particles were stuck inside the dent generated from polishing material or drill bit. AnEDS examination was carried to confirm the purity of dent from these foreign particles.

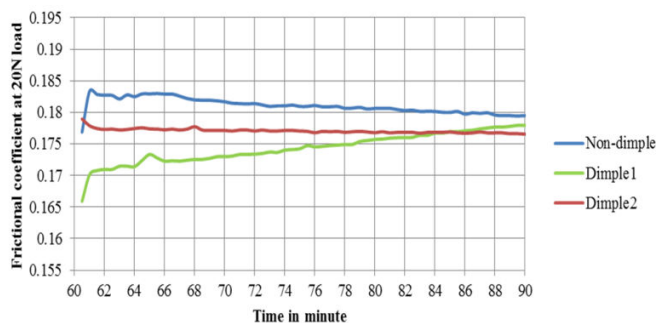
Fig. 6 Friction coefficient for different sample at 20N load

The results for the samples with 20N dimples are shown in Fig. 6. From figure it is clearly shown that due to increase of load the friction also increased. At the 20N load, initial the frictional coefficient was less on dimple1 but it was gradually increased and 90 minute it was higher than the dimple2 surface.
