Site Inspection and Evaluation Behavior of Qing Shang Concrete Bridge

Keywords—Field investigation, prestressed concrete box girder, maintenance, Qing Shan Bridge

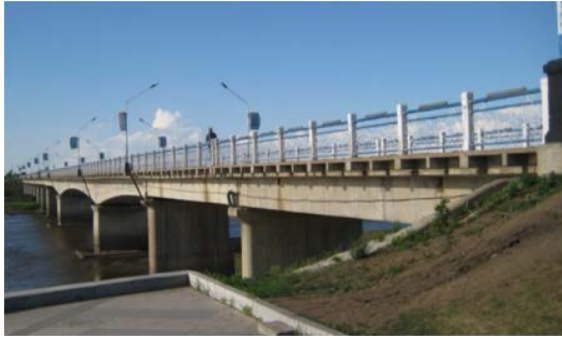
Qing Shan Bridge shown Fig. (1.1) is located in He Gang – Nenjiang 303 provincial highway lane, Heilongjiang Province, China; an important bridge in the urban areas of Wu Dalian Chi. The bridge has been operating for more than 29 years since August 1982. Bridge length is 314.0 meters, including 13 Span; the bridge consists of the left approach, right approach and the main bridge span. among them, the left approach abutment no. 1- Pier no. 2 (A1 ~ P2) has two span, 20 meter of reinforced concrete simply supported T beam; the main bridge pier no. 2 – pier no. 5 (P2 - P5) has three-span in total, overall prestressed concrete box girder, spans arrangement are (30m +50 m +30 m); the right (P5 ~ A2) Approach has eight spans, 20 meter of reinforced concrete simply supported T beam, the horizontal section consists of five simply supported T beam, jointed together.

Fig.1 is located in He Gang – Nenjiang 303 provincial highway lane, Heilongjiang Province, China

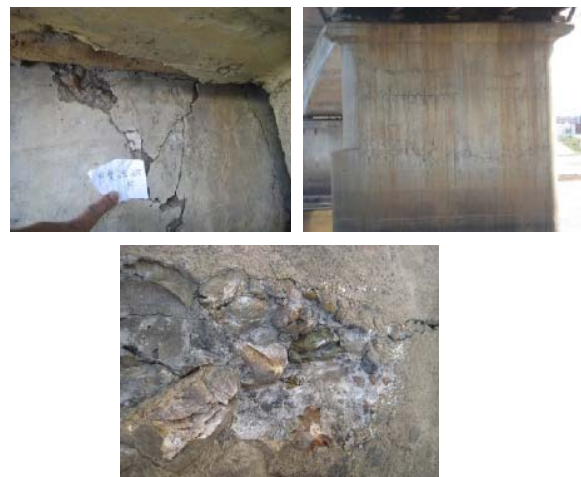
Fig. 4 Damage of concrete bridge abutment #14 and pier No. 5

After checking the abutment joints, the joints were filled with sand and small stones and other debris; the result will be the abutment expansion joints lose functionality. The beams were close to the abutment wall, and the reasons for these

defects include the following : (1) elongation due to heated up beam contract the concrete of back wall. (2). soil pressure behind the abutment makes the abutment move or tilt forward. In other word, the pressure between the beam and the back wall directly causes the damage and defect of concrete as shown in Fig. (4).

The cracked part of the back wall, affecting the durability of the bridge, also if the abutment is damaged to certain degree, the stability of the bridge will be worse.

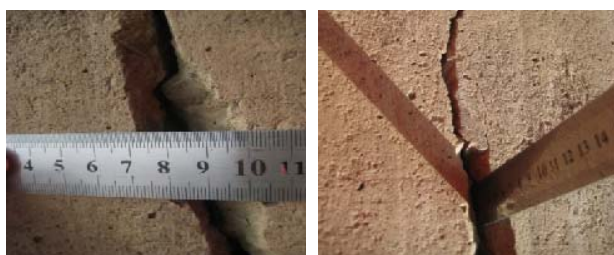
Fig. 5 5 Pier # 5 crack depth

- (7) The extent of serious damages in piers #5 and # 11 the maintenance and reinforcement must be carrying out for piers. The extent of other minor damage should also apply maintenance process.

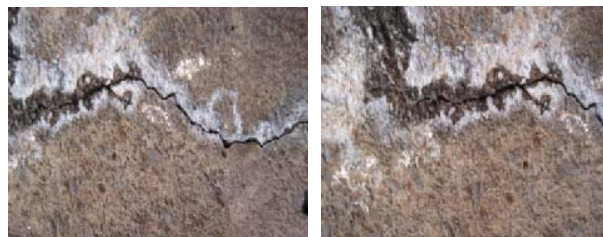
Pier #5 conditions is worse, badly influence on carrying capacity and the durability of the bridge. Some cracks there have white lime precipitation, crack width about 0.6mm, as shown in Fig. (6).

Fig. 6 South side of the pier # 5 surface cracks whitening

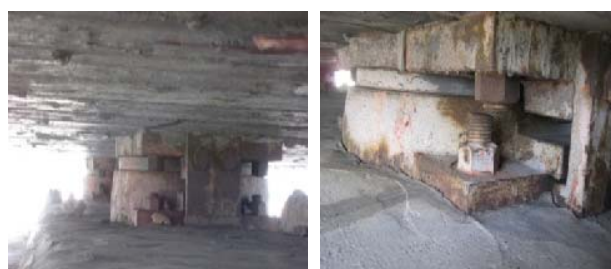
Simply supported reinforced concrete T beam was used steel bearing, bearing dose not showing damage reduction activities, Capping beam have no any obvious damage.

Fig. 8 Bearing steel plate

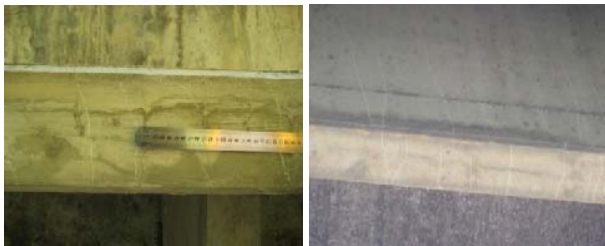
The T beam of all 10 spans were investigated, the occurrence of most T beams have cracking phenomenon occurred. T Beam crack region appears at the bottom under bent beam, crack extended upward along the ribbed T beam, the individual extends to the T beam flange crack, crack width distributed over 0.1mm to 0.4mm, the maximum was about 0.4mm, and crack spacing was about 10 to 15cm. The bridge needs to be improved the flexural bending strength. T beam support region have shear cracks, diagonal cracks were found there, but does not covered large area, crack width about 0.2mm. Cracks generated by the structural force and that

reflect the possible consequences of inadequate carrying capacity of the bridge, which effect on bridge safety and durability. Fig. (9) show the cracks types.

Fig. 9 (c) T beam cross-cracks in the region

- (1) The active implementation of the Qing Shan Bridge, detailed investigation, the static load test, designed must be carried out to provide the necessary technical basis for the maintenance.
- (2) Approach spans of reinforced concrete T-beam should provide design of the implementation reinforcement to increase the carrying capacity of the bridge.
- (3) Replacement of expansion joints. However, in order to improve driving conditions and improve the bridge level of service, while reducing the workload

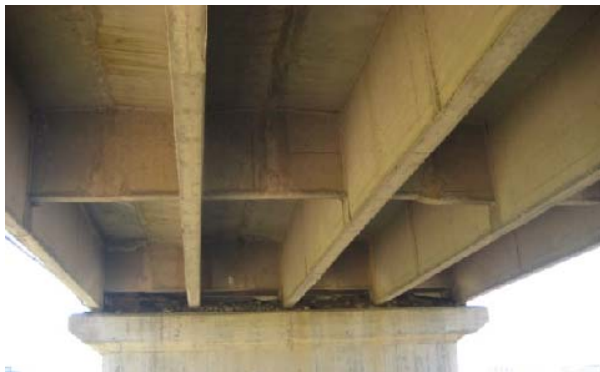
All lateral connections on the bridge observed in detail, simply supported T beam horizontal connections in good condition and the occurrence of cracking was apparent, diaphragm locally have crack, but crack width was small, about 0.1mm.

Fig. 9 (d) T Beam connections is good, no obvious damage (diaphragm)

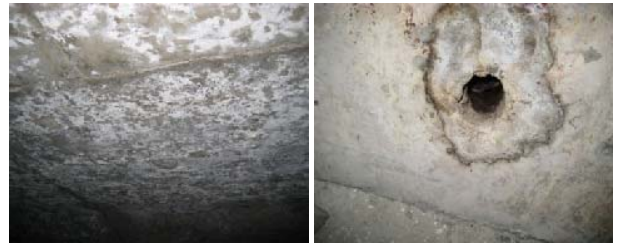
The continuous beam span for the whole box girder and the concrete surface was in a good condition, no obvious damage and cracks. Climb from the box at pier 2 internal inspection of the box found within the surface of structural cracks, top of the local area (especially the original hanging holes of hanging span) the concrete take off, tendons exposed and leaking.

Bridge deck waterproofing was in bad condition, box

leakage, closed hole wasn't dense construction which effect on the durability of the bridge

Fig. 9 (a) the internal box water drainage damage

- (4) Provide appropriate repairs for steel corrosion, concrete cracking and falling concrete parts.
- (5) Completely replace the waterproof layer, re-set the road vent pipe (vent pipe should be guaranteed about 20cm below the main beam);
- (6) Re-laying of pavement, to resolve technical issues such as Bump;

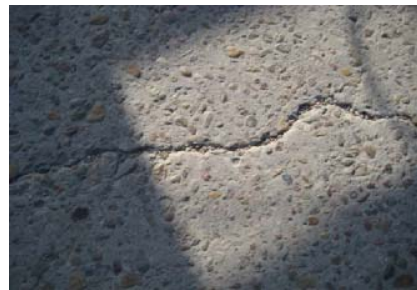
Cement concrete pavement deck with less smoothness, spots potholes, and cracks. Cracking phenomenon effect on carrying capacity of the bridge, functionality, durability,etc, as shown in Fig. (10)

Fig. 10 Deck Damage

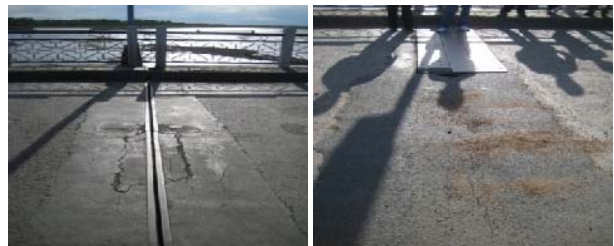
There are severely damaged expansion joints shown in Fig. (11), basically loss of functionality, overloading rolling, improper maintenance witch effect on durability.

Fig. 11 Serious damaged bridge deck expansion joint

of the daily maintenance and management, proposed a continuous deck structure, to minimize the number of joints.

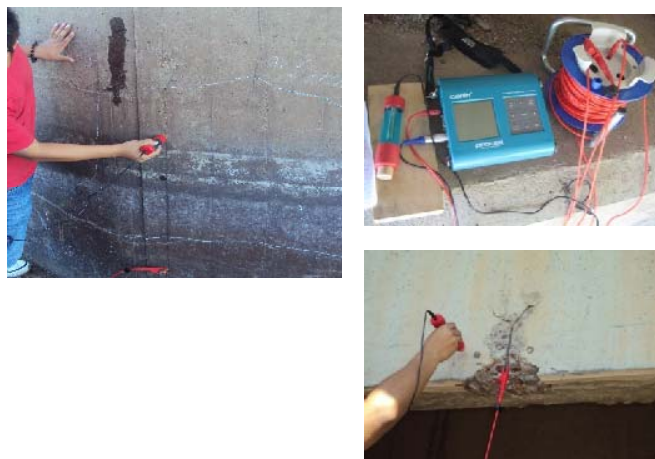
Test results showed that: According to the relationship between steel potential values and the steel corrosion, that the main reinforced concrete cover layer has serious damage, the other side layers had no visual cracks. The damage of concrete layer shows the seriously steel corrosion as shown in Fig. (12).

Fig. (12) Steel corrosion detectors
