# Analysis of Highway Slope Failure by an Application of the Stereographic Projection

**Abstract**—The mountain road slope failures triggered by earthquake activities and torrential rain namely to create the disaster. Province Road No. 24 is a main route to the Wutai Township. The area of the study is located at the mileages between 46K and 47K along the road. However, the road has been suffered frequent damages as a result of landslide and slope failures during typhoon seasons. An understanding of the sliding behaviors in the area appears to be necessary. Slope failures triggered by earthquake activities and heavy rainfalls occur frequently. The study is to understand the mechanism of slope failures and to look for the way to deal with the situation. In order to achieve these objectives, this paper is based on theoretical and structural geology data interpretation program to assess the potential slope sliding behavior. The study showed an intimate relationship between the landslide behavior of the slopes and the stratum materials, based on structural geology analysis method to analysis slope stability and finds the slope safety coefficient to predict the sites of destroyed layer.

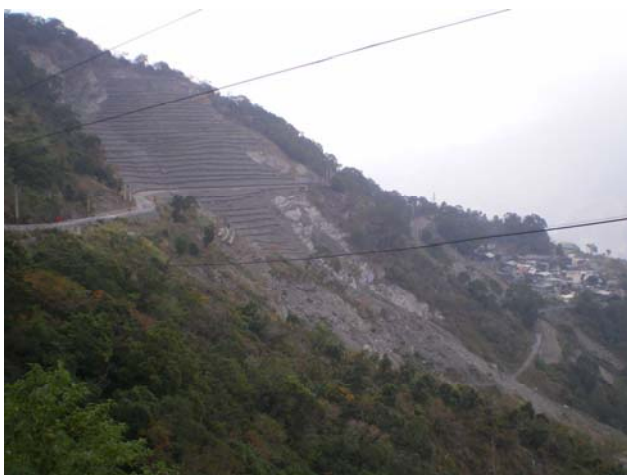
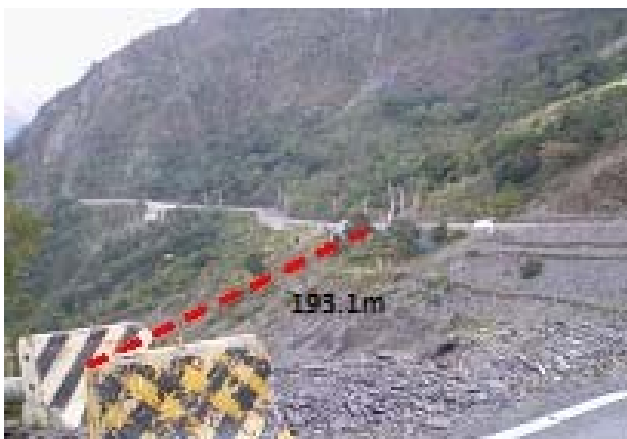
Fig. 1 Location of slope collapse and sliding

County, along which disasters such as slope collapse and sliding usually occur whenever there are typhoons or heavy rainfalls (Figure 1). Hence, in order to understand the slope collapse features of this sector of road, geological investigations in the collapse area in this research are based on site investigation and the evaluation of remote survey images. By applying this method, we can understand the landscape undulation, geological materials, geological structures, hydrological environment, and other main linear structures. Also, we can conduct slope stability analyses to better understand the sliding failure mechanism of the area of collapse by applying the Stereographic Projection Method, which is based on structural geology.

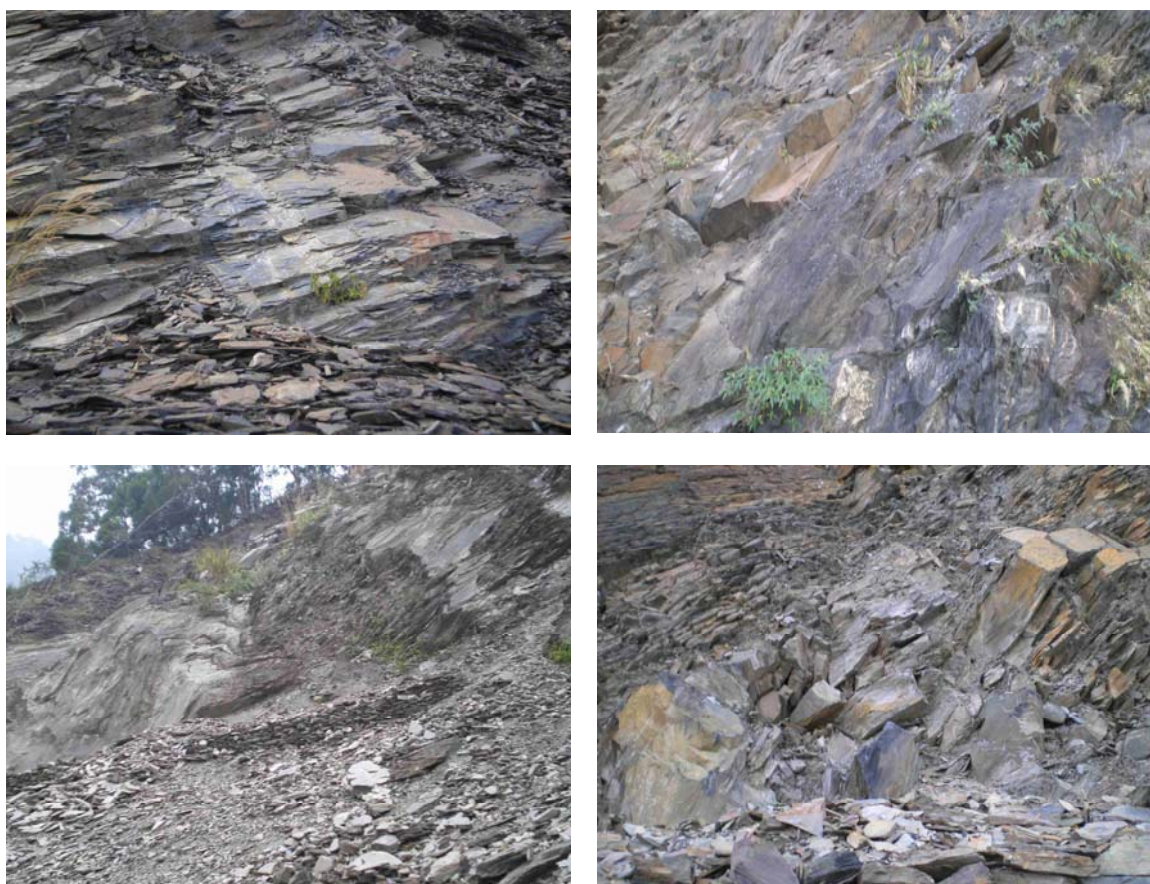
Fig. 3 Brief geological descriptions

With an average altitude of more than 1,000m, the terrain of Wutai Township is rugged with steep slopes. Ali Village is situated in east Wutai with altitudes ranging between 1,180m-1,300m; the level difference of this village is approximately 120m. The overall terrain descends from the east and southeast to the valleys in the north. Neighbored by Jilou Village on the northwestern side, the overall terrain there descends from the south to the north. The average altitude of Jilou Village is between 1,030m-980m, with a level difference of approximately 50m. Pingtung County is divided into two geological zones: the Central Mountain Range Geological Zone and the Hengchun Peninsula Geological Zone. Rocks there are mainly dark grey and grey-black hard shale, slate or phyllite and belong to the region of Tertiary low-grade metamorphic rock. Located at the south end of the Central Mountain Range, the regional geology of Wutai Township mainly consists of slate, which is one kind of metamorphic rock, due to the high temperature and pressure of the Earth's crust. Slopes along Provincial Road No. 24 in the mountains are closely aligned slates which are easy to break or shell off because of external forces, as shown in Figure 3. The rock stratum of the collapse area is shown in Table 1. The active faults in the adjacent area are as follows. With a distance of 11.8 km, the nearest fault is Chauzhou fault, which is followed by Liouguei fault and Cishan fault with distances of 21.64 km and 31.5 km, respectively.

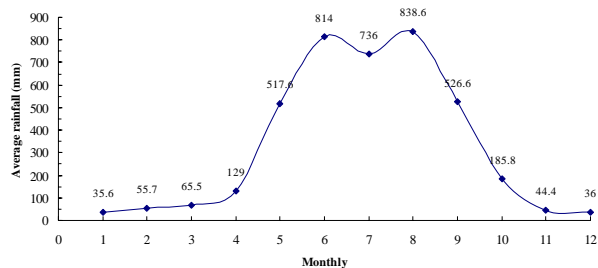
Fig. 4 Average monthly rainfall distribution map at Ali precipitation station

Figure 4 shows the average monthly rainfall distribution map at Ali precipitation station over a period of 41 years. The rainfall there is less than that in other mountainous areas and is concentrated in the summer time from May to September. There is less rainfall in the winter, which is the dry season, from October to May. The average temperature is approximately 17°C. This area is often covered in white fog in spring and summer, so it deserves to be called the township of fog.

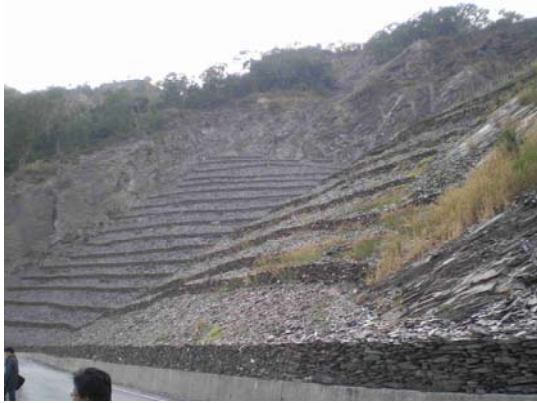
Picture 1

The main disaster location is situated at Point 46.2 km along Provincial Road No. 24 with the X-Y coordinate of (223202, 2515674) on the border between the tribes of Jilou and Ali. An extensive area of slopes is exposed to the air and failures occurred after several typhoons. Beneath the collapsed area is Ailiao North River. After the site investigation, it was found that several disasters such as serious roadbed loss happened along Provincial Road No. 24. A large collapse happened around Jilou Tribe close to the Point 46.4 km along the road. Continuous masonry rock parapets (Picture 1) were built with slate on the rock slopes. Although short retaining walls were built along the toe of the upper slope, collapse and rockfall still occurred. Construction of slope protection was also conducted on the lower slope with slate (Picture 2). However, it seems that some rocky parts were exposed on both sections. The cracking on that section of road is indicated in Picture 3, while undulation of the road surface is shown in Picture 4.

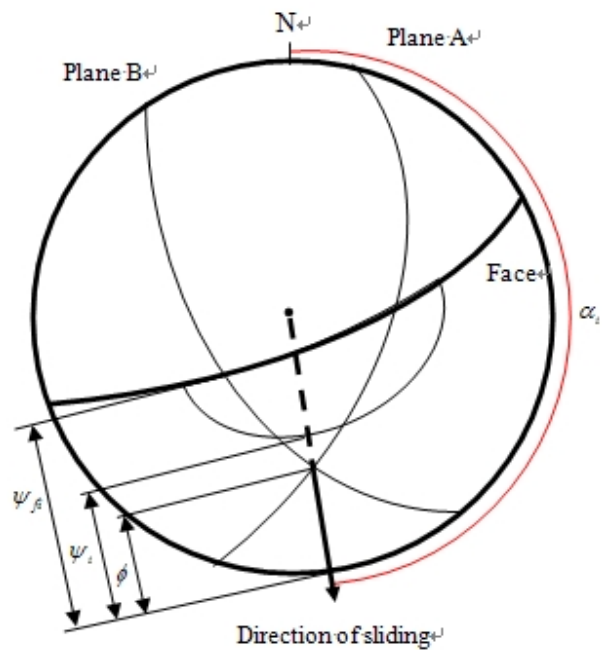
Figure 6 shows the line of intersection is represented by the point where the two great circles of the planes intersect, and the orientation of the line is defined by its trend ( $\alpha_i$ ) and its plunge ( $\psi_i$ ). The inclination of the slope face ( $\psi_{fi}$ ) is measured in the view at right angles to the line of intersection.

The trend ( $\alpha_i$ ) and plunge ( $\psi_i$ ) of the line of intersection of planes A and B can be determined on the stereographic projection, calculation using equations (1) and (2).

Fig. 6 The orientation of the line of intersection, and the range of the plunge of the line of intersection ( $\psi_i$ ) where failure is feasible [7]

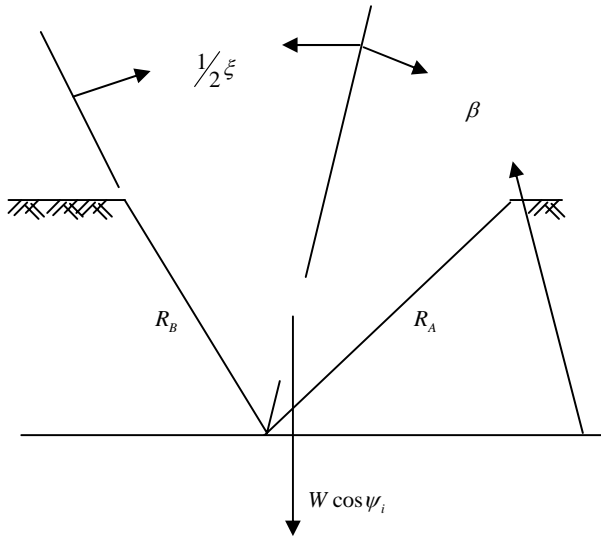
measured on the great circle containing the pole to the line of intersection and the poles of the two slide planes, the angles  $\xi$  and  $\beta$  are define in Figure 7 and Figure 8.

Fig. 7 Definition of angles  $\xi$  and  $\beta$  and reactions on sliding planes  $R_A$  and  $R_B$  [7]

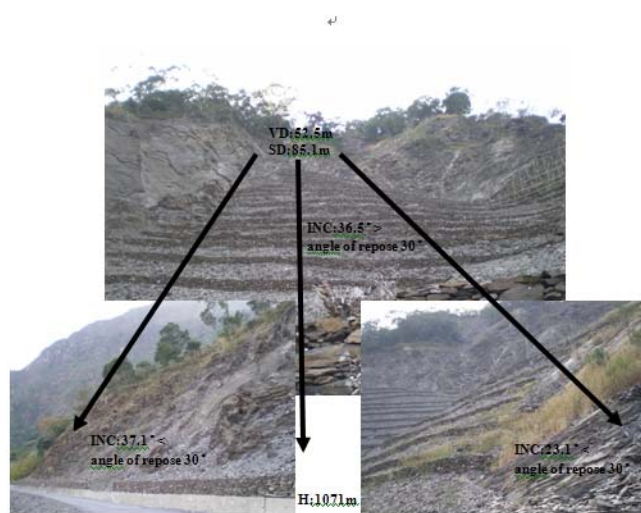
Small catchment areas are formed by the undulation of the landscape in this region (Figure 10). Figure 11 shows that the vertical distance of the collapse object's upper slope is 52.5m, while the tilting distance is around 85.1m. The angle of repose is 30° and the length of the side slope is about 163.3m. The dip angles are 23.1° on the left hand side, 36.5° in the middle, and 37.1° on the right hand side. It is evident that sliding continues to occur in this region because the angle on the left hand side is smaller than the angle of repose. Figure 12 shows that the vertical distance of the lower slope is 103m, and the tilting distance is approximately 191m. The dip angle of the slope is 32.1°, which is bigger than the angle of repose. Furthermore, the terrain of the areas along Ailiiao North River is cut by the river and meanders are formed. Also, the unstable situation of the side slope is probably caused by the depressurization of the valley. This phenomenon can result from the cracking of the short retaining walls and the road surface. Lastly, it can be judged that the cracking resulting from tension on the top of the upper slope is the key factor which will cause linear structural zoning collapse (Figure 13). Moreover, the geological materials are mostly slate with low weather resistant capabilities. It is possible that large scale collapse may occur if there are any inducements.

Fig. 11 Ground Stratum of Upper Slope on Collapse Site

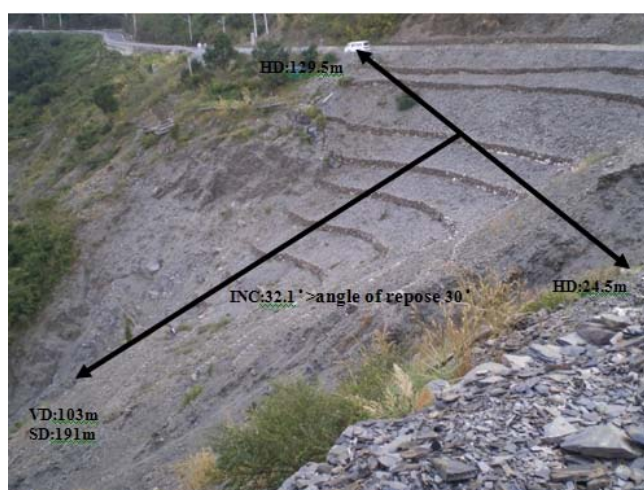
Fig. 12 Ground Stratum of Lower Slope on Collapse Site
