# Experimental Inspection of Damage and Performance Evaluation after Repair and Strengthening of Jiamusi Highway Prestressed Concrete Bridge in China

Ali Fadhil Naser and Wang Zonglin

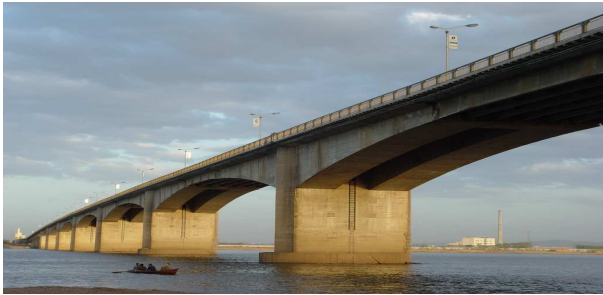
Fig. 1 (a) View of spans

Jamusi highway prestressed concrete bridge is located in the Jiamusi City within Heilongjiang province in the east north of China. The bridge crosses a Songhua river. The overall length of the bridge is 1396.2m and the total width of transverse section of the bridge is 17m. The bridge is kind of T-shaped rigid frame structure with hanging beams and simply supported T-beams. The bridge structure is made from prestressed concrete box girder and prestressed concrete T-beams. The bridge was open to traffic in September 1989. After the bridge is operating, the bridge subjected to heavy traffic loads and environmental condition. Therefore, the bridge suffers from many problems such as vertical deflection of corbels is about 10.3cm, cracks in the top and web of box girders, and large vibration of bridge structure when the traffic loads are passing. Figs. 1(a) to 1(d) show the view of bridge structure and Figs. 2 (a) and 2(b) show the section of box girder.

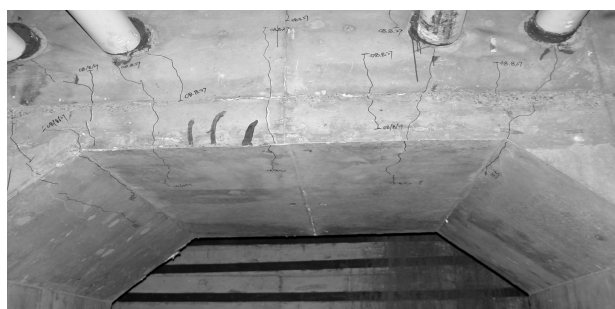
Chemical grouting method to plug all the visible cracks in web of box girders, diaphragm beam of pier top, corbels of T-shape cantilever structure, and corbel of hanging beams. According to inspection results, the crack grouting is dens, the surface of the grouting is regular, and the appearance of grouting area is clean. There are not new cracks in the grouting area, indicating that the quality of cracks grouting in good state. For anchor beam, there are more than 10 cracks before application of tension force in external prestressing tendons in the concrete of anchor beam. The length of cracks ranges between 5cm to 50cm and the width ranges from 0.01mm to 0.2mm. After strengthening, inspection results show that there are a few cracks have some development and there is some new vertical cracks appear in the structure of anchor beam. There are 7 vertical cracks. The length of cracks rang from 0.5cm to 2.5cm and the width rang between 0.1mm to 0.25mm. The new cracks are related with shrinkage of concrete. Therefore, the cracks have not influence on the mechanical properties of the bridge structure, but from the point of durability, the cracks should be sealed. Figs. 3(a) and 3(b) show cracks of anchor beam after strengthening.

Fig. 3 (a) Actual view of anchor beam cracks

Before strengthening of the bridge structure, there are many cracks within anchor beam. But after strengthening process is completed, there is not visible change in the length and width of cracks and there are not new cracks under experimental load. Therefore, the reason of cracks is not vehicles load, but the cracks are due to concrete shrinkage.

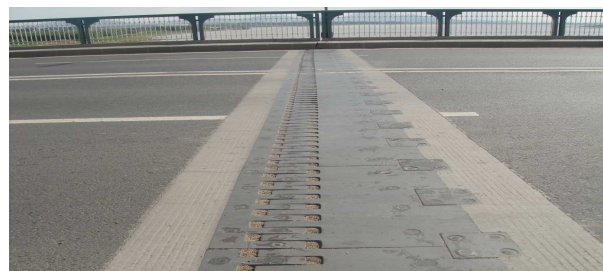
All expansion joints are replaced but most of the expansion joints are still damaged in serious degree. Therefore, the expansion joint loss the function of the expansion, which is influenced the performance of the bridge structure. Fig. 4(a) and 4 (b) show the expansion joints device after replacement.

Fig. 4 (a) Joint fill with dust

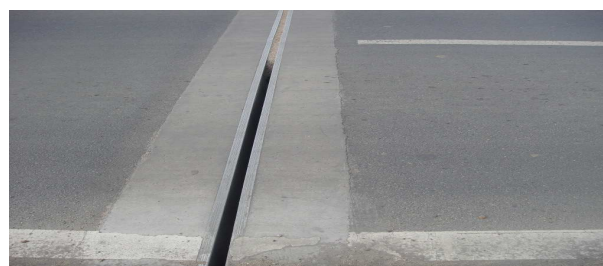
Fig. 4 (b) Losing of joint material

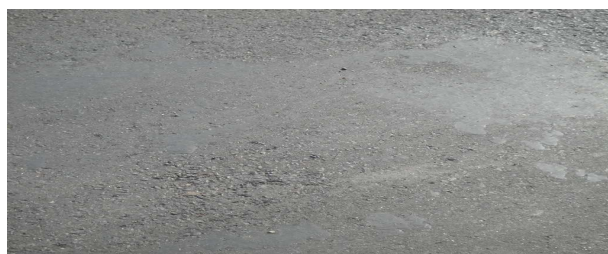
The deck pavement of the bridge suffers from serious damage such as spalling of asphalt and cracks which is caused the deck pavement unsuitable to carry the traffic load. The deck pavement is repaired by removing the old damaged layer of asphalt and the surface is poured by using asphalt concrete to required thickness. After repair, the results of inspection show that the state of the bridge deck pavement in good but there some places have cracks and bleeding. Fig. 5(a) to 5(c) shows the state of the deck pavement.

Fig. 5 (b) ) Bleeding of asphalt
