Laser Welded Ni-Cr Dental Alloys Inspection

Abstract—Minor problems arising from optimizations by welding of fixed prostheses frameworks can be identified by macroscopic and microscopic visual inspection. The purpose of this study was to highlight the visible discontinuities present in the laser welds of dental Ni-Cr alloys. Ni-Cr base metal alloys designated for fixed prostheses manufacture were selected for the experiments. Using cast plates, preliminary tests were conducted by laser welding. Macroscopic visual inspection was done carefully to assess the defects of the welding rib. Electron microscopy images allowed visualization of small discontinuities, which escapes visual inspection. Making comparison to Ni-Cr alloys taken in the experiment and laser welded, after visual analysis, the best welds appear for Heraenium NA alloy.

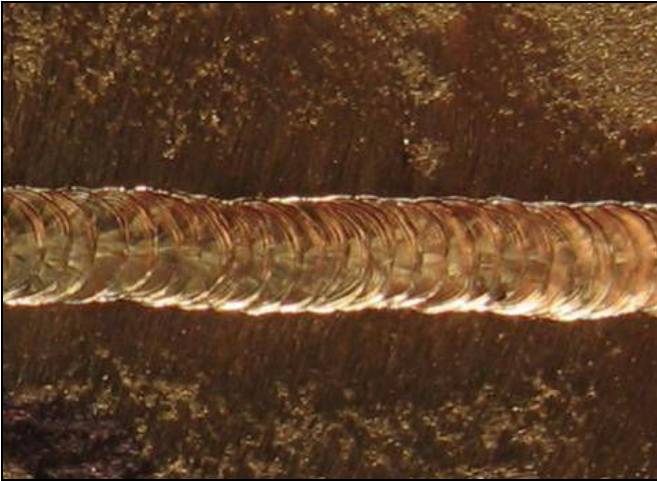
Fig. 1 Aspect of a welded Ni-Cr alloy sample (welding without filler): uniform overlapping of the spots, no visible defects

Macroscopic visual inspection was done carefully to assess the defects of the welding rib. Welding rib width, craters on the surface, continuity of the weld, visible cracks, penetration degree of the spot, and any surface inclusions were examined (Fig. 1-4). Some samples showed visible defects, but other seemed without any discontinuity and were completed with microscopy examinations.

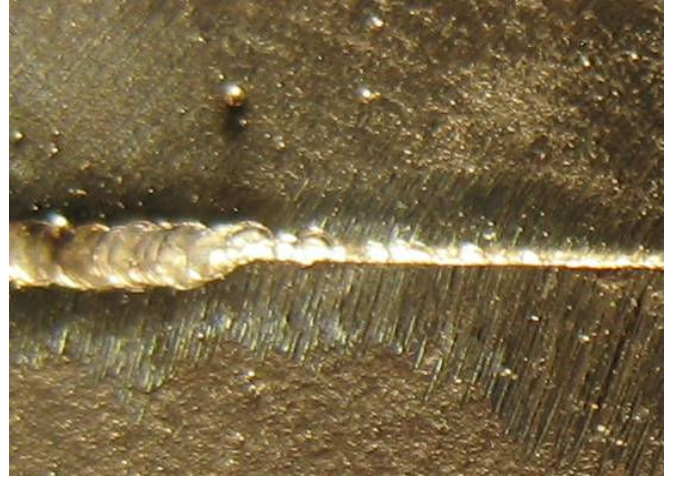
Fig. 4 Aspect of Ni-Cr alloy sample (welding with filler material): poor penetration on the opposite side

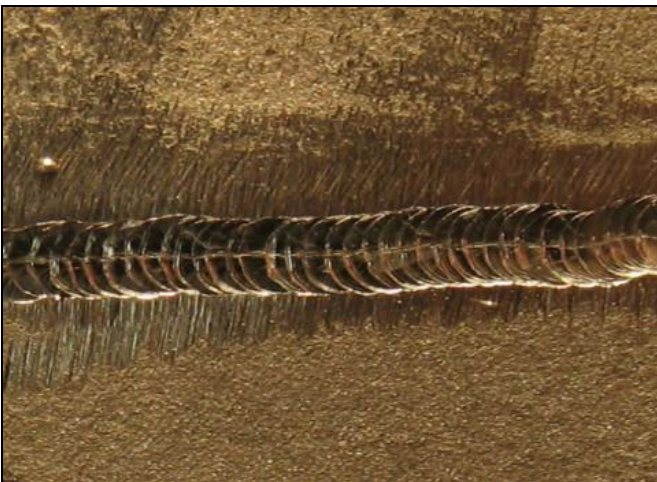
Fig. 2 Aspect of Ni-Cr alloy sample (welding without filler material): uniform width of the weld, continues crack along the joining line

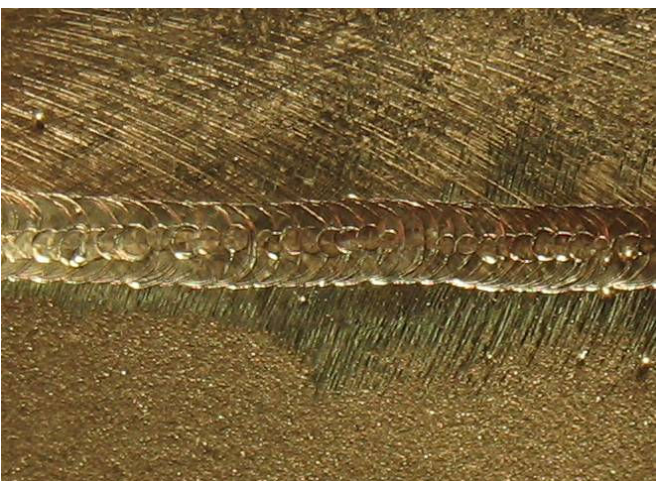
Fig. 3 Aspect of Ni-Cr alloy sample (welding without filler material): good penetration on the opposite side

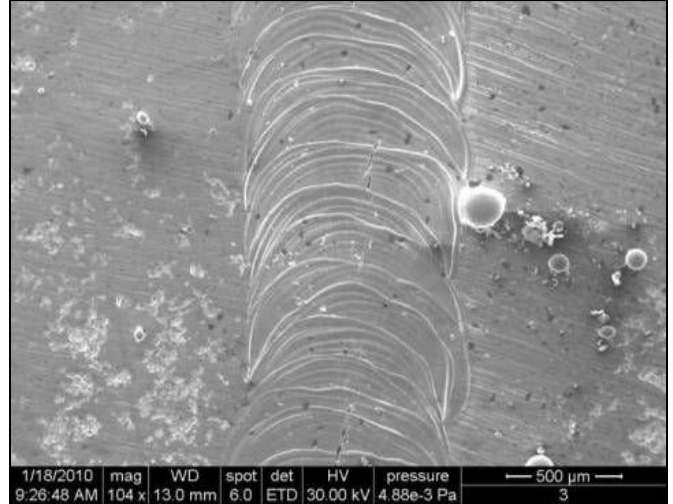
Fig. 5 Electronmicroscopic image of a Ni-Cr alloy welded joints without filler material: short longitudinal cracks on the welding rib (mag 104x)

The examined samples revealed some small cracks in the welding rib, both longitudinal and transverse or oblique. Some start from the main longitudinal cracks, some from the middle spot, others are completely isolated.

Also details of the the weld surface, spots aspect, their overlapping and distribution of filler material could be detected by microscopic analysis (Fig. 5-8).

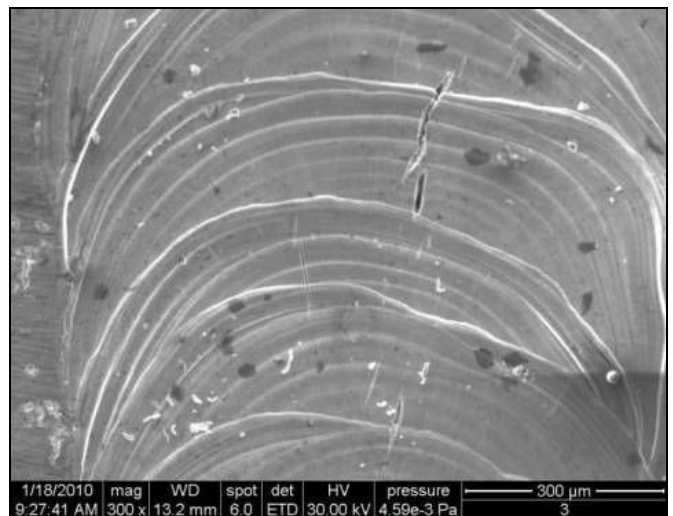
Fig. 6 Electronmicroscopic image of a Ni-Cr alloy welded joints without filler material: short longitudinal cracks on the welding rib (mag 300x)

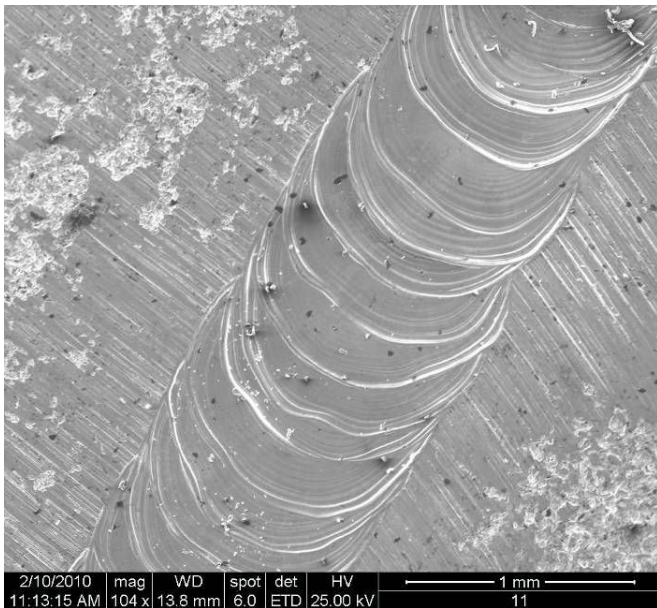
Fig. 7 Electronmicroscopic image of a Ni-Cr alloy welded joints without filler material: no visible defects on the welding rib (mag 104x)

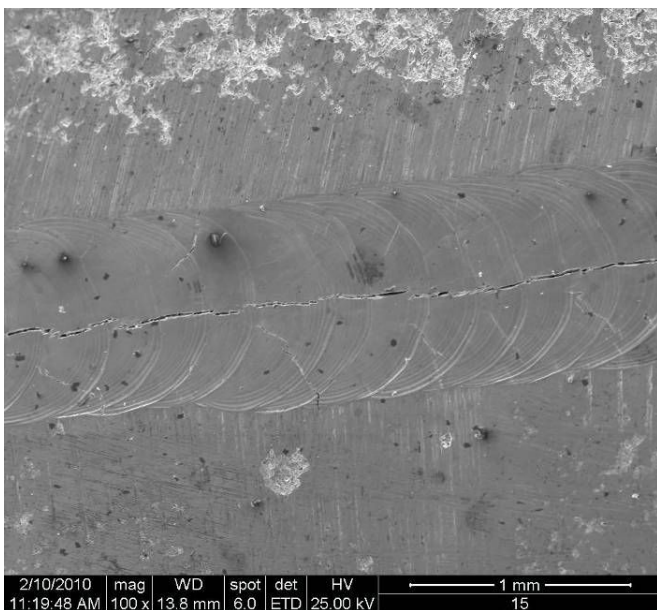
Fig. 8 Electronmicroscopic image of a Ni-Cr alloy welded joints without filler material: continuous longitudinal crack on the welding rib (mag 100x)
