Amine Solution Recovery Package and Controlling Corrosion in Regeneration Tower

Abstract—Sarkhoon gas plant, located in south of Iran, has been installed to removal H₂S contained in a high pressure natural gas stream. The solvent used for the H₂S removal from gaseous stream is 34% by weight (wt%) Di-ethanol amine (DEA) solutions. Due to increasing concentration of heat stable salt (HSS) in solvent, corrosivity of amine solution had been increased. Reports indicated that there was corrosion on the shell of regeneration column. Because source formation of HSS was unknown, we decided to control the amount of HSS at the limit less than 3% wt amine solvent. Therefore, two small columns were filled by strong anionic base and carbon active, and then polluted amine was passed through beds. Finally a temporary amine recovery package on industrial scale was made based on laboratory's results. From economical point of view we could save \$700000 beside corrosion occurrence of the stripping column has been vigorously decreased.

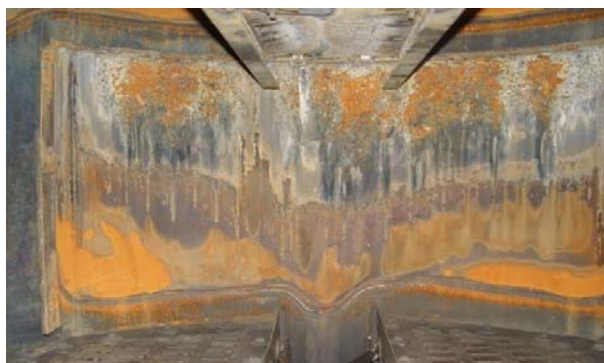
Because of increasing HSS in DEA solutions, amine regenerator column had faced with huge corrosion on shell side especially at places between trays is which continent of vapor most likely had had (fig 1).

Fig. 1 Corrosion on shell on vapor area

Due to visual check of regenerator during its overhaul – based on inspection on inspection department report we had about 3.4mm corrosion at different site on shell of regenerator

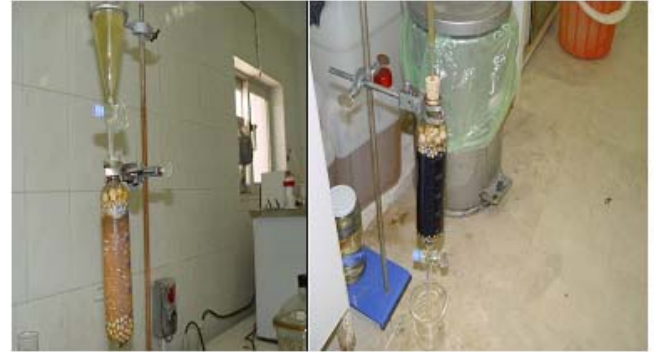
Lean amine solution feed through a bubbler in to an activated column filter and the resin column. The ion exchange rosin removes the heat stable salts and the purified amine solution is collected for further analysis. Diluted caustic soda is used to regenerate the resin column.

Fig. 4 Laboratory set up of (Left Resin Bed, Right Carbon Active bed)

Laboratory scale .The HSS in solution were at approximately 3.5 wt% (as DEA) when laboratory test started to removal HSS form the solution .In order to reduce level of HSS to 0.5/wt% which strong ion resin studied an onions strong resin type was selected and all experimental test on it . As shown (figure4) our set up was consist of two 250 glass (decanter) which used as anionic resin column and activated carbon .That scope was removing HSS and fine Particles and color of amine(figure 5) by means of those manipulated column respectively .

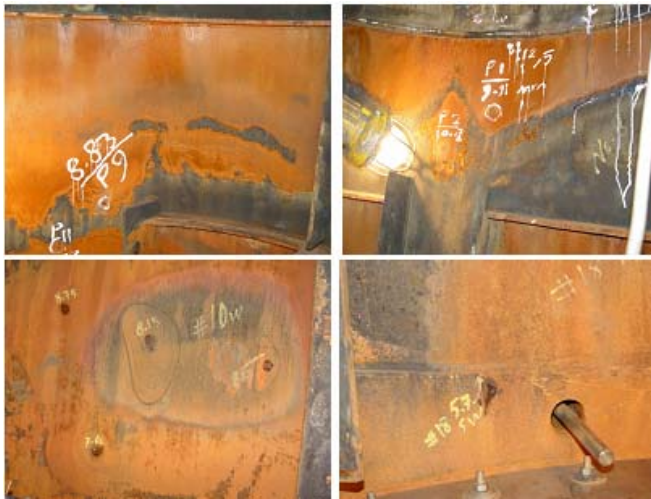
Fig. 3 CORROSION on Different Side of Shell(Top left to right ,Tray 9,Tray 8,Bottom left to right ,Tray 10,Tray 18)

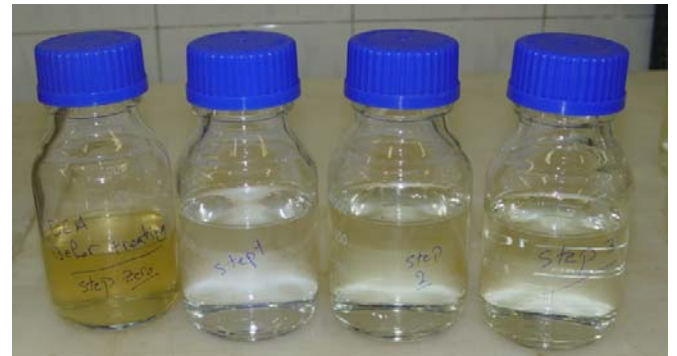
Fig. 5 Quality of sample in inlet and outlet of resin and carbon active beds(left. 1st, polluted amine right, 2st to 4rd batch of outlet bed)

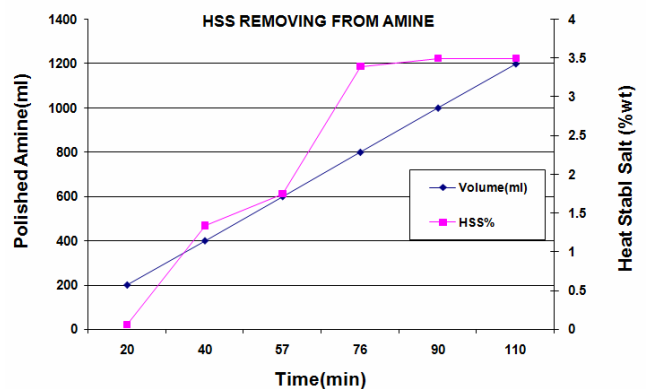
As results is shown figure 6, it is proved that selected resin have capability of remove about 5 times of bed volume. From economical point of view amine purification by resin column is move profitable than "bleed to feed" strategy.

Fig. 6 Evaluation the capacity of resin bed to remove HSS)

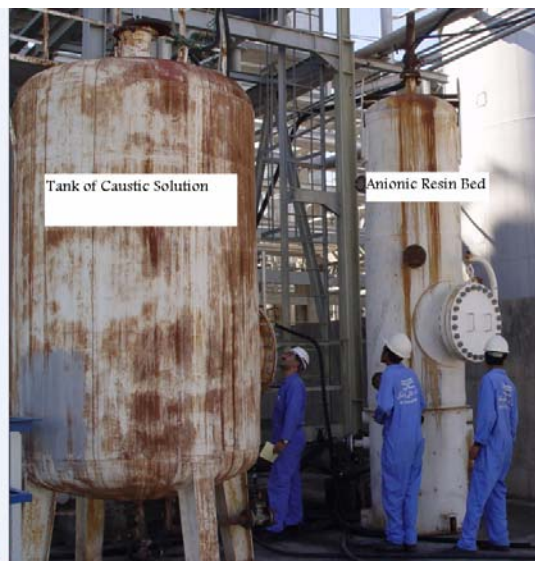
According to result of laboratory test industrial resin column designed and about 1.5 cubic meter of a strong anionic resin charged into it .After regeneration with caustic soda 4%wt lean amine from outlet of cartridge filter which installed on side stream of lean amine routes to amine column which accumulated in storage tank.

Fig.7 DEA Package recovery (left vessel Caustic Solution tank , right Anionic Resin Bed)

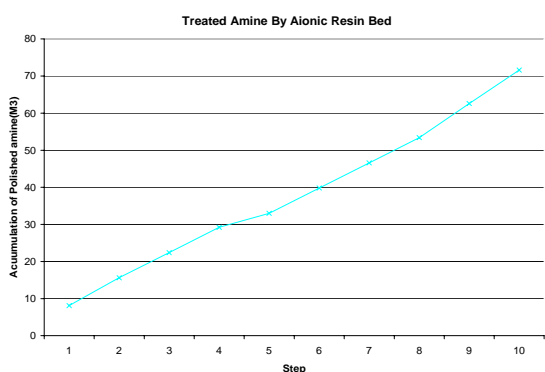
Because the scope of installation of package recovery was to remove HSS form amine solution , the parameter of HSS in inlet and exit of bed was selected to operation of package .In figure 8 and table 1 are shown for Treatment of 71.6 m polluted amine with concentration 30%wt about 7 ton caustic soda , 382 m deionized water were consumed for 10 batches for a long of 3 months .

Fig.8 trend of accumulated polished amine

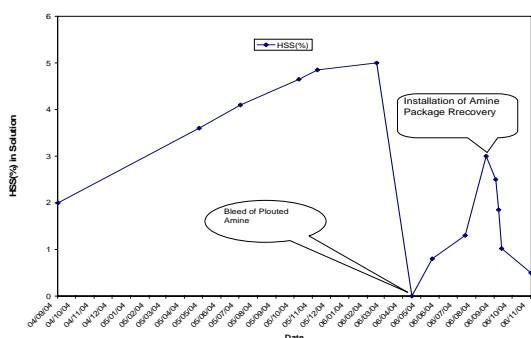
By Jan 2006, after a unit shutdown for maintenance of the amine regenerator tower , the HSS level was down to 1 wt% .A substantial decrease in the corrosion rate was observed. The ultimate goal of the plant is to keep corrosion rate and level of HSS as close zero and 0.5% wt as possible respectively. To achieve this goal it was decided to decrease the HSS concentration further .So amine treating package was run in more batches. As shown in figure 6 from august 2006 to Dec 2006 About 71.6 cubic meter amine degraded was treated. Figure 7 is the cure of the heat stable slate of solution which has declined.

Fig. 9 trend of declining of HSS in Amine solution
