# Comparison Ageing Deterioration of Silicone Rubber Outdoor Polymer Insulators in Artificial Accelerated Salt Fog Ageing Test

**Abstract**—This paper presents the experimental results of silicone rubber outdoor polymer insulators in salt fog ageing test based on IEC 61109. Specimens made of HTV silicone rubber with ATH content having three different configurations, straight sheds, alternated sheds, and incline and alternate sheds, were tested continuously 1000 hrs. in artificial salt fog chamber. Contamination level, reduction of hydrophobicity and hardness measurement were used as physical damaged inspection techniques to evaluate degree of surface deterioration. In addition, chemical changing of tested specimen surface was evaluated by ATR-FTIR to confirm physical damaged inspection. After 1000 hrs. of salt fog test, differences in degree of surface deterioration were observed on all tested specimens. Physical damaged inspection and chemical analysis results confirmed the experimental results as well.

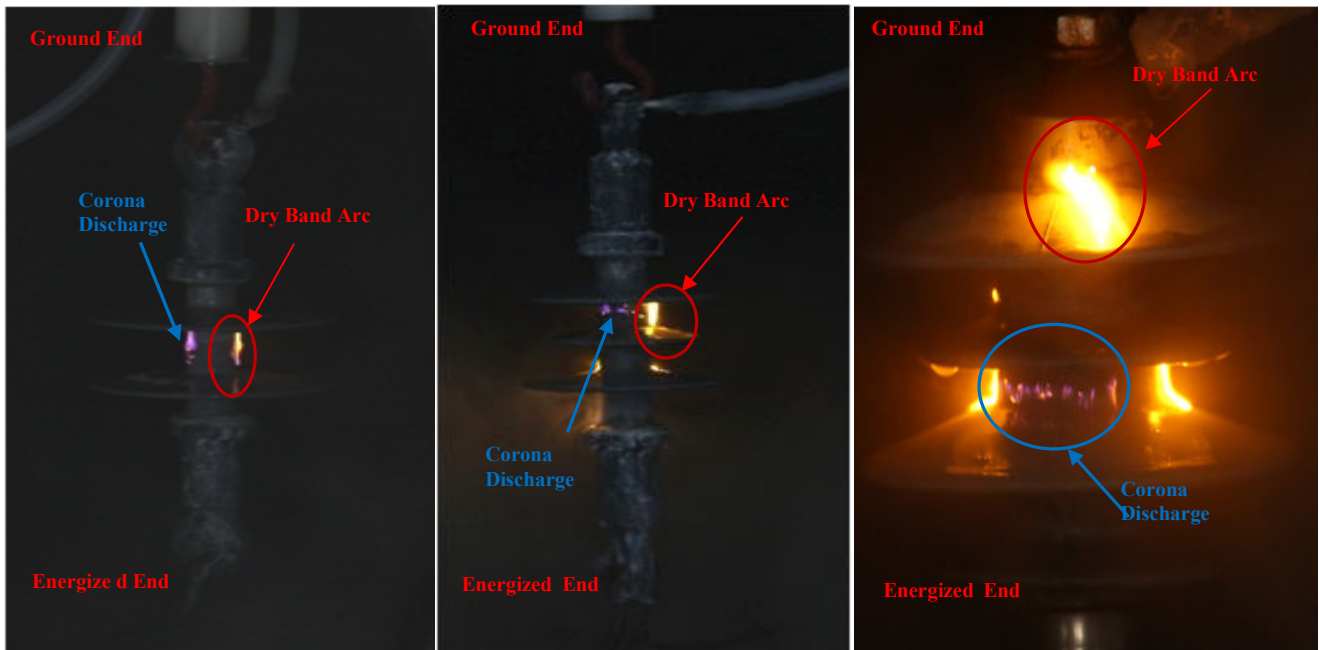
Fig. 5 Discharge Activities

During salt fog ageing test, many discharge activities along surface of tested specimen during salt fog injection were observed. As shown in Fig.5, many discharge activity were observed. Mainly discharge activities were observed on the trunk between sheds of all testing specimens. However, large discharge was also observed on upper shed surface of incline and alternate shed specimen. Yellow light for dry band arcing was observed. Such discharge indicated that large dry band arc discharge occurred on the trunk surface between sheds. Small discharge activity or corona discharge was also observed on trunk surface between sheds.

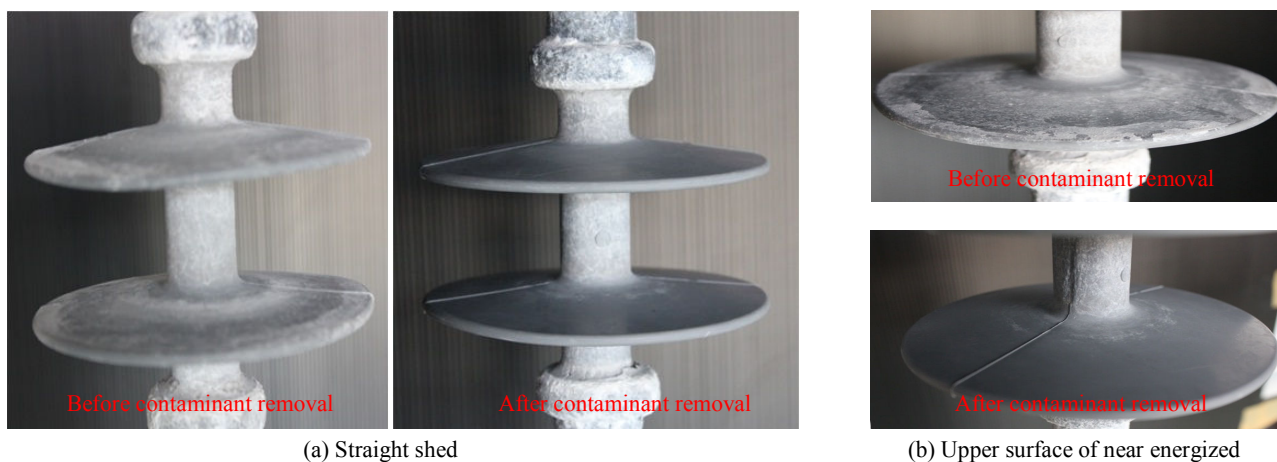
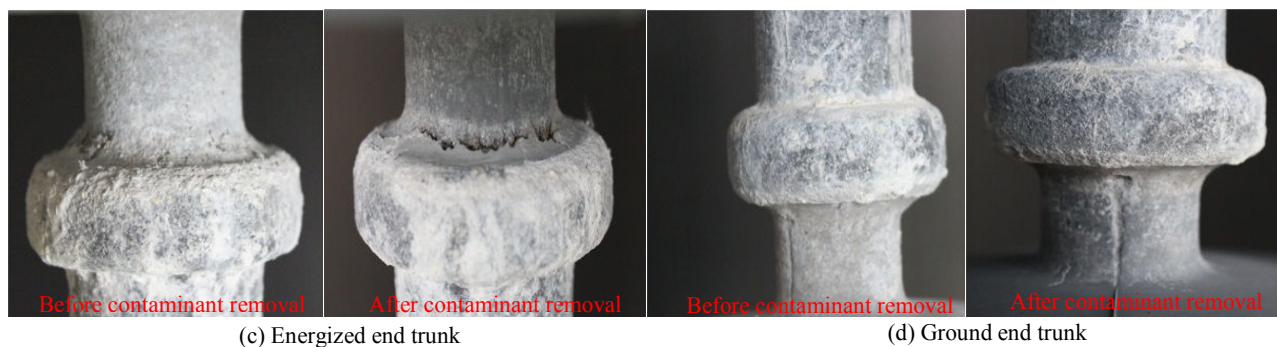
Fig. 6 Surface damaged straight shed specimen

In case of straight sheds specimen, more contaminant was observed on trunk surface than on shed surface, as shown in Fig. 6 (a). Obviously surface erosion was observed on trunk surface when comparing with shed surface. Parting line tracking was only observed on trunk portion. Also, severely tracking was observed on trunk surface at energized end, as shown in Fig. 6 (c).

(a) Straight shed

(b) Upper surface of near energized

(c) Energized end trunk

(d) Ground end trunk

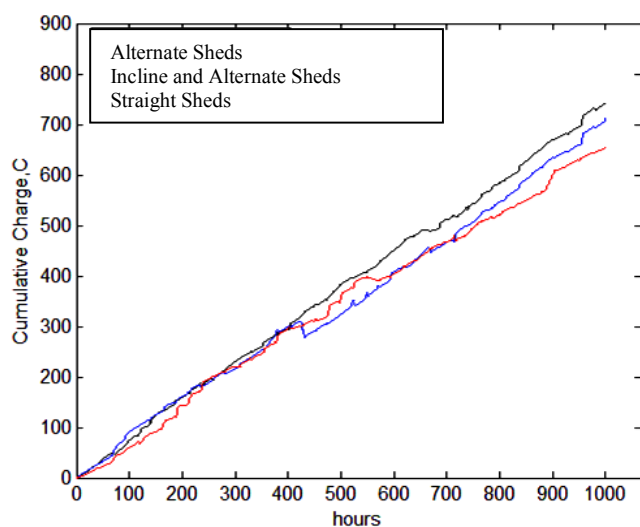
Fig. 14 Cumulative Charges

Surface cumulative charge was calculated from leakage current measurement results. The cumulative charges are shown in Fig. 14. The highest cumulative charge was obtained from the alternate sheds specimen. The lowest cumulative charge was obtained from the straight sheds
