Performance Evaluation of an Aboveground LNG Storage Tank Cover using Nondestructive and Destructive Tests

Sungnam Hong, Sun-Kyu Park, Jieun Jeong, and Jinwoong Choi

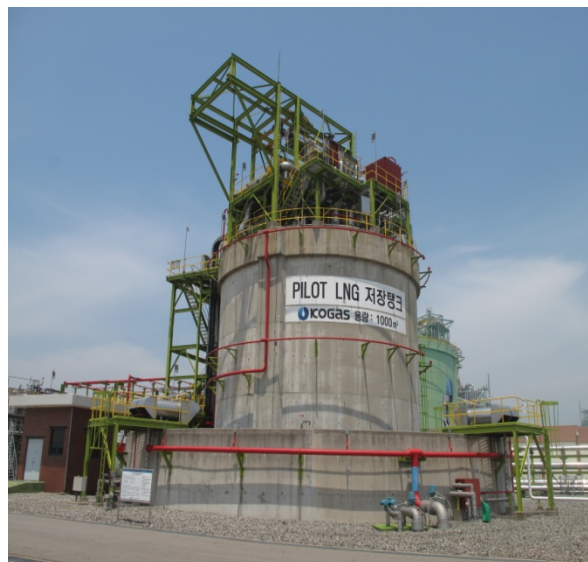
Fig. 1 Pilot LNG storage tank (1,000m⁴)

The object of the tests was the 1,000m³ pilot LNG storage tank located in the Incheon LNG receiving terminal, as shown in Fig. 1. As mentioned, few precedent studies on tests of the concrete cover of LNG storage tanks have been reported. In this study, a concrete cover test procedure is suggested using nondestructive tests and destructive tests [8]-[14], as described in Fig. 2. The suggested procedure can be used for regular performance evaluation of the concrete cover of LNG storage tanks. Before the nondestructive tests were conducted, the LNG storage tank was sectionalized into a front side, a back side, a right column, and a left column. The front and back sides were gridded with a horizontal distance of 27 cm and a vertical distance of 54 cm, as shown in Fig. 3. Numbers were given clockwise at each horizontal intersection, and letters were given in alphabetical order at each vertical intersection from the bottom to the top.

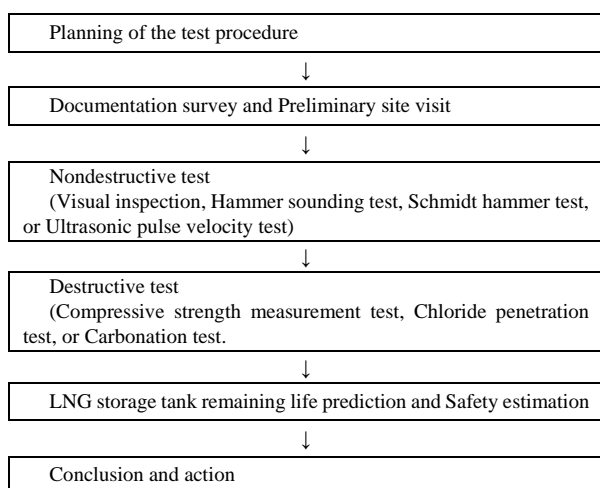
Fig. 2 LNG storage tank performance evaluation procedure

The deterioration and performance of the concrete cover of an LNG storage tank were evaluated to manage the tank cover's service life, in accordance with the procedure suggested in Fig. 2 The following conclusions were drawn.

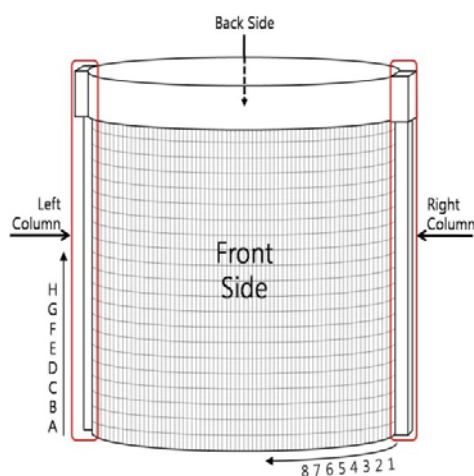
Fig. 3 Grid system for the front and back sides of the LNG storage tank cover

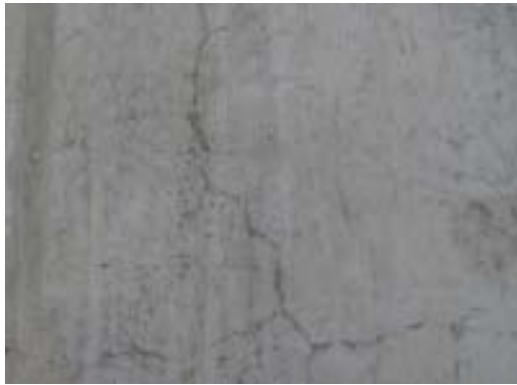
(a) Sector J86

During the visual inspection of the LNG storage tank cover, cracks similar to those shown in Fig. 4 (a) were observed, but they were not considered problems based on their widths and patterns. The cracks observed in sectors A117-C117 and B65 were also thought to have not affected the structure; but considering their lengths, an ultrasonic test was conducted. Other than the cracks and areas with peeling, exfoliation, or steel exposure, no serious anomaly that can result in structural problems was observed during the visual inspection of the LNG storage tank cover.

Fig. 4 Cracks on the concrete wall

(1) Based on the width and patterns of the cracks that were observed during the visual inspection of the LNG storage tank, the cracks were considered non-structural cracks. The concrete strength of the suspected areas that were found through the Schmidt hammer test was estimated using the strength estimation equation. The results showed that all the sections had a higher design strength value of 30MPa, which means they had no anomaly.

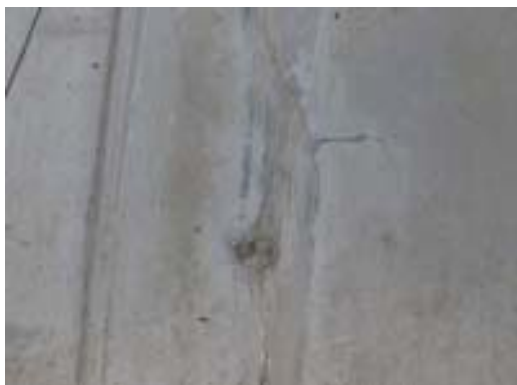
(b) Sector A117-C117

The ultrasonic test was conducted in the suspected areas based on visual inspection and the Schmidt hammer test. The test was conducted at the A117-C117 and B65 grids that had long cracks and at J46-M46, K56-N56, K68-N68, J97-M97, and Q110-T110, which were suspected based on the Schmidt

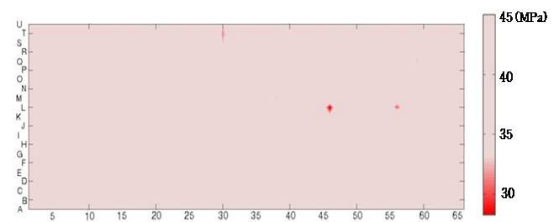
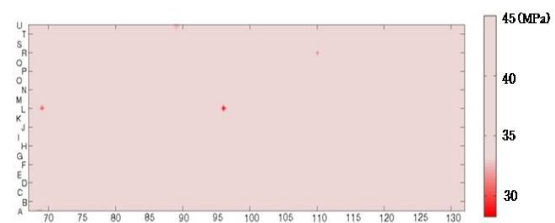
Fig. 5 Schmidt hammer test results

In the preceding equations, F_c represents the estimated compressive strength, and R_0 , the corrected result of the Schmidt hammer test[6]. Equation (1) showed overestimated results with large deviations, compared with the other suggested equations. In contrast, Equation (2) tended to be underestimated with a smaller deviation, compared with Equation (1). Equation (3) showed a compressive strength between that from the two equations with the smallest deviation, from among the three equations. The final concrete compression strength was calculated from the three equations. Fig. 5 shows a contour graph of the results. The estimated concrete strength had a mean of 41.55MPa and ranged from 31.64MPa to 48.80MPa. The estimated compressive strength exceeded the design strength of 30.00MPa, which is the standard for LNG storage tanks. Based on the results of the Schmidt hammer test, the strength of the structure was considered normal.

(4) The 41.55MPa estimated concrete compression strength from the Schmidt hammer test significantly differed from the

30.2MPa actual concrete compression strength from the destructive tests. This was due to the following reasons: first, to obtain reliable estimated values from the Schmidt hammer test, about 20 hammering strokes at each measurement site were required [10], [11], but only five hammering strokes per measurement site were executed in this study due to the limitations of reality. Second, the neutralization on the surface of the concrete significantly affected the level of restitution in the Schmidt hammer test. Neutralization is more significant on older concrete, and is 50% more severe than on concrete without neutralization[10],[11]. In addition, the material age and the moisture of the concrete also affected the results of the Schmidt hammer test. Therefore, the actual compressive strength could not be determined with only the Schmidt hammer test due to its lack of reliability. Rather than using the Schmidt hammer test to directly estimate the compressive strength, the test can be reasonably used to detect relatively suspected areas.

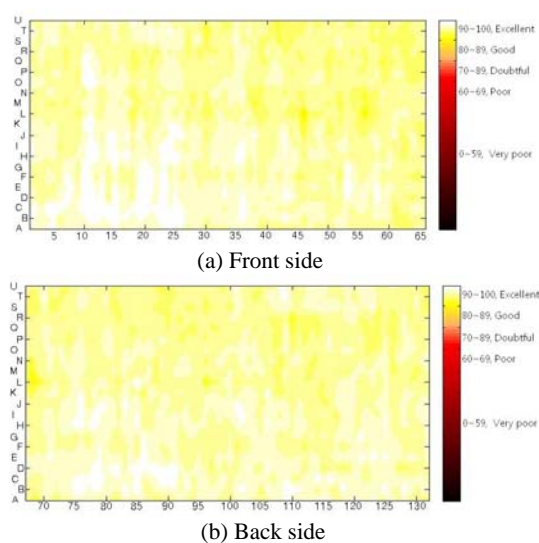
Fig. 6 Combined results of the nondestructive test

The results of the Hammer sounding test, the Schmidt hammer test, and the straight-line ultrasonic tests were combined using Equation (1), and then plotted on a contour graph. The converted marks of the concrete cover of the LNG storage tank, which were calculated using a combination of nondestructive tests, ranged from 88.13 to 100, with a mean of 95.77, which confirmed that they were normal in all the sections. Fig. 6 shows the contour graph of the results of the combined nondestructive tests.
