Study of Ageing Deterioration of Silicone Rubber Housing Material for Outdoor Polymer Insulators

Abstract— This paper presents the experimental results of salt fog ageing test of silicone rubber housing material for outdoor polymer insulator based on IEC 61109. Four types of HTV silicone rubber sheet with different amount of ATH were tested continuously 1000 hours in salt fog chamber. By visual observation after tested, slightly surface erosion was observed on tested specimen surface near the energized end. Furthermore, increasing in hardness and reduction in hydrophobicity were measured on tested specimen comparing with new specimen. In addition, chemical analysis by ATR-FTIR was conducted in order to elucidate the chemical change of tested specimens comparing with new specimen. Physical and chemical results confirmed the experimental results as well.

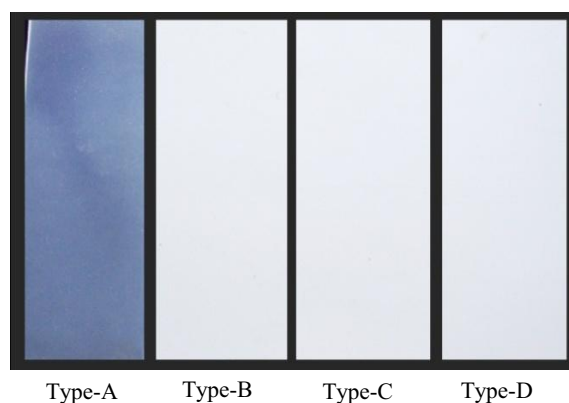
Fig. 1 specimens

Specimens made of high-temperature vulcanized silicone rubber (HTV SiR) with/without alumina trihydrate (ATH: $\text{Al}_2\text{O}_3 \cdot 3\text{H}_2\text{O}$) having content 0%, 50%, 100% and 150% by weight were used in this experimental, as shown in Table I and Fig. 1. Configuration of tested specimen illustrated in Fig. 2. All specimen having 2 mm in thickness, 30 mm in width and 200 mm in length attached with metal electrodes on the both ends of each specimen were hung vertically in test chamber during test.

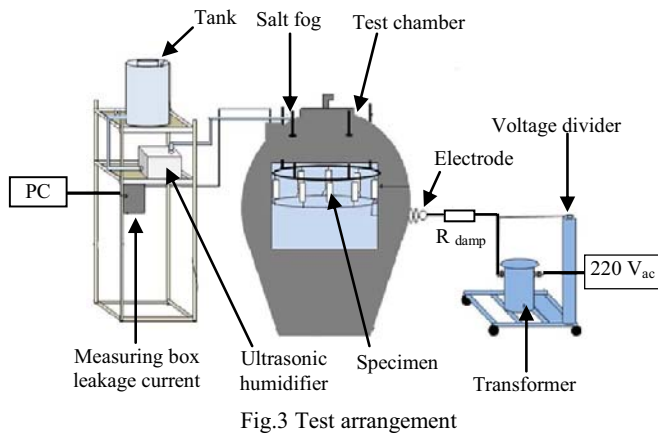
Fig.3 Test arrangement

A polyethylene tank having the volume 4.0 m³ was used as the salt fog test chamber. During salt fog ageing tests, specimens were hung vertically in the test chamber. An ultrasonic humidifier was used as salt fog generation and salt fog was injected from the top of the test chamber. Fig. 3 shows the test arrangement and Fig. 4 shows the actual test chamber.

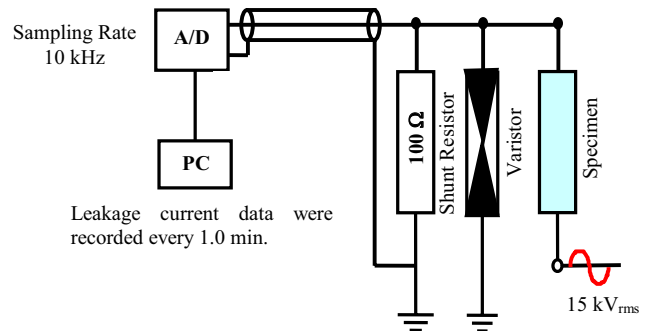
Fig. 5 Diagram of leakage current measuring system

cyclic salt fog ageing test was conducted by injecting salt fog in to the test chamber for 8 hours and stopping it for 16 hours every day under ac high voltage 15 kV. The salt fog having injection 0.5 l/hr/m³ was injected from the top of the chamber as test conditions shown in table II. All specimens were hung vertically in test chamber and were tested together. Leakage current measurement system is shown in Fig. 5. Individual specimens were connected to the leakage current measurement system via the shunt resistors of 100 Ω by means of coaxial cables. Leakage currents were continuously measured for individual specimens during the test. The leakage current was fed to an A/D board and converted to voltage. The leakage current data measured at the sampling rate of 10 kHz were recorded once every 60 s by postulating the data continuing for this period using the computer software developed via LabView.

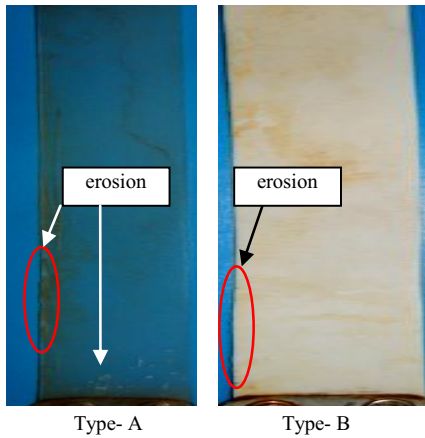
After 1000 hours salt fog ageing test, visual observation was conducted in order to inspect any change on tested specimen surface. Slightly surface erosion near the energized end, as shown in Fig. 5, was observed on specimens type A and type B. This may be caused by discharges on specimens surface during test due to higher electric field stress on such position. No surface erosion was observed on specimen type C and type D. The results confirm that the amount of ATH is effective to improve the anti-erosion performance of silicone rubber.

Fig.6 Specimens surface after 1000 hours.

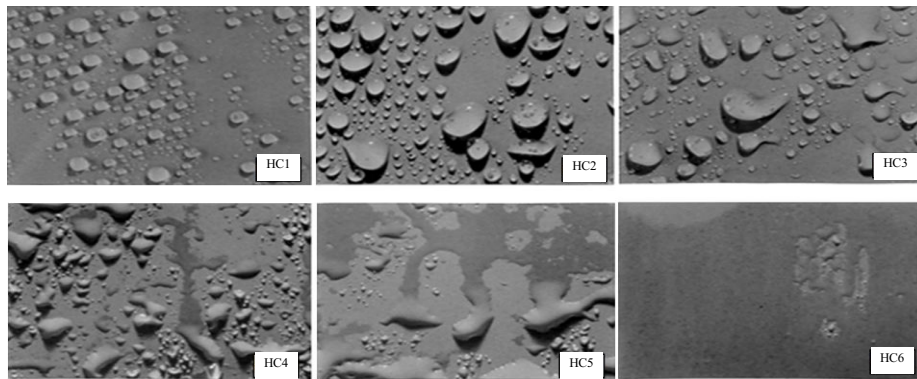
reduction in hydrophobicity and/or may be related to the amount of ATH. Reduction in hydrophobicity was evaluated by STRI criteria, as shown in Fig.7 [9,10]. Characteristics of hydrophobicity on tested specimen surface are shown in Fig.8. Hydrophobicity measurement results are shown in Table III.

Fig. 7 Characteristics of the sample surface HC1-HC6

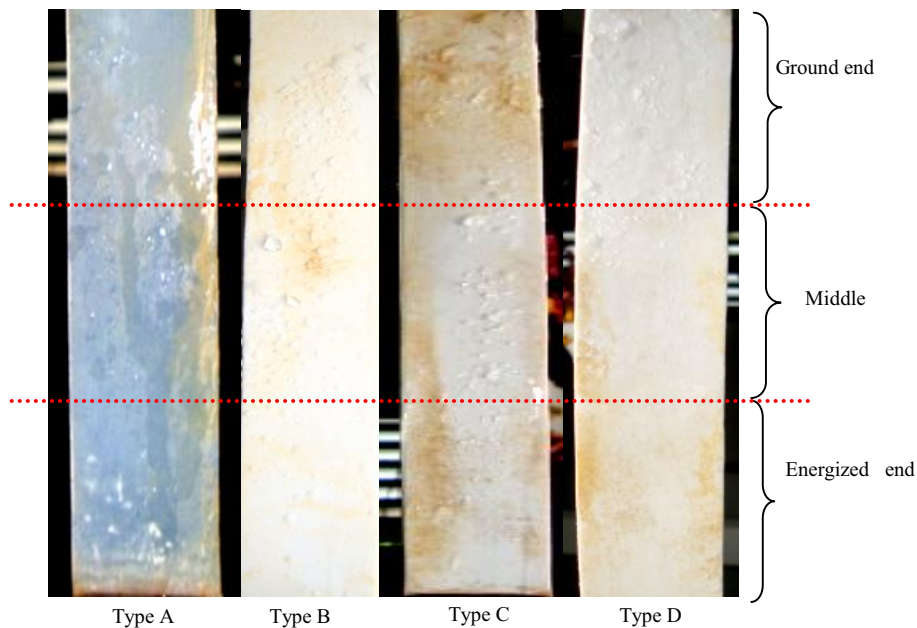
Significant decreasing in hydrophobicity can be observed on thoroughly surface of the specimens. Extremely loss of hydrophobicity (HC 6) was observed on thoroughly surface of specimen type A. In the case of the specimen without ATH and without filler surface treatment, a larger reduction in hydrophobicity can be seen compared with the other specimens having ATH. Such results indicate that ATH filler and filler surface treatment can delay the reduction of hydrophobicity on silicone rubber surface. Also, extremely loss of hydrophobicity (HC 6) at energized end was observed on all specimen surfaces. Such results indicate that high electric field stress can accelerate the reduction of hydrophobicity on the specimen surface.

Fig. 8 Characteristics of hydrophobicity on surface

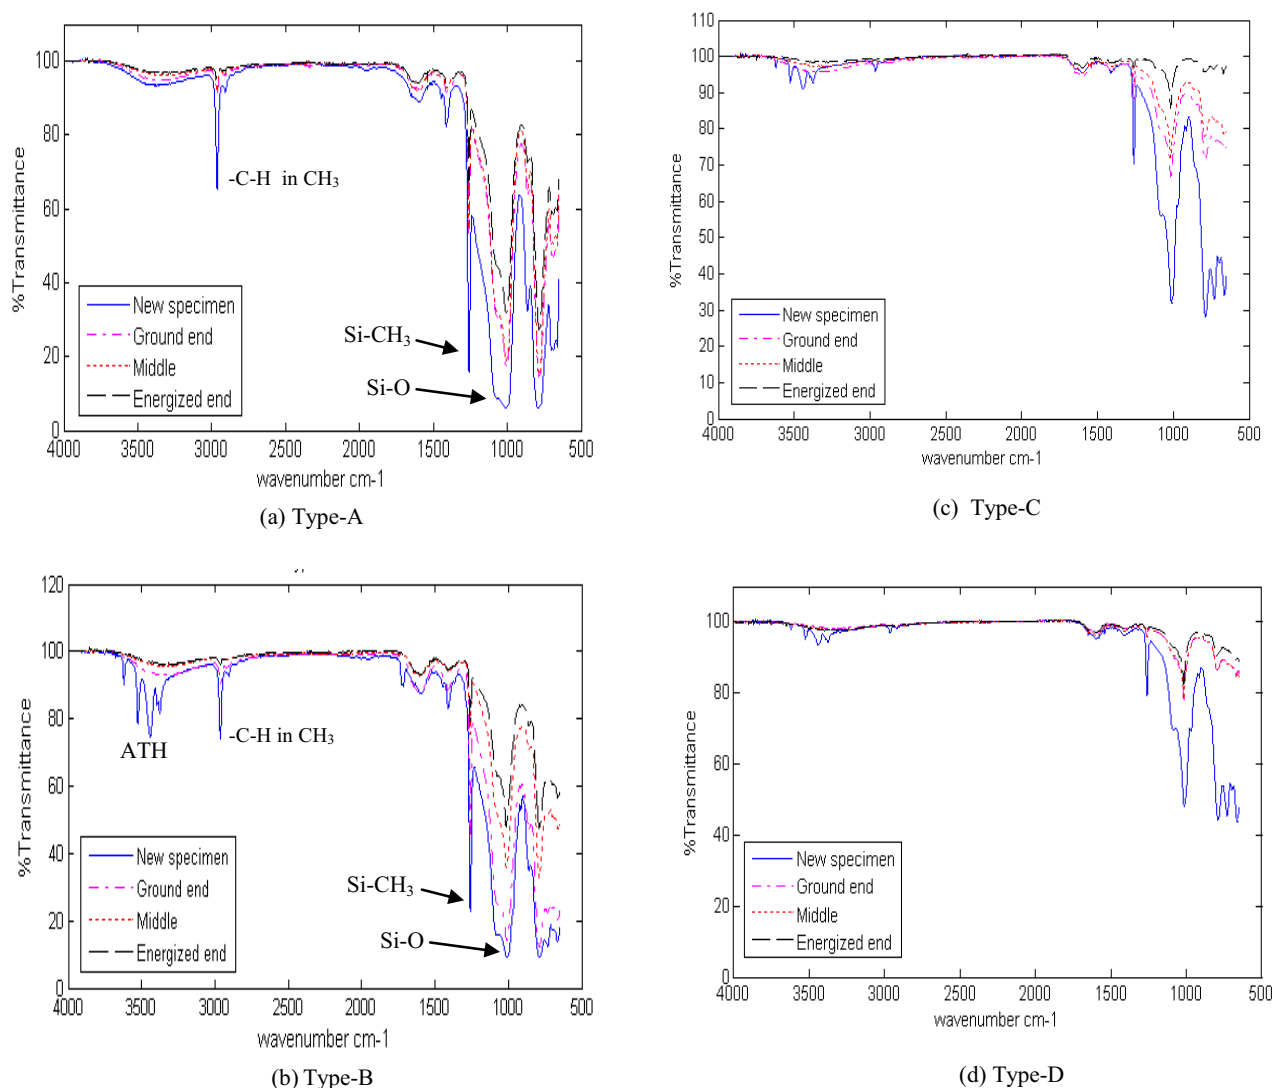
The chemical bonds of interested chemical structure are bonding side chain (Si-CH₃) with wave number 1261 cm⁻¹, backbone (Si-O) with wave number 1041 cm⁻¹. Decreasing of Si-CH₃ means separation of side chain and decreasing of Si-O refers to the separation of the back bone of polydimethylsiloxane bonding changes. The changes in the absorption peak of Si-CH₃ and Si-O bonds show degree of specimen surface deterioration. FTIR spectra of specimens and %Transmittance of specimens after 1000 hrs salt fog test are shown in Fig.9 and Table IV.

Fig. 9 FTIR spectra of test specimens

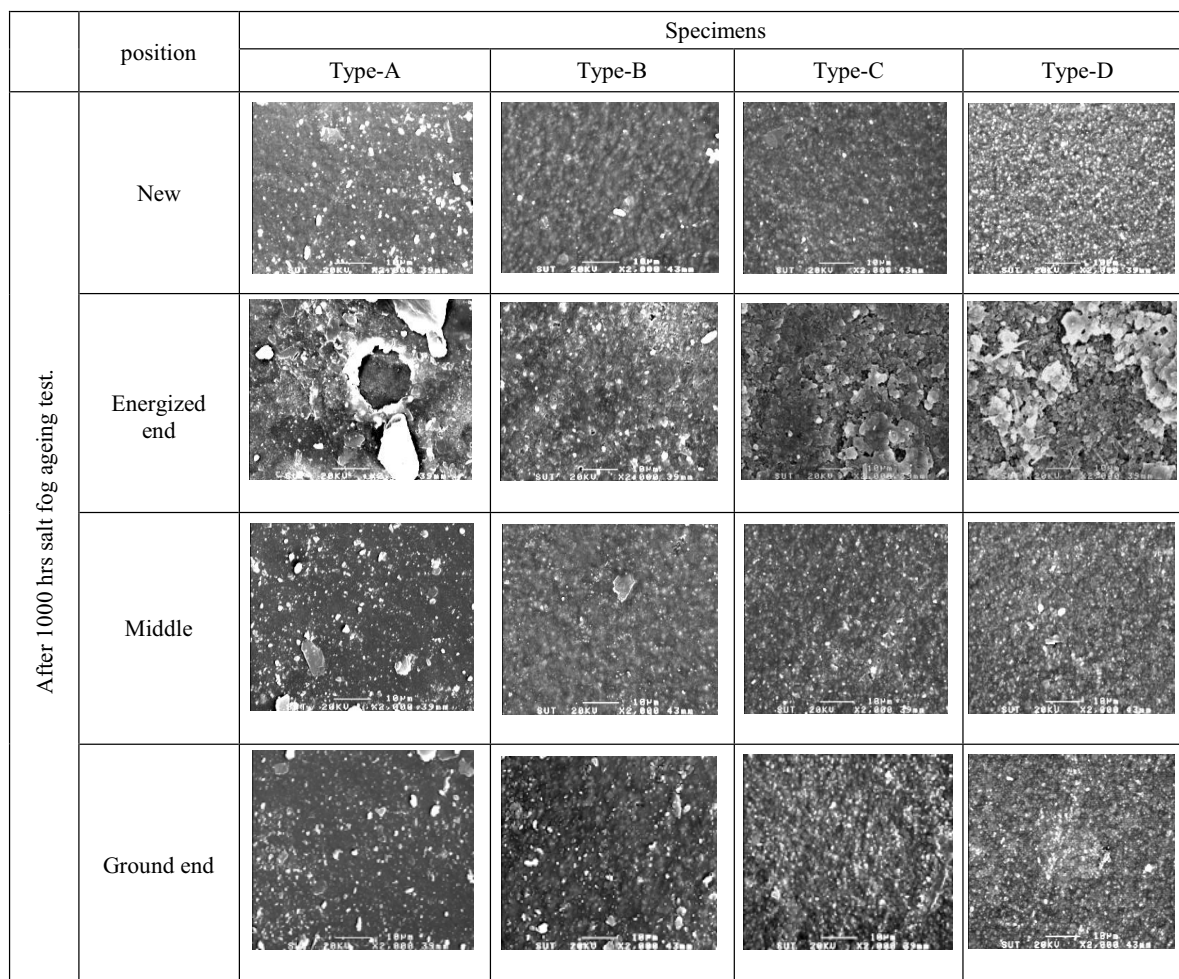
A comparison of the photo-micrographs between the aged and new specimen can provide a comparative indication of the surface conditions. Specimens were gold coated prior to examination [11]. Severe micro-erosion was observed on the energized end of tested specimen type-A comparing with the other type, as shown in Fig. 10.

Fig. 10 SEM analyzes of the specimens surface.

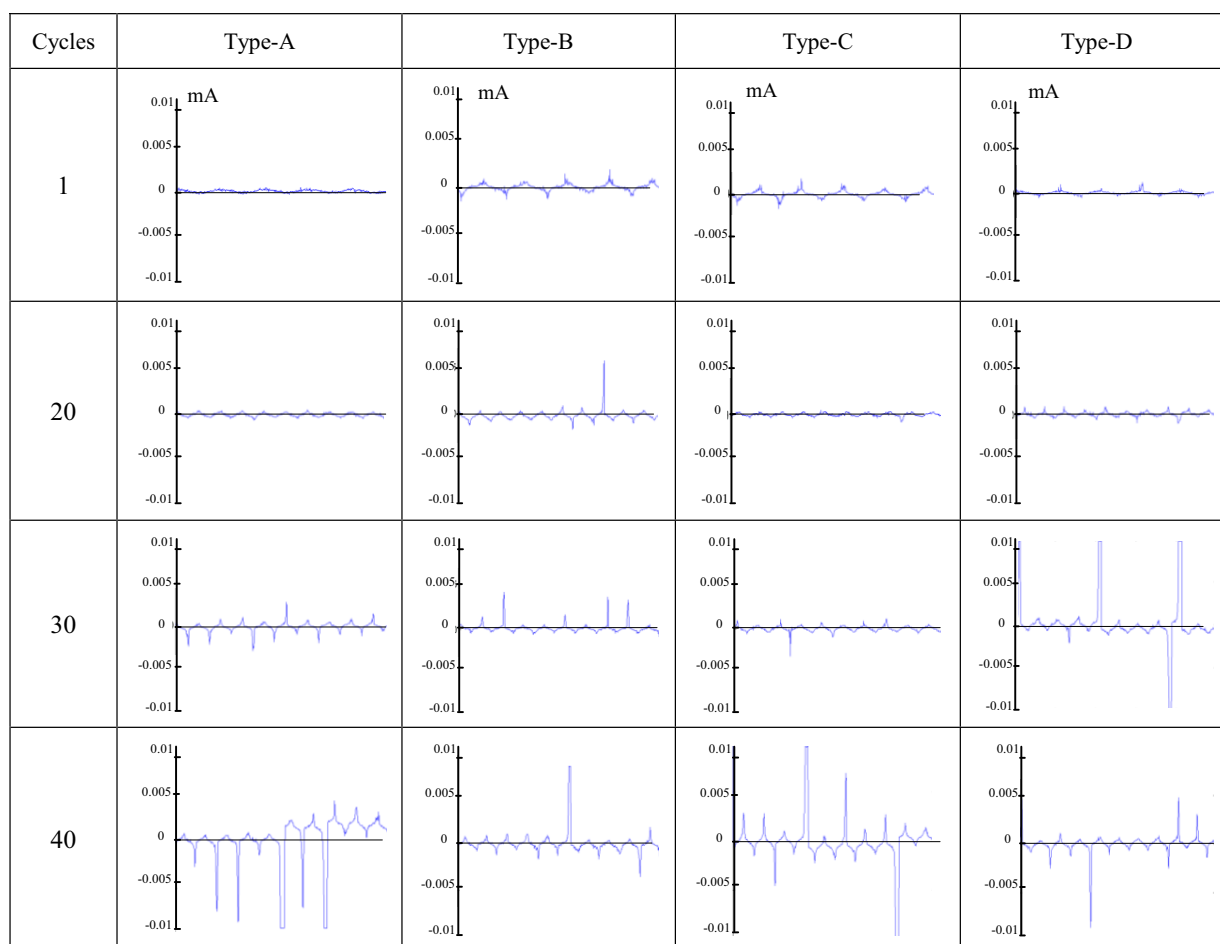
Leakage current flowing along the specimen surface was continuously measured and was recorded every 1 minute by leakage measuring software via LabView. Typical leakage current waveforms in each test cycle during salt fog injection are shown in Fig.11. The magnitudes of the leakage current increased gradually as the number of test cycles increased. The degree of the surface deterioration correlated with magnitudes of the leakage current.

Fig. 11 Leakage current waveform (1 cycle is 24 hrs).
