Energy Systems and Crushing Behavior of Fiber Reinforced Composite Materials

Hakim S. Sultan Aljibori

Abstract—Effect of geometry on crushing behavior, energy absorption and failure mode of woven roving jute fiber/epoxy laminated composite tubes were experimentally studied. Investigations were carried out on three different geometrical types of composite tubes (circular, square and radial corrugated) subjected to axial compressive loading. It was observed in axial crushing study that the load bearing capability is significantly influenced by corrugation geometry. The influence of geometries of specimens was supported by the plotted load – displacement curves of the tests.

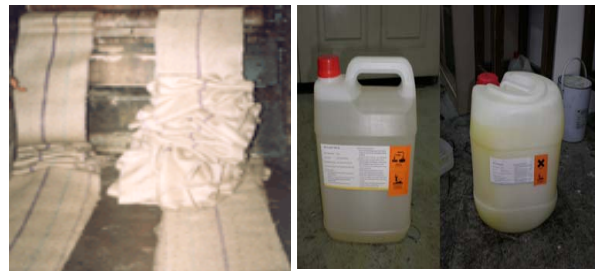
Fig. 4 Jute Fiber, Epoxy with hardener

Three types of specimen have been investigated, SJFT, CJFT and RCJFT. The entire structures are made of woven roving jute fiber/epoxy as shown in Figure 4. Three specimens were fabricated under the same conditions with a fixed fiber orientation angle of 0°/90° and epoxy resin (ZE-LAM 7892 A) with hardener (ZE-LAM 7892 B). All the specimens have inside diameter (d) 10 cm, height (h) 10 cm and wall thickness (t) 5mm. Three types of wooden mandrels have been manufactured in the workshop. The mandrels have the same length of 30 cm as shown in Fig 5.

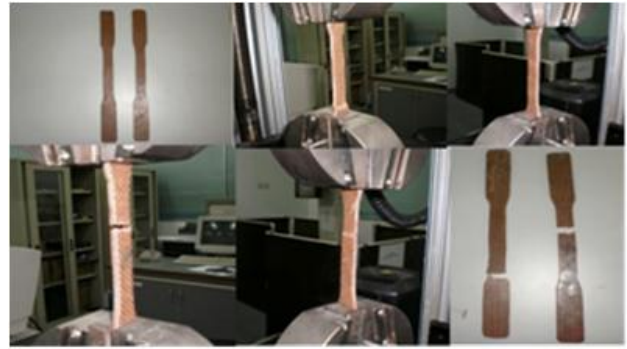
Fig. 6 Set Up of Tensile Test

The mechanical properties of jute fabric/epoxy composite materials have been investigated by using the INSTRON tensile testing machine, where the specimen is subjected to tension as shown in Figure 6. Mechanical properties of jute fiber/epoxy composite material are listed in Table 3.

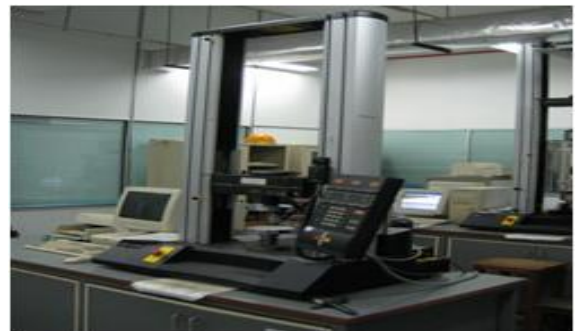
Fig. 7 Photograph of the INSTRON machine

The specimens were tested in quasi-static axial compression between two flat steel plates one is static and the other one moving with constant crushing speed. INSTRON 4469 digital testing machine (Figure. 7) with full scale load range of 50kN was used. Three specimens of each type of composite tubes were tested. Load platens were set parallel to each other before testing. All composite tubes were compressed at a loading rate of 15 mm/min until limited crush, which implies complete compaction of the tubes being tested. Load and displacement were recorded by an automatic data acquisition system. Progress and history of triangular crushing test of SJFT, CJFT and RCJFT are shown in Figures 8-10.

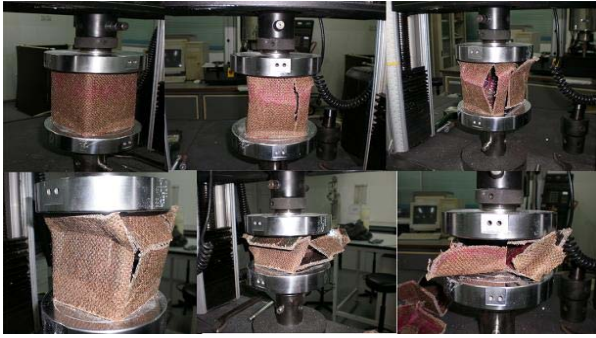
Fig. 8 Progress of Crashing Test of SQJFT

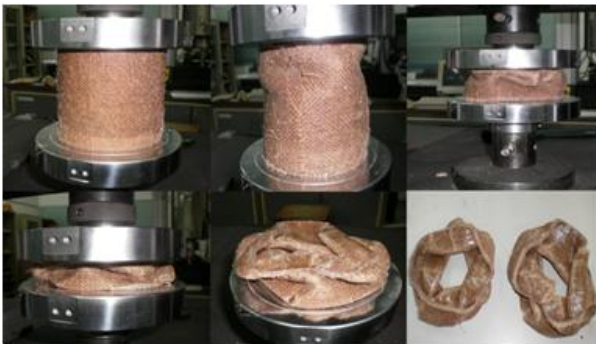
Fig. 9 Progress of Crashing Test of CJFT

Figure 12 (a) shows a typical crushing deformation of the CJFT subjected to quasi-static compressive load. Non-linearity is evident during the pre-crush-stage as shown in Figure 9b, where non-axisymmetric buckling is seen, which is characterized by unstable local tube wall buckling initiated the failure at the top end of the specimen as shown in Figure 12b. In this stage the tube resistance reaches its first and highest peak (45.35kN) at a deformation of 4.44 mm. On the other hand, the tube load-carrying capacity decreases gradually with the progress of crushing process. It is seen that the progressive folding in buckling is characterized by hinge formation and folding of the tube walls as in the case of ductile fiber-reinforced materials with the development of wrinkles. These wrinkles and buckles initiate and develop sequentially from one end of a tube under buckling process. The accumulation of the materials of the specimen caused the growth in the load/displacement curve at the end as shown in Figure 12c.

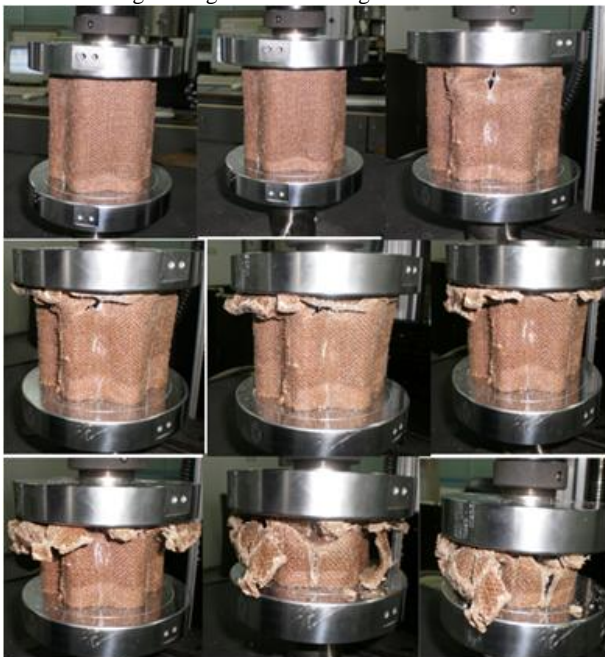
Fig.10 Progress of Crashing Test of RCJFT

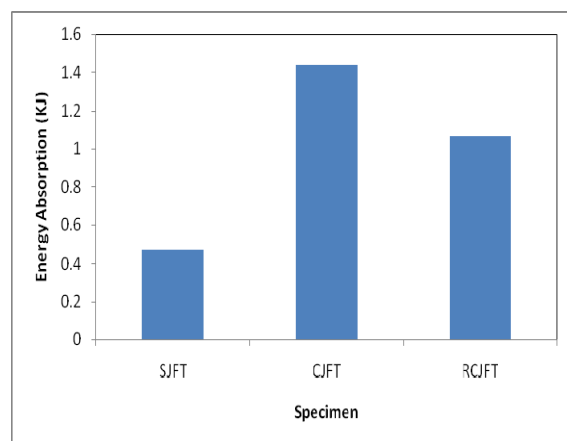
Fig. 16 Total Energy Absorption (TEA) of the specimens

The total energy absorbed (TEA) is the area under the load-displacement curve. It is a function of the specimen cross-sectional area and the material density. This energy can be obtained by numerical integration of the load displacement curve. Figure 16 shows the values of energy absorption (EA) for the three types of geometry obtained by variable design of jute fabric/epoxy resin. The highest value of 1.43 kJ is obtained by the circular tube (CJFT). The corrugated tube (RCJFT) has higher energy absorption than that of the square tube (SJFT), which has the lowest energy absorption (EA).

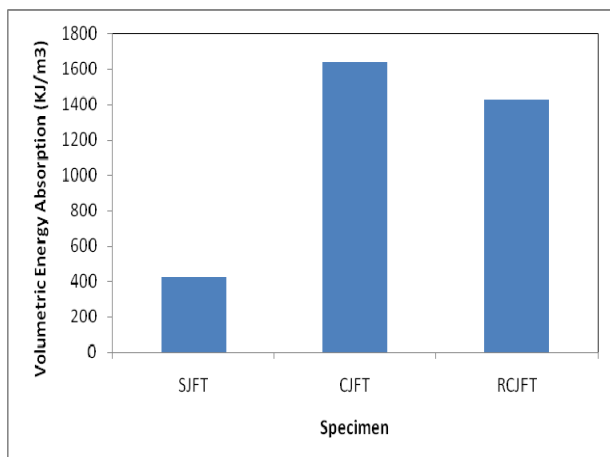
Fig. 18 Volumetric Energy Absorption (VEA)

Volumetric Energy Absorption (VEA) is the ratio between the energy absorption to the volume of the specimen. The unit is kg/m^3 . Figure 18 presents the variation of volumetric energy absorption VEA with the design of specimen by jute fiber/epoxy resin. The highest value was obtained by the circular tube CJFT which also corresponds to higher energy absorption EA. The corrugated tube RCJFT generated a lower value of VEA, 87.5% and the square tube generated the lowest 25% of VEA obtained in case of CJFT.
