Effects of Corrosion on Reinforced Concrete Beams with Silica Fume and Polypropylene Fibre

S.Shanmugam, V.G. Srisanthi, and S.Ramachandran

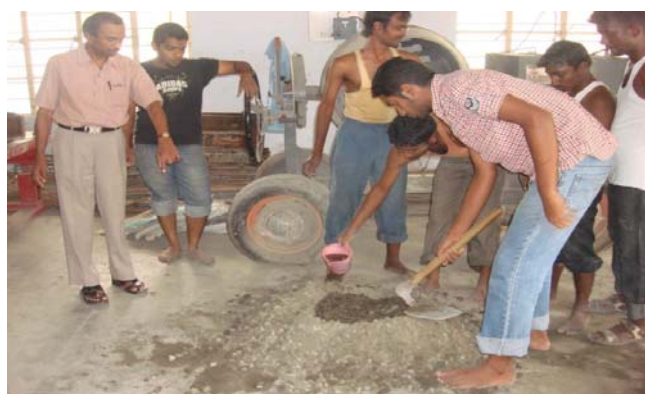
Fig. 1 Mixing of Concrete for Casting of Beam Specimens

1000 mm were selected. Bottom reinforcement of 2 numbers of 10 mm diameter, top reinforcement of 2 numbers of 8 mm diameter and shear reinforcement of 6 mm diameter two legged stirrups were used. The surface of rebars was derusted using wire brush and rust clear solution in order to remove any loose rust particles. The coating material was applied over the surface of the rebars with a brush and was allowed to cure. The initial weight of the rebars was taken and then the rebars were tied together to form the skeleton reinforcement cage. Twenty four numbers of beam specimens were cast using M35 grade of concrete. (Fig. 1). After curing for a period of 28 days, the specimens were transferred to Fibre Reinforced Plastic (FRP) tanks and were subjected to accelerated corrosion process.

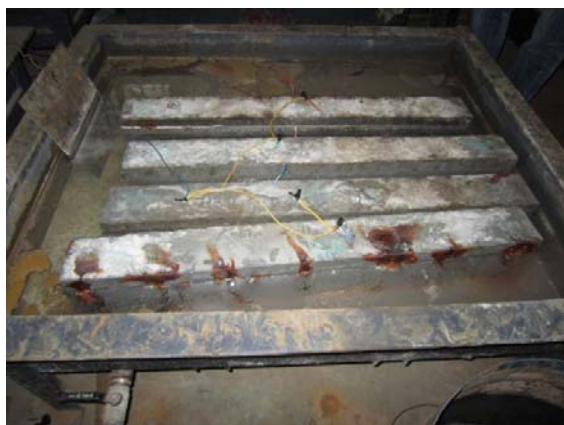
Fig. 3 Accelerated Corrosion Process for Unstressed Condition

Galvanostatic method was used to accelerate the corrosion process. Having the embedded steel as anode and an external stainless steel plate as cathode the beam specimens were impressed a selected current intensity under low voltage conditions for a period of 15 days. The specimens and steel plates were immersed in an electrolyte solution of 3% sodium chloride concentration [2] to simulate the conditions of sea water artificially. The current was applied using a regulated D.C. Rectifier. (Figs. 2 & 3)

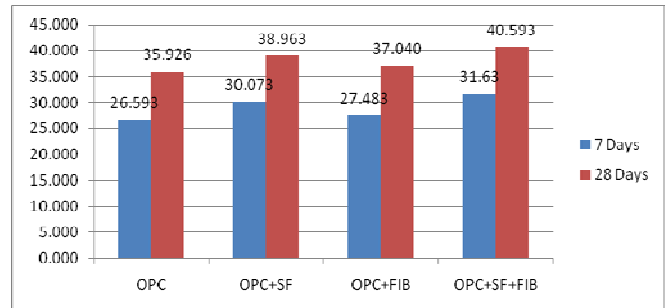
It was observed that the compressive strength is highest (40.59 N/mm²) for the cube with the combination of OPC, SF and Fibre. Fig.12 shows the 7 days and 28 days compressive strength values of the different combinations mentioned above.

Fig. 12 Compressive Strength for Cube Specimens (in N/mm²)

Cubes of size 150 mm X 150 mm X 150 mm were cast using M 35 grade of concrete and tested after 7days and 28 days for compressive strength for the following combinations.

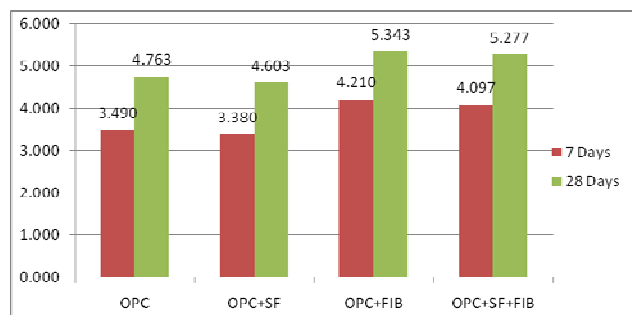
Fig.13 Flexural Strength for Prism Specimens (in N/mm^2)

Prisms of size 100 mm x 100 mm x 500 mm were cast using M35 grade of concrete and tested after 7days and 28 days for flexural strength of the concrete mix for the following combinations.
