Analyzing the Historical Ayazma Bath within the Scope of Integrated Preservation and Specifying the Criteria for Reuse

Meryem Elif Çelebi Yakartepe, Ayşe Betül Gökarslan

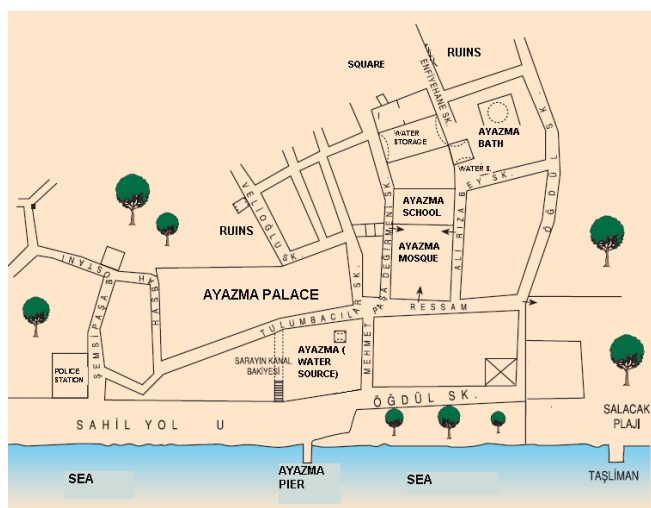
Fig. 1 Ayazma Social Complex Layout [7]

Ayazma Social Complex consists of a mosque in its center and structures around this mosque such as sultan mansion, time assignment center, primary school, stores, bath, and water reservoirs. Mosque, sultan mansion and the water reservoirs survived to today as mostly preserved status. However, time assignment center, primary school and the stores didn't live up today and new structures were built on their plots. The bath was mostly damaged and only the wall residues live up today (Fig. 1).

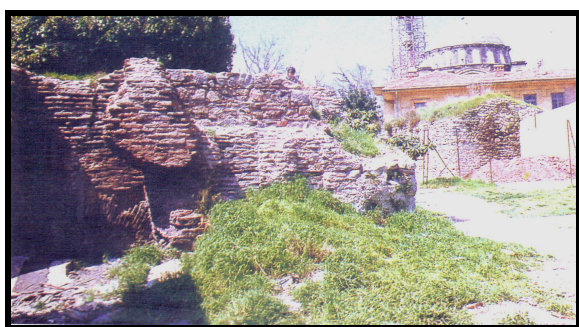
Fig. 5 Ayazma Bath's old photograph from 1987 [10]

The bath, which was abandoned for some time during World War I, started to serve again 1916. In a record dated September 17, 1769; it is claimed that the bath is used as a snuff workshop. Despite being a property of the foundation, it became a private property later with lawful resolution. The date until the bath served under the property of a person and its structural status is not precisely known. Nahide Şimşir (2004) states that the bath was in ruins in 1946 [12]. In 1974, the owner of the bath had stores built on the side of the bath facing Ögdül Street. In 1976, the bath is used as a dump [11] (Fig. 4). It is understood from a photo in the article of Sadi Bayram and Adnan Tüzen (1987) that the top cover of the bath was demolished in 1987 and that only the wall residue remained [10] (Fig. 5). Today, it is desolate.

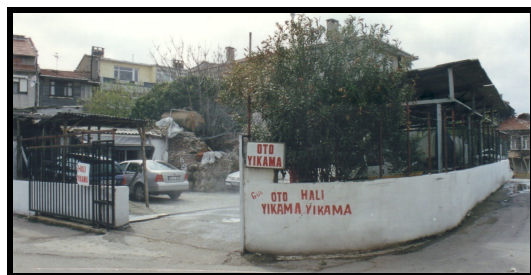
Fig. 8 Ayazma Bath, 2014

The structure is in ruins today. Its domes and furnace is completely destroyed, only the wall residues survived to today. A car and carpet wash service was built in its garden next to the bath. The residues of the structure and its surroundings were closed by new premises built by this enterprise. Water reservoirs were put inside the structure. The water and chemical based leaks used by the enterprise caused

serious deteriorations on the bath. The bath is faced with the danger of collapsing today (Figs. 8, 9).

In order to preserve Ayazma Bath and hand it down to the next generations, it should be purified of the dense structuring surrounding it; it should be saved from the usage type that damages the structure; surveying, restitution and restoration projects should be prepared as soon as possible and the restoration applications should immediately commence.

Firstly, the new additions of the enterprise in the surrounding of Ayazma Bath and the trees and soil dump in the bath should be cleaned. After this, ground excavations should be made and the status of the foundations should be examined. Necessary foundations and the walls should be subjected to strengthening and consolidation works. If there is ground water problem, the water should be kept away from the

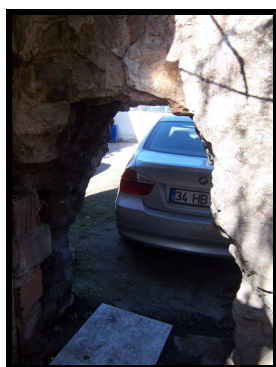
Fig. 10 The gap opened on the body wall of the bath by the enterprise - 2014

It is observed that an entrance gap was opened on the body wall by the Car Wash Service in order to be able to use the interior of the bath (Fig. 10).

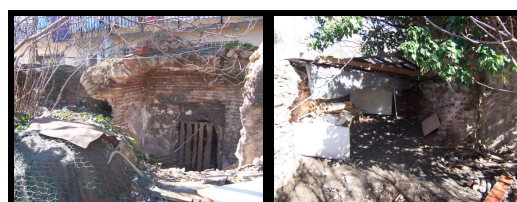
Fig. 12 Bath's interior views - 2014

The interior of the bath became the storage and dump of the Car Wash Service. It is observed that the trees in the interior part of the structure were randomly cut without considering its effects to the structure.

The complete destruction of the upper cover of the structure, the interior being in ruins, vegetation in the wall

residue, darkening and salinization effects, trees and soil dumps in the interior and wrong usage are the important deteriorations in the historical bath (Figs. 11, 12).

structure with drainage system. After the structural liberation, side liberation should be made. The plants, especially on the sides, should be removed from the structure with their roots. Next, the darkening and salinization should be cleaned.

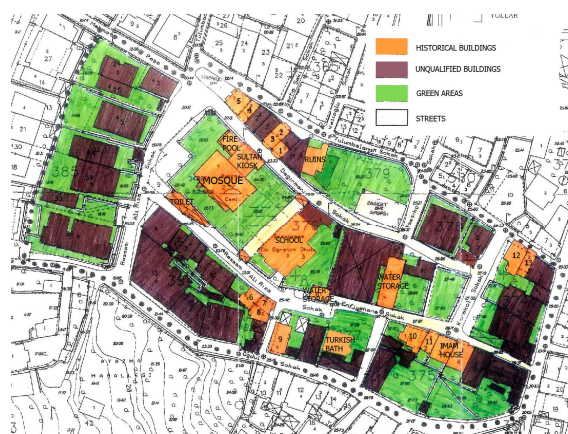
Fig. 13 Buildings at Ayazma Complex and its current situation analysis

Ayazma Complex's buildings have to conserve within the scope of integrated preservation. Firstly, the structures to be protected are determined by study of fabric analysis (Fig. 13).
