# Preservation of Isparta Yılan Kırkan (Yılan Kıran) Fountain within the Scope of Sustainability

Meryem Elif Çelebi Yakartepe, Ayşe Betül Gökarslan

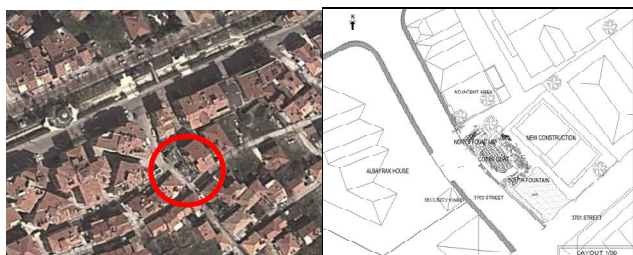
Fig. 2 Yılan Kırkan Fountain location and layout (relief)

Yılan Kıran (Yılan Kırkan) Fountain is located in Isparta Province, Sülübey Neighborhood, İçgi Street (street no 3702), in front of the house known to be owned by İlyasoğulları (Fig. 2) It is located in parcel 55 in island 1321. It's also known as "Dolma" or "Çukur" Fountain. It was built by İsa Fakıh, son of Mehmet.

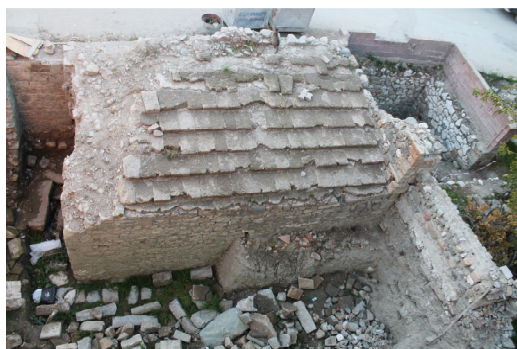
Fig. 4 Yılan Kırkan Fountain, from worksite which located besides fountain

The debris on the immovable was cleaned in 1999 and the fountain was revealed. During the debris cleaning, an inscription of the fountain with the proportions of 0.26 x 1.01 m was found. A cleaning excavation was carried out with the by the decision no. 3087 by Antalya Cultural Heritage Preservation Board dated 30.04.2009 [3] (Fig. 4).

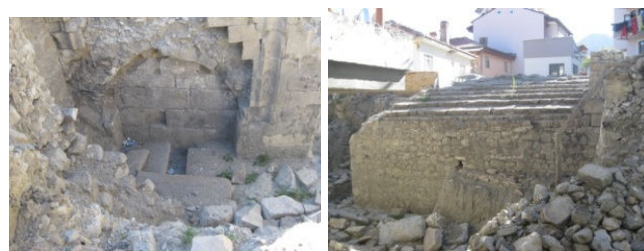
Fig. 6 Fountain's south and east facades

The north and south sides of the fountain consist of niches with semi-circle arch within a rectangular molding. It is known that there were inscriptions in these sides; however, this inscription did not survive to these days. In the north side of the fountain, there is a semi-circle arch window gap opening to the water reservoir (Figs. 6 and 7).

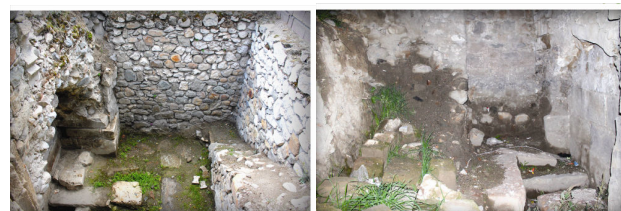
A large portion of the fountain is destroyed; material losses occurred in the north and south sides. There are vegetation problems on the sides and dampness and mossiness problem on the ground. The west side remained under the rising road elevation and the main mass of the structure remained in the construction yard of an apartment that is being built. The distance between the apartment and the fountain is less than 1 meter (Fig. 10).

Fig. 10 Fountain deteriorations (material losses, vegetation on the sides, dampness, mossiness problems from the ground etc.)

It is suggested that the fountain should be moved to an area appropriate for its nature in the town center and repaired, since;

After the historical fountain is moved, the restoration should be completed with reintegration, consolidation and liberating techniques.
