Vibration, Lubrication and Machinery Consideration for a Mixer Gearbox Related to Iran Oil Industries

Abstract—In this paper, some common gearboxes vibration analysis methods and condition monitoring systems are explained. In addition, an experimental gearbox vibration analysis is discussed through a critical case history for a mixer gearbox related to Iran oil industry. The case history also consists of gear manufacturing (machining) recommendations, lubrication condition of gearbox and machinery maintenance activities that caused reduction in noise and vibration of the gearbox. Besides some of the recent patents and innovations in gearboxes, lubrication and vibration monitoring systems explained. Finally micro pitting and surface fatigue in pinion and bevel of mentioned horizontal to vertical gearbox discussed in details.

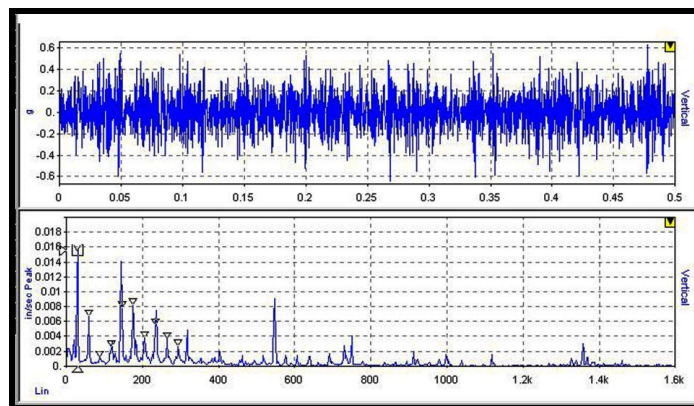
Fig. 1 FFT and TWF samples in GMF

Three main vibration analysis methods are explained in this part. Traditional FFT vibration analysis indicated that faults could produce side band families around tooth mesh frequency (TMF) or gear mesh frequency (GMF). GMF is calculated by data collector software automatically. The gear dimension, geometry, the number of teeth and RPM of different shafts in gearboxes are inputted in options then the software (like spectra pro) could introduce the TMF in cursors automatically and accurately. FFT and TWF samples in GMF are shown in Fig. 1.

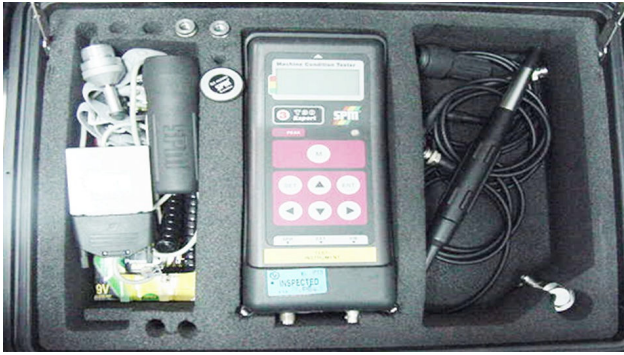
Fig. 2 Shock Pulse Transducer with Probe TRA-22 and a typical SPM data collector

This second phase of the collision is vibration and its frequency depends on the shape, mass, stiffness, and dampening of the metal. Shock Pulse Method filters out this phase of the collision, as the magnitude of the vibration is structure and material dependent. Typical SPM data collector and methodology had shown in Figs. 2 and 3 respectively.

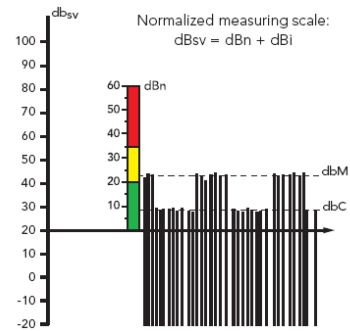
Fig. 6 Shock Pulse Method Evaluation; Range/Scale

The dB_i value is calculated once the RPM and shaft diameter have been input into the Tester. This becomes the starting point for 0-60 scale. dbm and dbc represented maximum value and carpet value respectively. The yellow represented alert condition and red represented danger condition in gearbox.

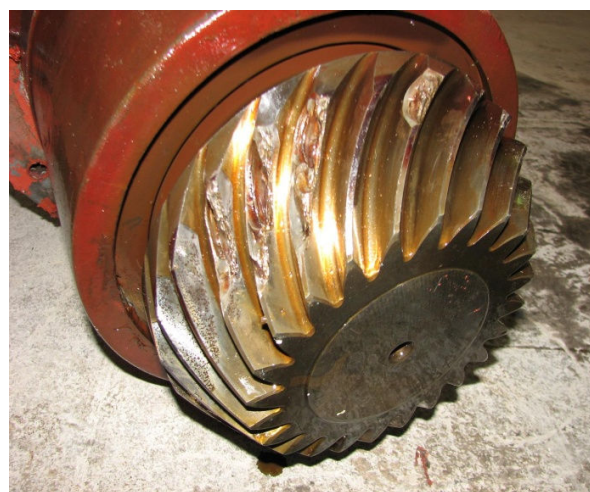
Fig. 16 Damaged gear (pinion)

The abnormal noise was increased in gearbox considerably then the monitoring group decided to recommend the machinery to check the gears. Both pinion and bevel was damaged. [17].

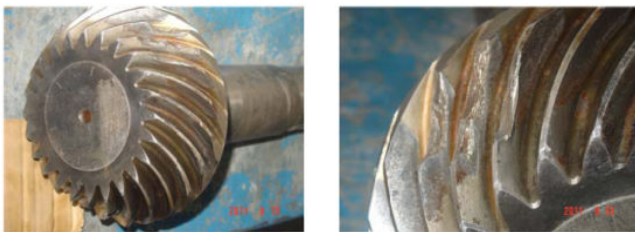
Fig. 18 Damage in gears in the next stage

Spare mixer was in rough condition and we had to send that gearbox to machinery workshop. Then we had to continue running of this equipment. The damages developed to other gears teeth with the same mechanical and metallurgical nature and characteristics.

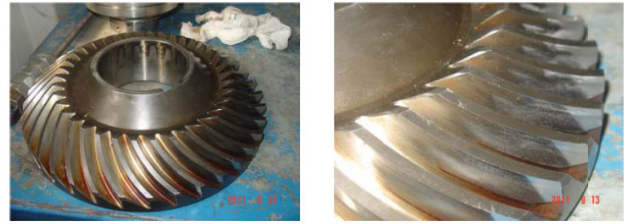
Fig. 19 Bevel gear engaged with pinion

The bevel gear engaged with pinion seemed to be ok but after checking this gear accurately, the microscopic porosities and a light changing in color was visible. That phenomenon was because of higher strength in these kinds of gears [20].
