# Influence and Interaction of Temperature, H<sub>2</sub>S and pH on Concrete Sewer Pipe Corrosion

Anna Romanova, Mojtaba Mahmoodian, Morteza A. Alani

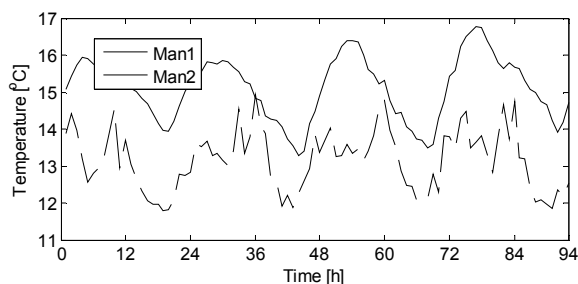
Fig. 1 Effluent temperature for Manhole 1 and Manhole 2 for a period of 4 days in the beginning of April shown in hours

The effluent temperatures for both manholes were found to follow very similar daily trend, however each of them has individual hourly pattern. Fig. 1 represents the data of effluent temperature recorded at a manhole 1 and manhole 2 in 5 days period in the beginning of April, where zero is set at 10am.

The data on Fig. 1 and for all other graphs was resampled to represent an average value for each given hour. Overall, in Feb-Apr the temperatures measurements minimum, maximum and mean for Man1 and Man2 were, 10.8°C, 17.1°C, 13.2°C and 11.6°C, 17.6°C, 15.1°C, respectively. In general the temperatures in Man2 are found to be higher and this is thought to be influenced by a closer location to the rising main, pumping station and generally the industrial sector which have larger use of hot water.

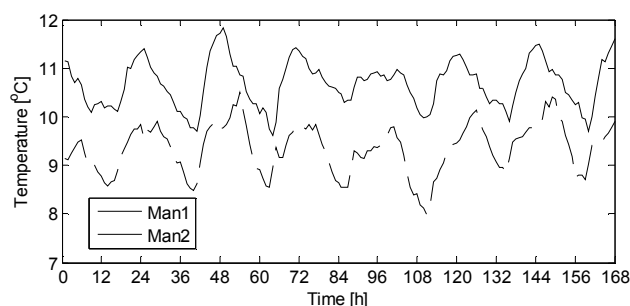
Fig. 2 Ambient temperature for Manhole 1 and Manhole 2 for a period of 1 week in the beginning of March shown in hours

The ambient temperatures for both manholes were found to follow overall an identical pattern. The general pattern of this behavior for both manholes is illustrated in Fig. 2, with zero set at midnight. From Fig. 2 it can be noted that the temperature in Man 1 is generally slightly lower for that compared with Man 2, with mean temperature values of 9.3°C and 10.6°C, respectively. Overall, in Feb-Apr the temperatures measurements minimum, maximum and mean for Man1 and Man2 were, 7.6°C, 12.9°C, 10°C and 8.7°C, 13.8°C, 11.2°C, respectively. The temperatures increased over the day with peak times at 11pm-4am after which they declined. This coincided with the discharge of overflow in the pumping station which generally takes place at midnight or when the chamber is full. However each manhole had manhole-specific minor pattern which is thought to be governed by house hold and industry activity in the area.

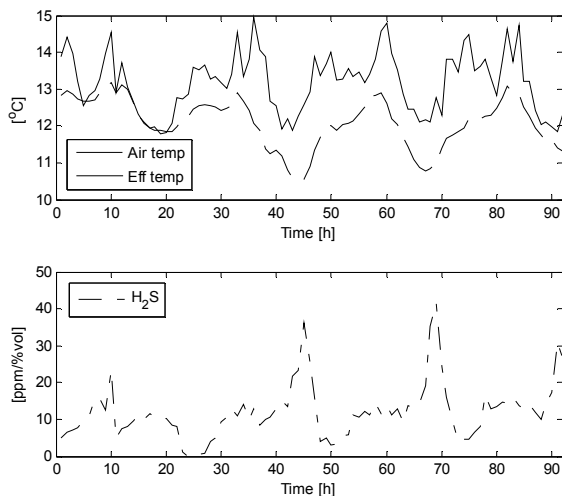
Fig. 4 Temperatures and hydrogen sulphide concentration for Manhole 1 for a period of 4 days in April shown in hours

The interaction between parameters of ambient temperature, effluent temperature and concentrations of hydrogen sulphide was investigated. Fig. 4 demonstrates the recorded data for the above for first four days in April for Manhole 1, with zero starting at 10am.

The data suggests that there is a relation between the ambient and effluent temperatures as they follow the same hourly pattern (which is governed by the effluent temperature, which in turn is related to domestic and industrial activities) and daily trend (governed by effluent temperature and general temperature of air outside the manhole). Furthermore, it can be noted that the  $H_2S$  level peaks together with the general decrease in temperature inside the manhole in late evening and early morning hours (during this time the general household and industrial activity is minimal, the flow levels are low to

moderate which allows for gas build-up). Furthermore, there is an apparent 10h shift in  $H_2S$  level increase and decrease behavior compared to temperatures. The above findings were confirmed for both of the manholes during Feb-Apr period.
