Wear Behavior of Commercial Aluminium Engine Block and Piston under Dry Sliding Condition

M. S. Kaiser, Swagata Dutta

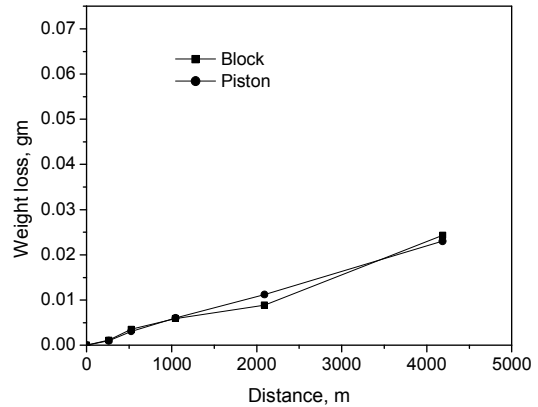
Fig. 1 Variation of weight loss (gm) with the variation of sliding distance (m) at applied pressure of 0.30MPa (Load 5N) and sliding velocity 0.29 ms^{-1}

Figs. 1 and 2 elucidate the variation of weight loss with the variation of sliding speed for both engine block and piston alloy at applied pressure of 0.30MPa (Normal Load 5N) and 1.4MPa (Normal Load 20N) respectively. Moreover, Figs. 3 and 4 depict the variation of wear rate with the variation of sliding speed for both engine block and piston alloy at applied pressure of 0.30MPa (Normal Load 5N) and 1.4MPa (Normal Load 20N) respectively. Other parameters, such as sliding velocity (0.29 ms^{-1}), surface roughness ($2 \mu\text{m}$), and humidity (80%) are identical for these four figures. It can be seen from Fig. 1 that, at lower applied pressure (0.30MPa) the weight loss at all sliding distances vary insignificantly for both block and piston. As the sliding distance increase the weight loss increases for both the alloys. At relatively higher applied pressure (1.4MPa) both the alloys show higher weight loss as compared to weight loss at low load and at all sliding distances (Fig. 2). However, for higher applied pressure, differences in weight loss values for block and piston are evident. The block showed higher weight loss at relatively low and high ends of sliding distance.

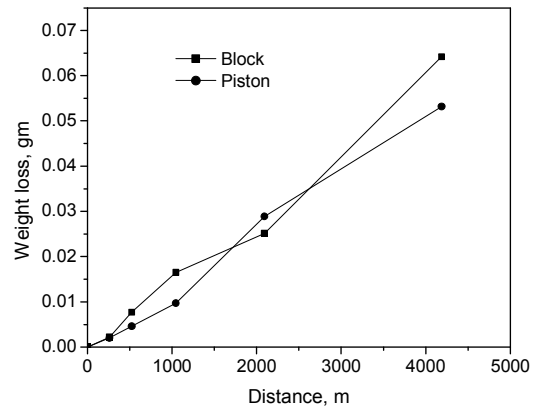
Fig. 2 Variation of weight loss (gm) with the variation of sliding distance (m) at applied pressure of 1.4 MPa (Load 20N) and sliding velocity 0.29 ms^{-1}

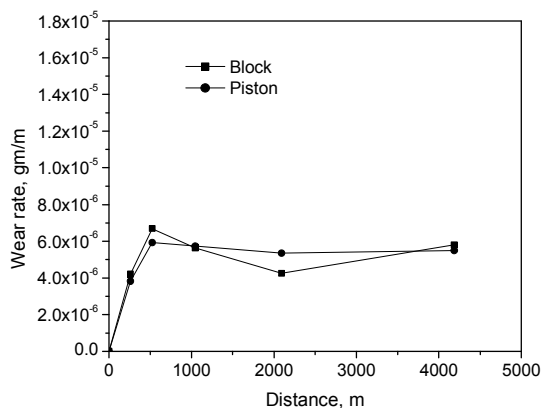
Fig. 3 Variation of wear rate (gm/m) with the variation of sliding distance (m) at applied pressure of 0.30 MPa (Load 5N) and sliding velocity 0.29 ms⁻¹

Figs. 3 and 4 present the wear rate vs. sliding distance plot for both block and piston. At lower applied pressure, it can be observed that wear rate increased at a steep rate initially for both block and piston and after a certain point onwards attained a constant value (Fig. 3). In the case of higher applied pressure, the nature of the curves are quite similar to that of the lower applied load, only difference is in the value of wear rate increased quite significantly for both the alloys (Fig. 4) with block showing higher values than piston at lower and higher realm of the investigated sliding distance range. The competition of frictional heat softening and strain hardening determined the down -and-up trend. Figs. 3 and 4 clearly indicate that the wear rates of both the alloy increased with increasing the load from 5N to 20N. The wear rate for engine block increased from $6 \times 10^{-10} \text{ gm/m}$ (5N) to 1.6×10^{-5} (20N) at sliding distance of 1000 m. For all sliding distances, the wear rate for both the alloys increased one order of magnitude with increasing load from 5N to 20N. For both applied pressures the piston alloy showed lower wear rate as compared to that of block alloy. The result is due to the presence of higher percent of Ni and Mg in piston alloy as seen from the chemical analysis (Table I). Ni forms an intermetallic Al_3Ni which

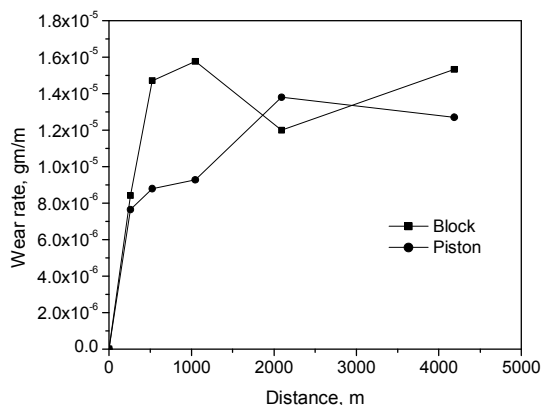
Fig. 4 Variation of wear rate (gm/m) with the variation of sliding distance (m) at applied pressure of 1.4 MPa (Load 20N) and sliding velocity 0.29 ms⁻¹

increases as Ni content increases. This intermetallic increases the strength of the piston alloy leading to lower wear rate. More over Mg addition is beneficial to enhance the abrasion resistance of the alloy due to uniformly distribution of hard particles and reduction of friction coefficient [10]. The sliding movement occurs in very small areas at the peaks and over time. The ruptures or breaks at the peaks increase the contact area and results in rise in temperature. The increase in the load causes rise in friction.

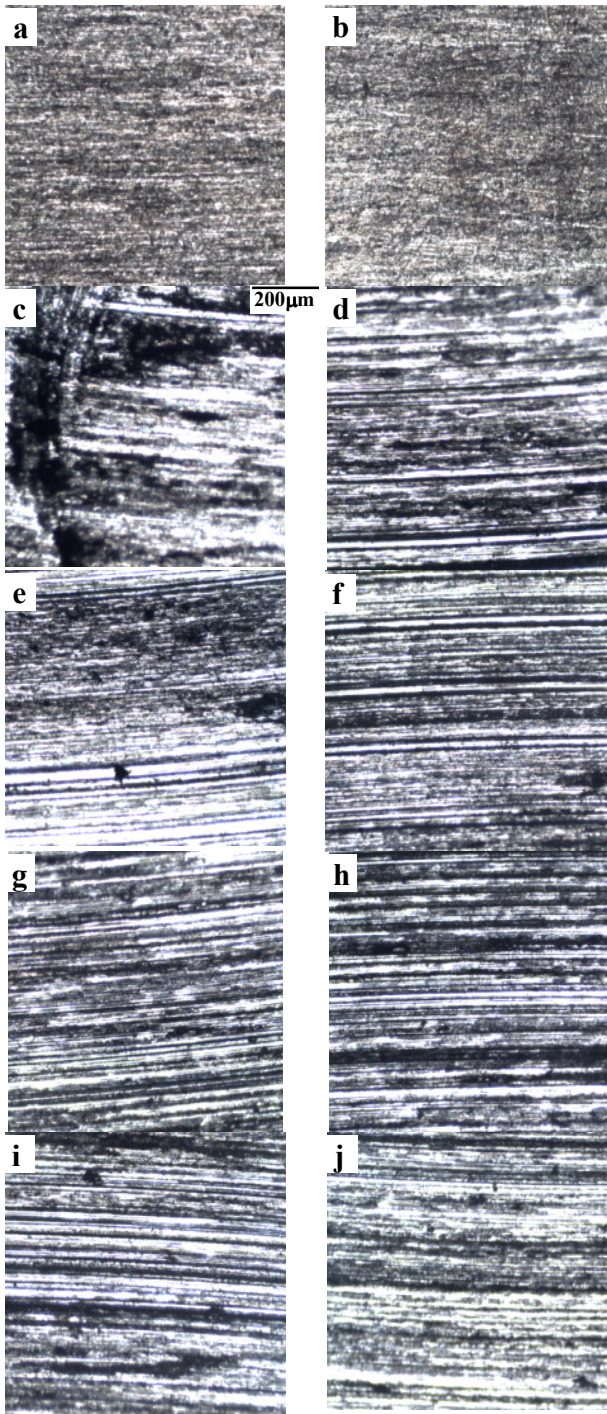
Fig. 5 Optical micrograph of worn surfaces before wear (a) block, (b) piston, after wear at applied pressure of 0.30MPa for 15 min (c) block, (d) piston, for 4 hours (e) block, (f) piston, at applied pressure of 1.40MPa for 15 min (g) block, (h) piston and for 4 hours (i) block (j) piston

In this study of dry sliding wear of two Al-Si alloys against a cast iron counter-body, the wear was described as a mixed mode of elastic-plastic contact where Archard's law was obeyed. The applied pressure range investigated was 0.30 MPa and 1.4 MPa. This range of applied pressure was previously found to exhibit mild wear (MW) in these alloys [11]. In Fig. 5 are presented the worn surfaces for both block and piston alloys at different loads and sliding distances. Firstly, it can be observed that for a given alloy and for a given load, as the sliding distance increase the wear marks becomes more visible and deep. In some portions of the investigated worn surface there are evidence of crater formation. It can also be seen that for a given alloy and at a given sliding distance, as the load is increased the wear marks also becomes more deep and prominent. Increasing the load from 5N to 20N also increases the fraction of flaky wear debris. At low loads and at all sliding distances, the wear marks in the worn surfaces of block and piston alloy are similar in nature whereas at higher applied loads the wear marks in the worn surfaces of block are more deep and intense than that of the piston alloy leading to their higher material loss and corresponding high wear rate. The wear mechanisms in the dry sliding of Al-Si alloys can be classified as oxidative wear. Oxidative wear occurred at low applied loads. In this wear process an aluminium oxide layer (10-80 pm) formed on both the wearing Al-Si surface and the counter-face [11]. Wear occurred firstly by oxidation of the asperities and then secondly by fracture and compaction of the oxidized wear debris into this film. The wear rate was low, due to the amount of metal removed being confined to the thickness of this oxide formation. Some localized deformation of the substrate and fracture of the Si particles was observed. Oxidative wear was considered to be generally independent of the Si content or Si particle size. Under conditions of mild wear a tribolayer was formed on the surface of Al-Si alloys. This layer was found to consist of an ultrafine mixture of aluminium, silicon and α -iron. The formation of this surface resulted from the transfer of material from both the Al-Si alloy pin material and the steel counter-face. It was also found that the observed iron-rich layer, formed on the Al-Si surface due to mutual material transfer between the sliding surfaces, was composed of an ultrafine mixture of Al, Si and α -Fe (<1 μ m). Furthermore, it was argued that as wear continued, the deposition reached a stage where these transferred layers could not adhere and became detached [11].

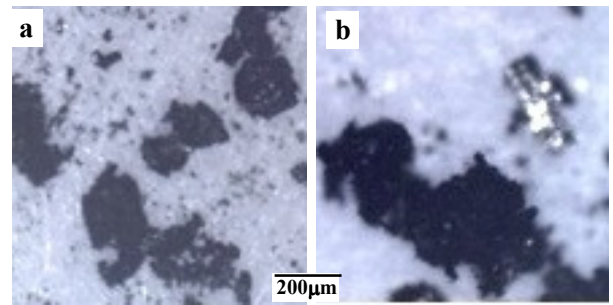
Fig. 6 Wear debris collected from wear test at 1.4 MPa (20N) applied pressure and sliding distance of 4200m for (a) Block, (b) Piston

Fig. 6 shows the typical wear debris collected from the wear test. At low loads the wear debris was equiaxed, laminar and consisted of a small iron content. An increase in the applied normal load formed wear debris of various shapes and sizes. The debris size ranged from a few microns, to a few millimeters. Visually, the debris produced at 20 N appeared in

the form of a dark, brown powder. The micrograph (Fig. 6) shows the debris produced at a load of 20 N was mainly composed of very fine, equiaxed particles but also contained plate-like and ribbon-shaped iron particles in smaller amounts. The fine and large debris particles were a mixture of Al, Si, Fe, and oxygen. The ribbon-shaped particles had an appearance similar to machined chips, and were mainly composed of Fe indicating that they were cut from the steel counter-face.

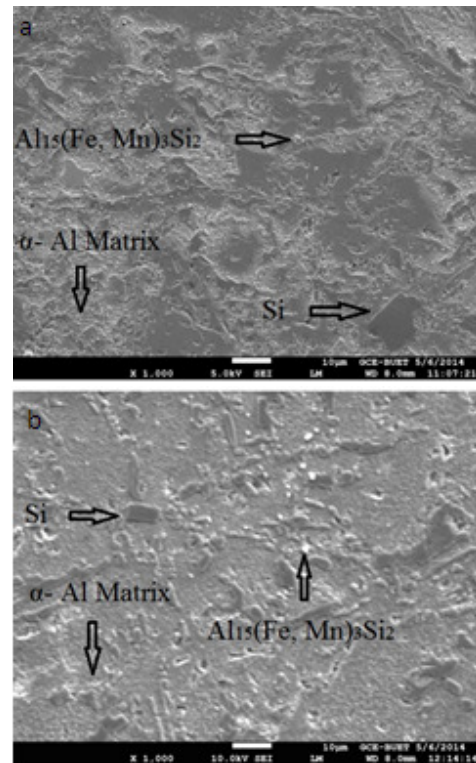
Fig. 7 SEM micrographs of as-received Al-Si (a) block and (b) piston

The SEM micrographs of as-received Al-Si block and piston are shown in Figs. 7 (a) and (b) respectively.

The microstructure consisted of mainly primary Al dendrite, eutectic Si, $Al_{15}(Fe, Mn)_3Si_2$, Mg_2Si and a few number of Fe-rich intermetallic phases on α -Al matrix in the inter-dendritic region. It can be seen that the eutectic Si phase is flake-like

and acicular morphologies. Two type of NiAl_3 phase are the plate-like and needlelike morphologies [7].

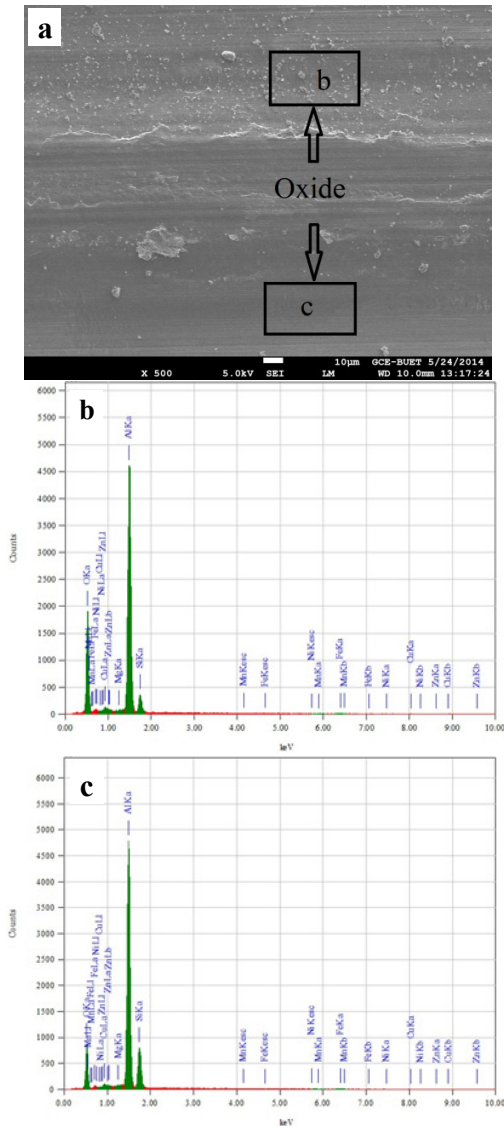
Fig. 8 SEM images of worn surfaces of aluminium engine block after wear at 1.4 MPa applied pressure and sliding distance of 4200m

The SEM micrographs of the worn surfaces of Al-Si block and piston are shown in Figs. 8 and 9. The corresponding EDX profile analysis of the block alloy for the selected area of the SEM is shown in Figs. 8 (b) and (c). The weight percentage of elements found by EDX analysis in these areas were 37.67% O, 51.03% Al, 5.60% Si, 0.75% Mn, 3.74% Fe and 0.76% Cu, 0.44% Zn and, 22.23% O, .04% Mg, 58.01% Al, 15.49% Si, 2.27% Fe, 0.72% Ni, 0.80% Cu, 0.42% Zn respectively.

0.86% Cu, 0.13% Zn respectively. The EDX data clearly reveals the high oxide content in the selected areas which suggest the oxidative wear was the dominant process. In case of block alloy the EDX analysis of the investigated areas reveals that the oxide content is unevenly distributed. Whereas for piston alloy the oxide content is roughly uniform which can be responsible for lower wear rate for the piston alloy. This can be due to the variation of chemical composition of the alloys.

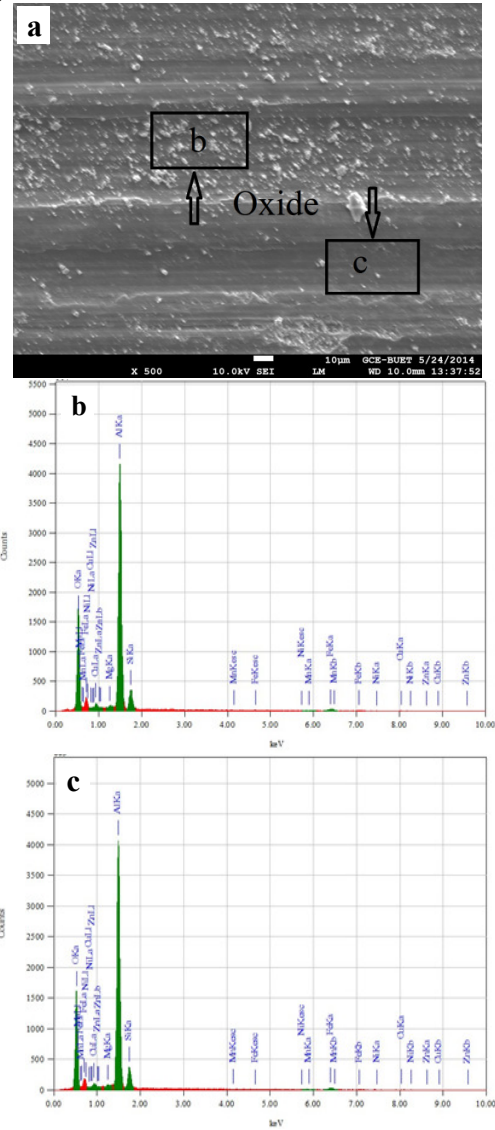
Fig. 9 SEM images of worn surfaces of aluminium engine piston after wear at 1.4 MPa applied pressure and sliding distance of 4200m

The corresponding EDX profile analysis of piston alloy for the selected area of the SEM is shown in Figs. 9 (b) and (c). The weight percentage of elements found in these areas were 33.82% O, 0.12% Mg, 48.00% Al, 5.69% Si, 0.17% Mn, 10.61% Fe, 0.42 Ni, 1.01% Cu, 0.1% Zn and 33.93% O, .15% Mg, 48.45% Al, 5.99% Si, 0.45% Mn, 9.70% Fe, 0.34% Ni,

Generally, a transferred layer either in continuous or discontinuous form was observed for the samples. The widths of the surface grooves were between 4 μm and 20 μm . In this wear process an aluminium oxide layer (10-80 μm) formed on both the wearing Al-Si surface and the counter face. Wear occurred firstly by oxidation of the asperities and then secondly by fracture and compaction of the oxidized wear debris into this film. The wear rate was low, due to the amount of metal removed being confined to the thickness of this oxide

formation. Some localized deformation of the substrate and fracture of the Si particles was observed. Sliding marks are observed on all the worn surfaces which are of typical ploughing action in comparatively soft metal. It is also seen that the depth and width of the sliding marks increases with increase of applied load and sliding distance. The worn surface is relatively rough and exhibits rather coarse and deep sliding marks. In contrast, the coarseness and deepness of the sliding marks increases with increasing load on the tested alloys. At relatively low speeds and loads, the heat generated by the asperity contact leads to oxide formation on the aluminum surface. The layer is thin and can deform elastically contributing to very low wear rates which can be considered as mild wear. Increasing the load causes adhesion to occur between the two materials in contact and removal of the surface oxide in the form of laminar particles. At low loads the wear debris was characterized by dark-brown coloured powder mixed with Fe, Al, and Si and O, very fine equiaxed particles, small amounts of ribbon shaped particles (Fe chips), and Plate-like particles (Fe-Al-Si-O). At relatively high loads Plate-like particles composed of Fe, Al, and Si and O and metallic Al flakes (Al-Si) was observed [11]. The worn surface was characterized by surface with shallow grooves at loads while the groove width and depth increased as the loads increases.
