Comparison of Ageing Deterioration of Silicone Rubber Outdoor Polymer Insulator under Salt Water Dip Wheel Test

J. Grasaesom, S. Thong-om, W. Payakcho, A. Oonsivilai and B. Marungsri

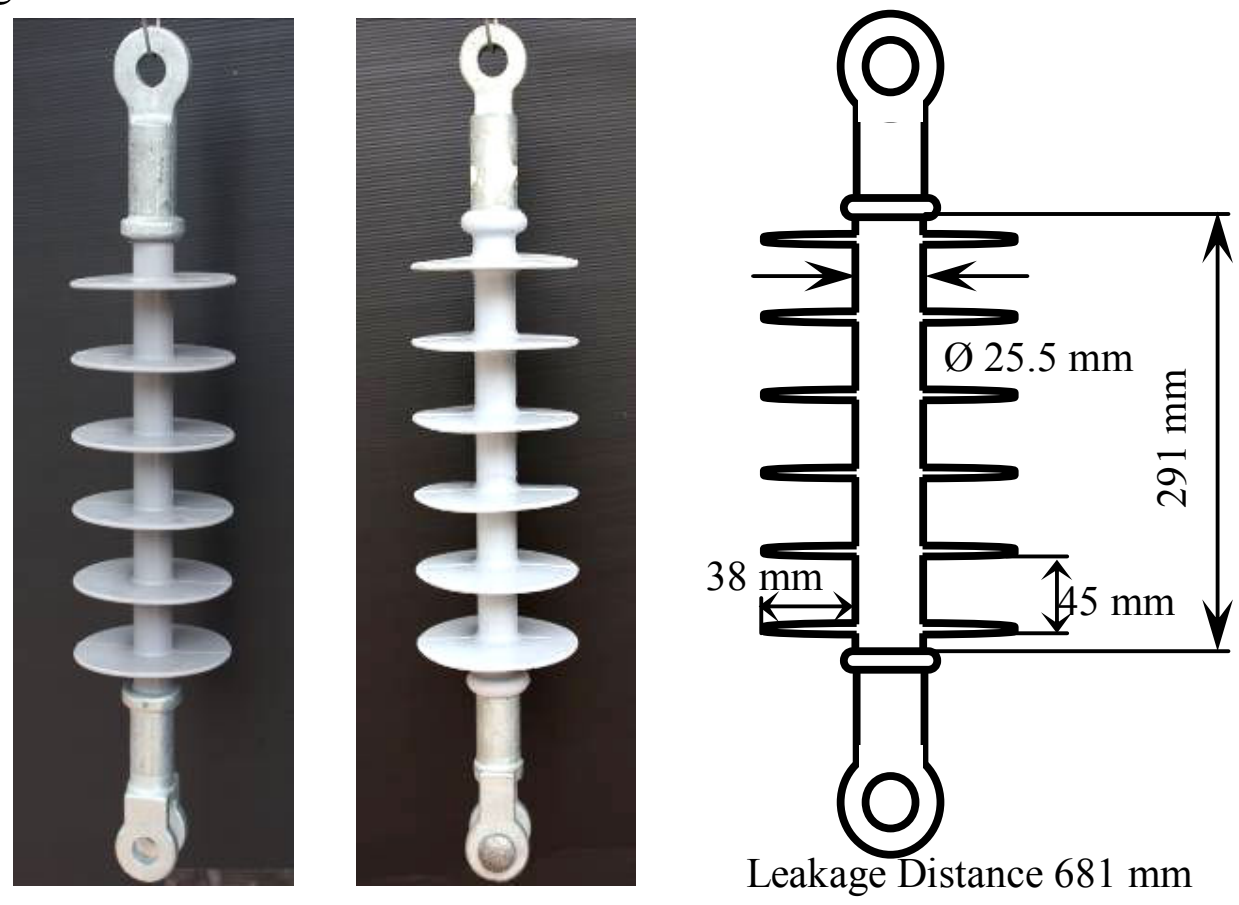
Fig. 1 Specimen

(a) Type-A (b) Type-B (c) Dimension

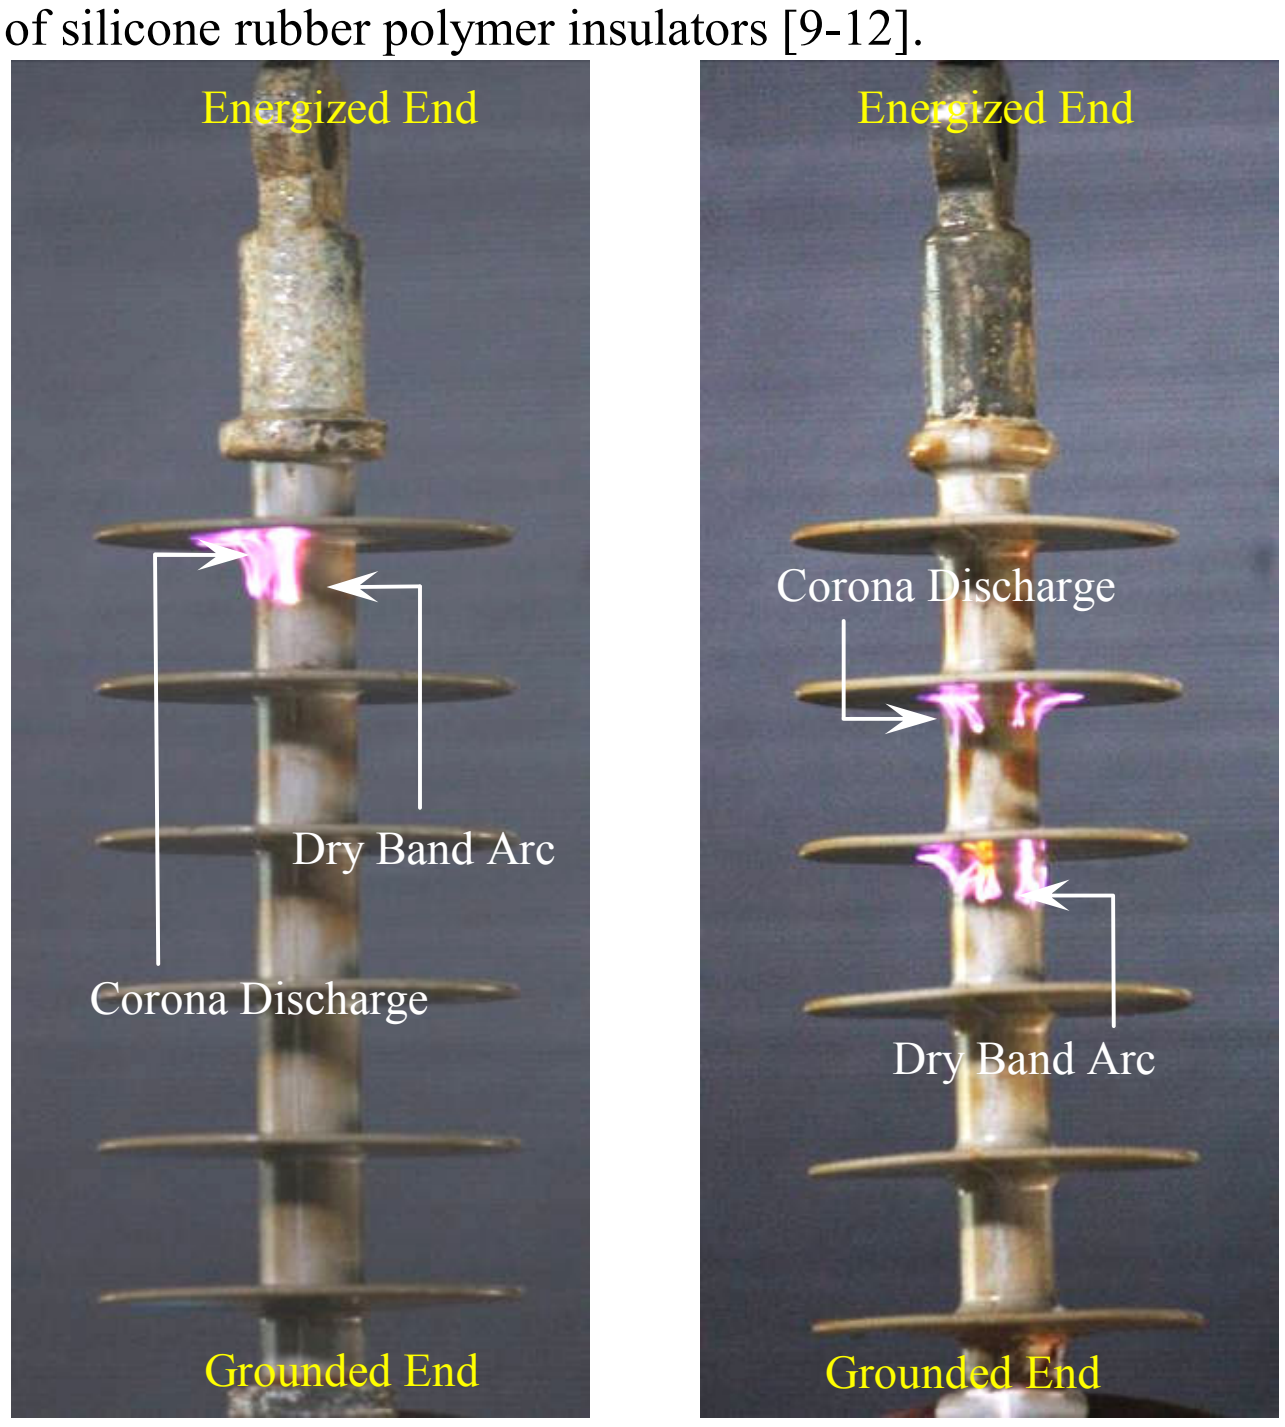
Fig. 4 Visible discharge activities during salt water dip wheel test.

As shown in Fig. 4, visible discharge activities during the test were often observed on the trunk surface for all specimens. Yellow light paths indicate dry band arcing and purple light spot indicate corona discharges. These phenomenons caused reduction of hydrophobic and ageing deterioration on surface of silicone rubber polymer insulators [9-12].

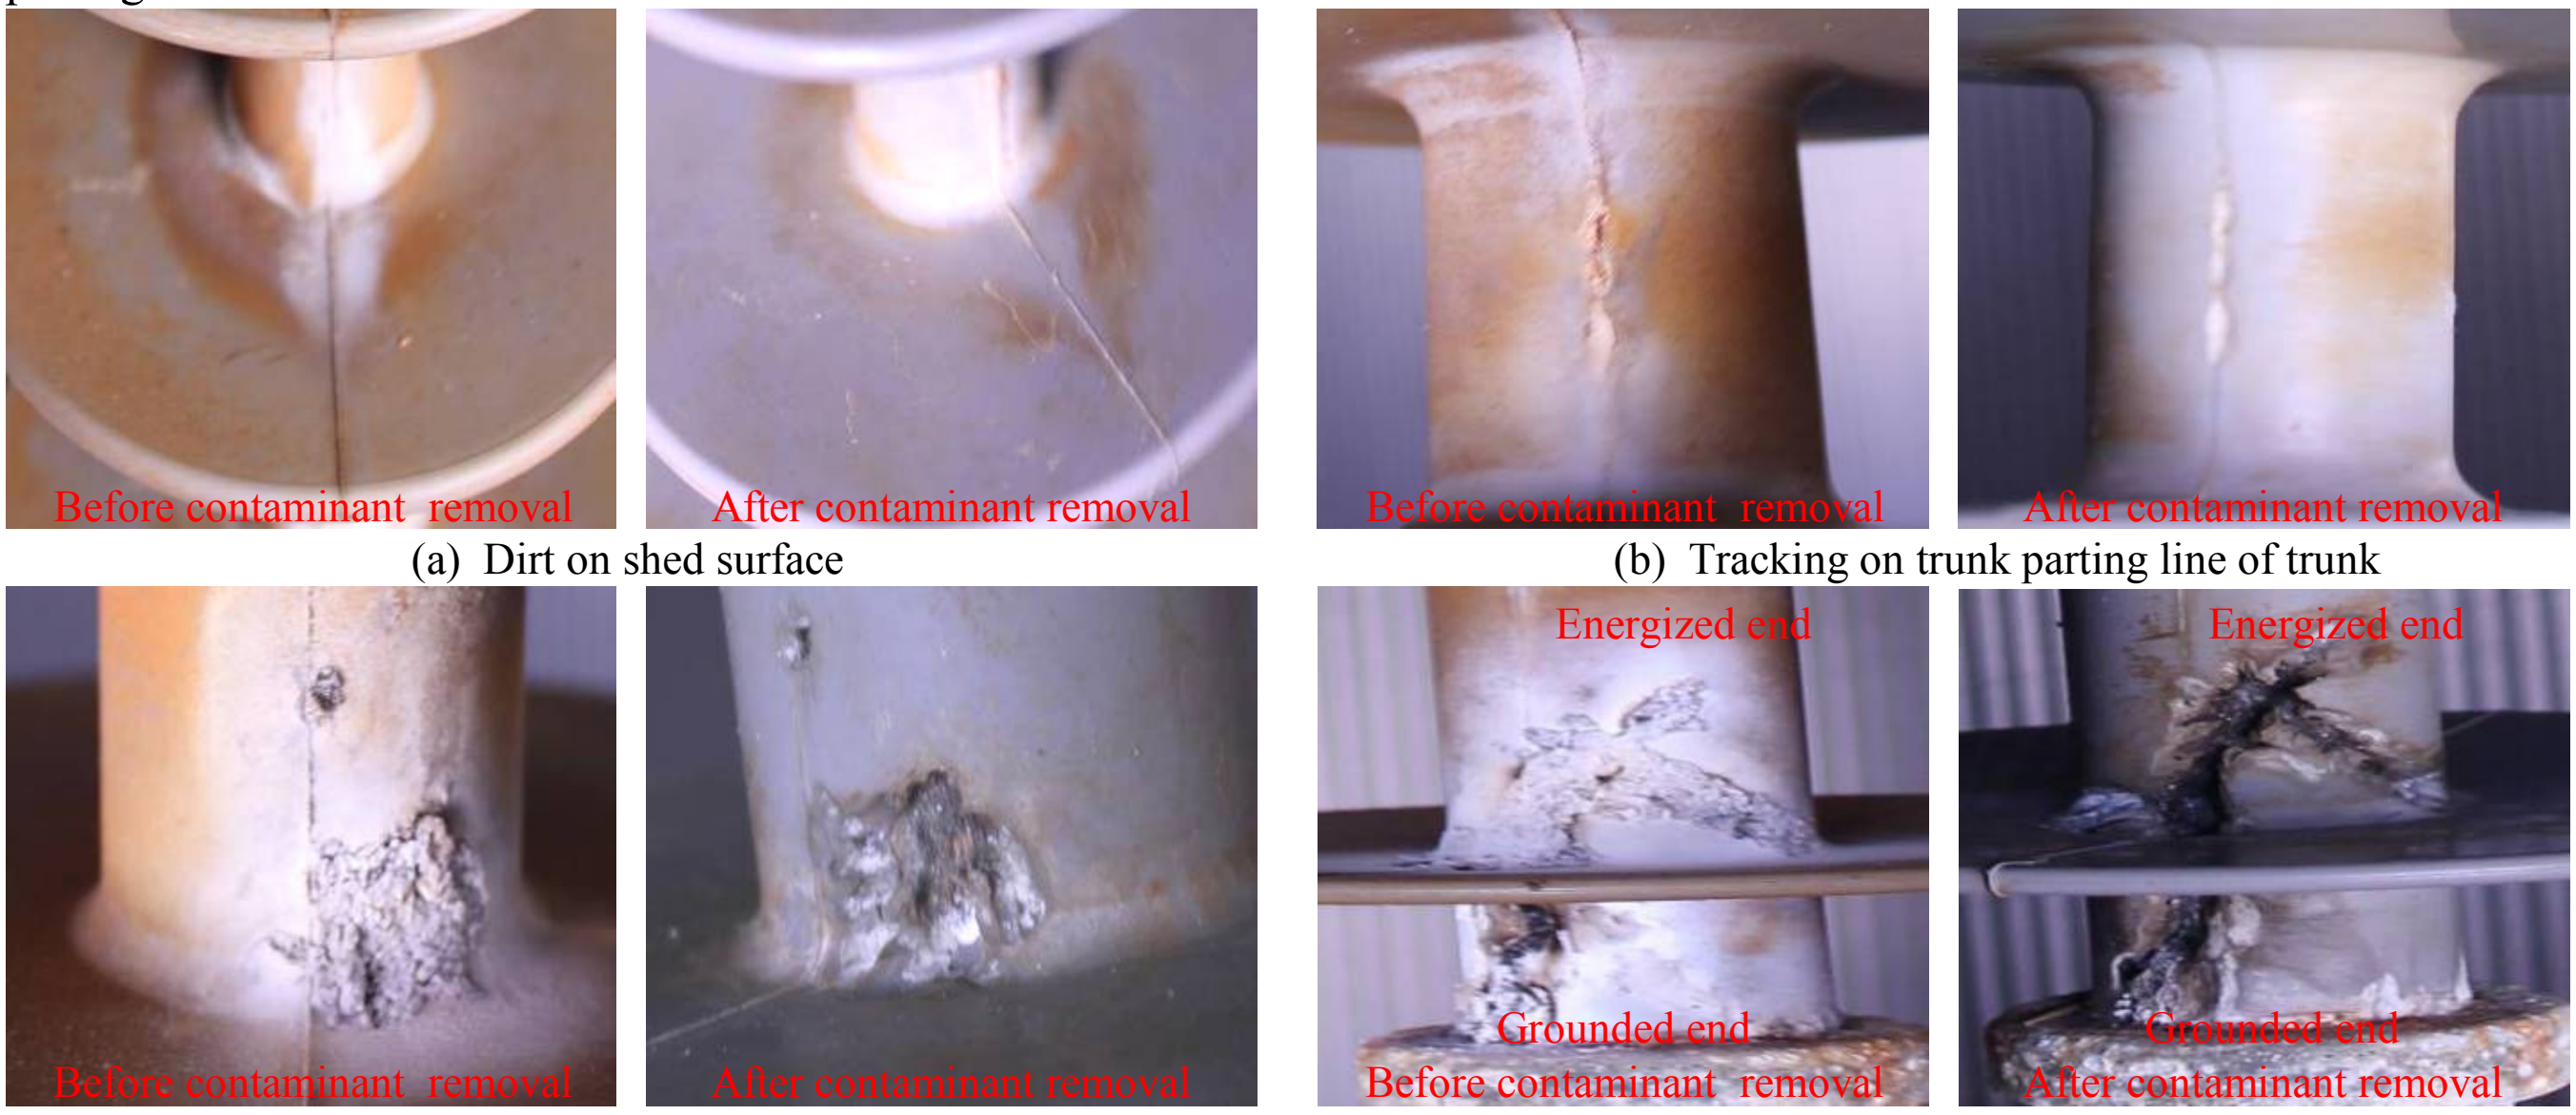
Fig. 5 Surface damaged of Type-A specimen

As shown in Fig. 5 (a), dirt was observed on both shed and trunk surfaces of tested specimen.

As shown in Fig. 5 (b), slightly surface tracking was observed on parting line of trunk surface near the energized end.

As shown in Fig 5 (c) and Fig. 5 (d), severely tracking was observed on the parting line of trunk surface near the grounded end. The occurrence of surface tracking on such position may due to higher electric field stress. Electrical discharges may cause surface damaged [13].

(a) Dirt on shed surface (b) Tracking on trunk parting line of trunk

(c) Tracking on trunk (d) Tracking on trunk

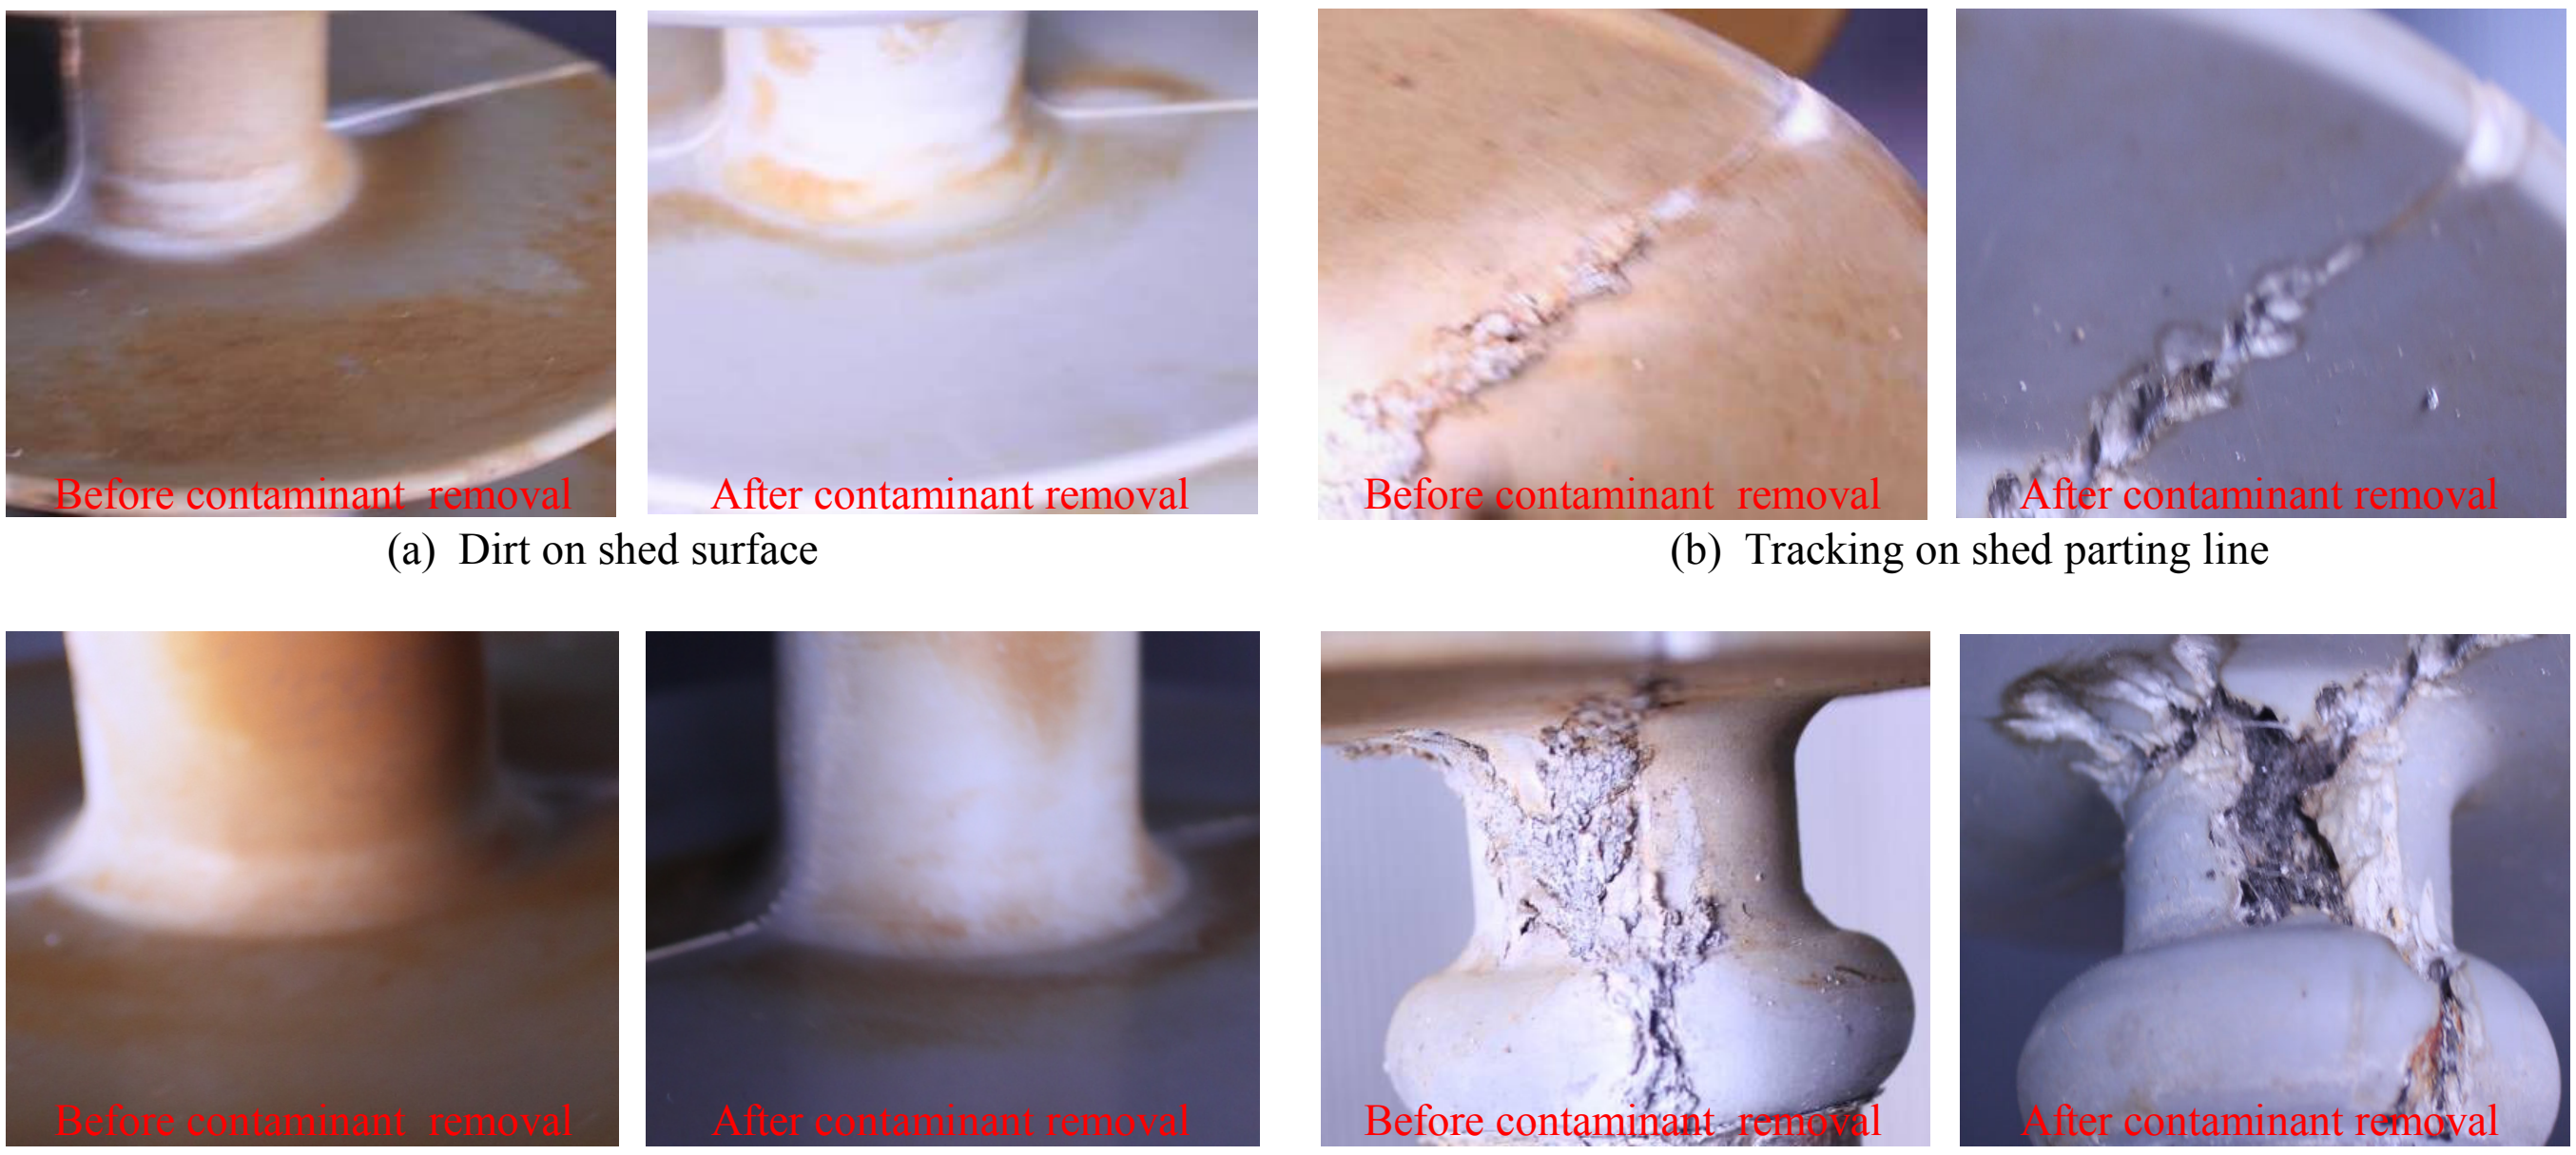
Fig. 6 Surface damaged of Type-B specimens

As shown in Fig. 6 (a), dirt was observed on both shed and trunk surface of type-B specimen same as type-A specimen

As shown in Fig. 6 (b) and Fig. (c), slightly surface tracking was observed on both shed and trunk surface near the energized end.As shown in Fig. 6 (d), punched of trunk near ground end was observed. The puncture was observed on the parting line of trunk.

(a) Dirt on shed surface (b) Tracking on shed parting line

(c) Tracking on parting line of trunk. (d) Tracking on parting line of trunk.

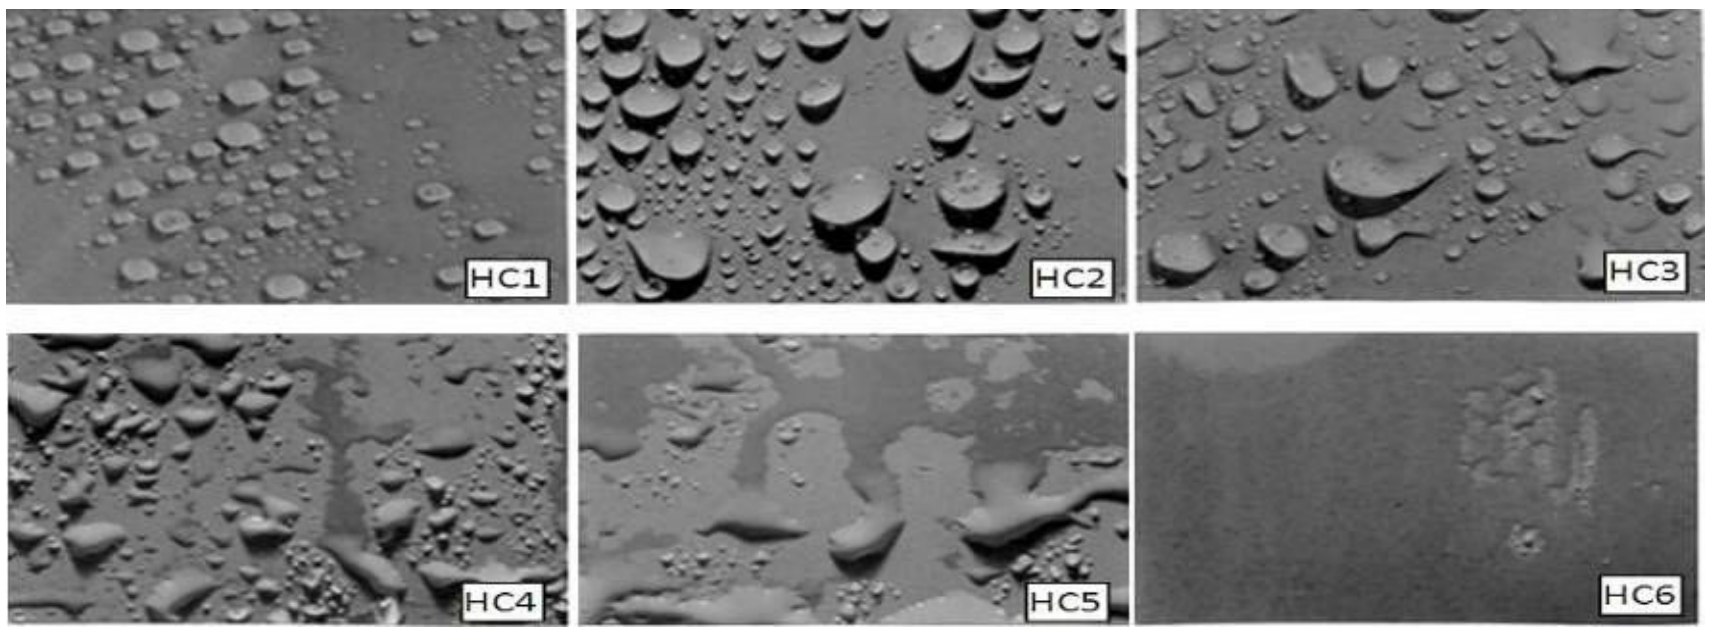
Fig. 7 Classification of hydrophobicity (HC1-HC6)[15]

By products from discharge activities such as heat and UV can cause reduction of hydrophobicity of polymer insulator surface. STRI classification guide as shown in Fig. 7, is used to specified the level of hydrophobicity for the specimens [16,17]. HC level for tested specimen was evaluated. The evaluation results are shown in Fig. 8 and are shown in Table III.

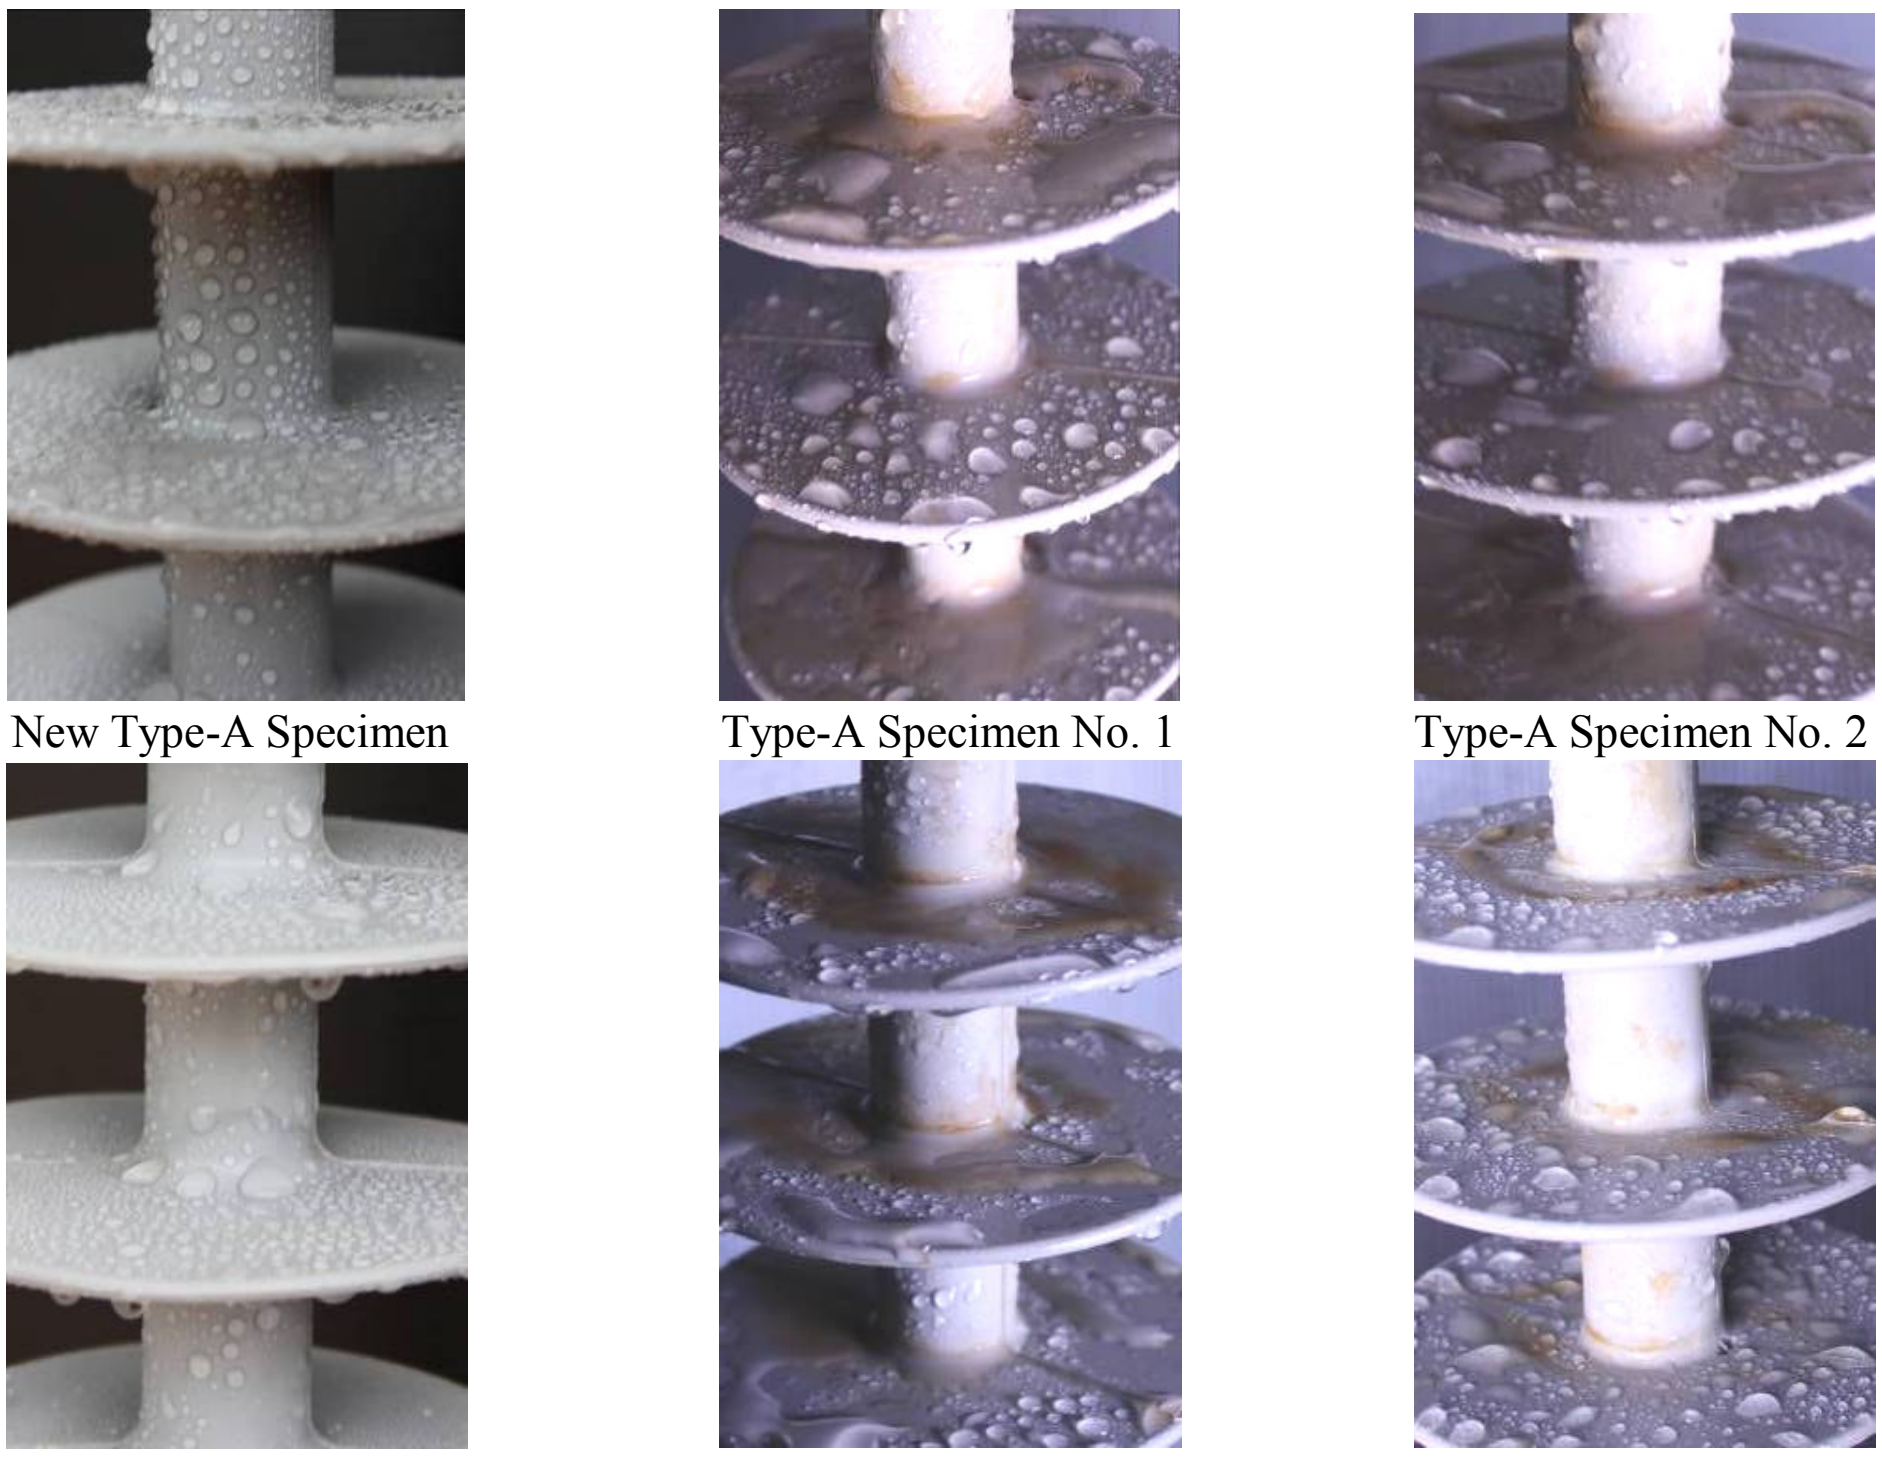
Fig. 8 Comparison of reduction of hydrophobicity

After 30,000 test cycles, reduction of hydrophobicity level on all specimens was obtained when comparing with the new specimen. As illustrated in Table III, largest reduction of hydrophobicity (HC5) was measured on trunk surface of all specimens. For shed surface, reduction of hydrophobicity level at HC3 was measured.

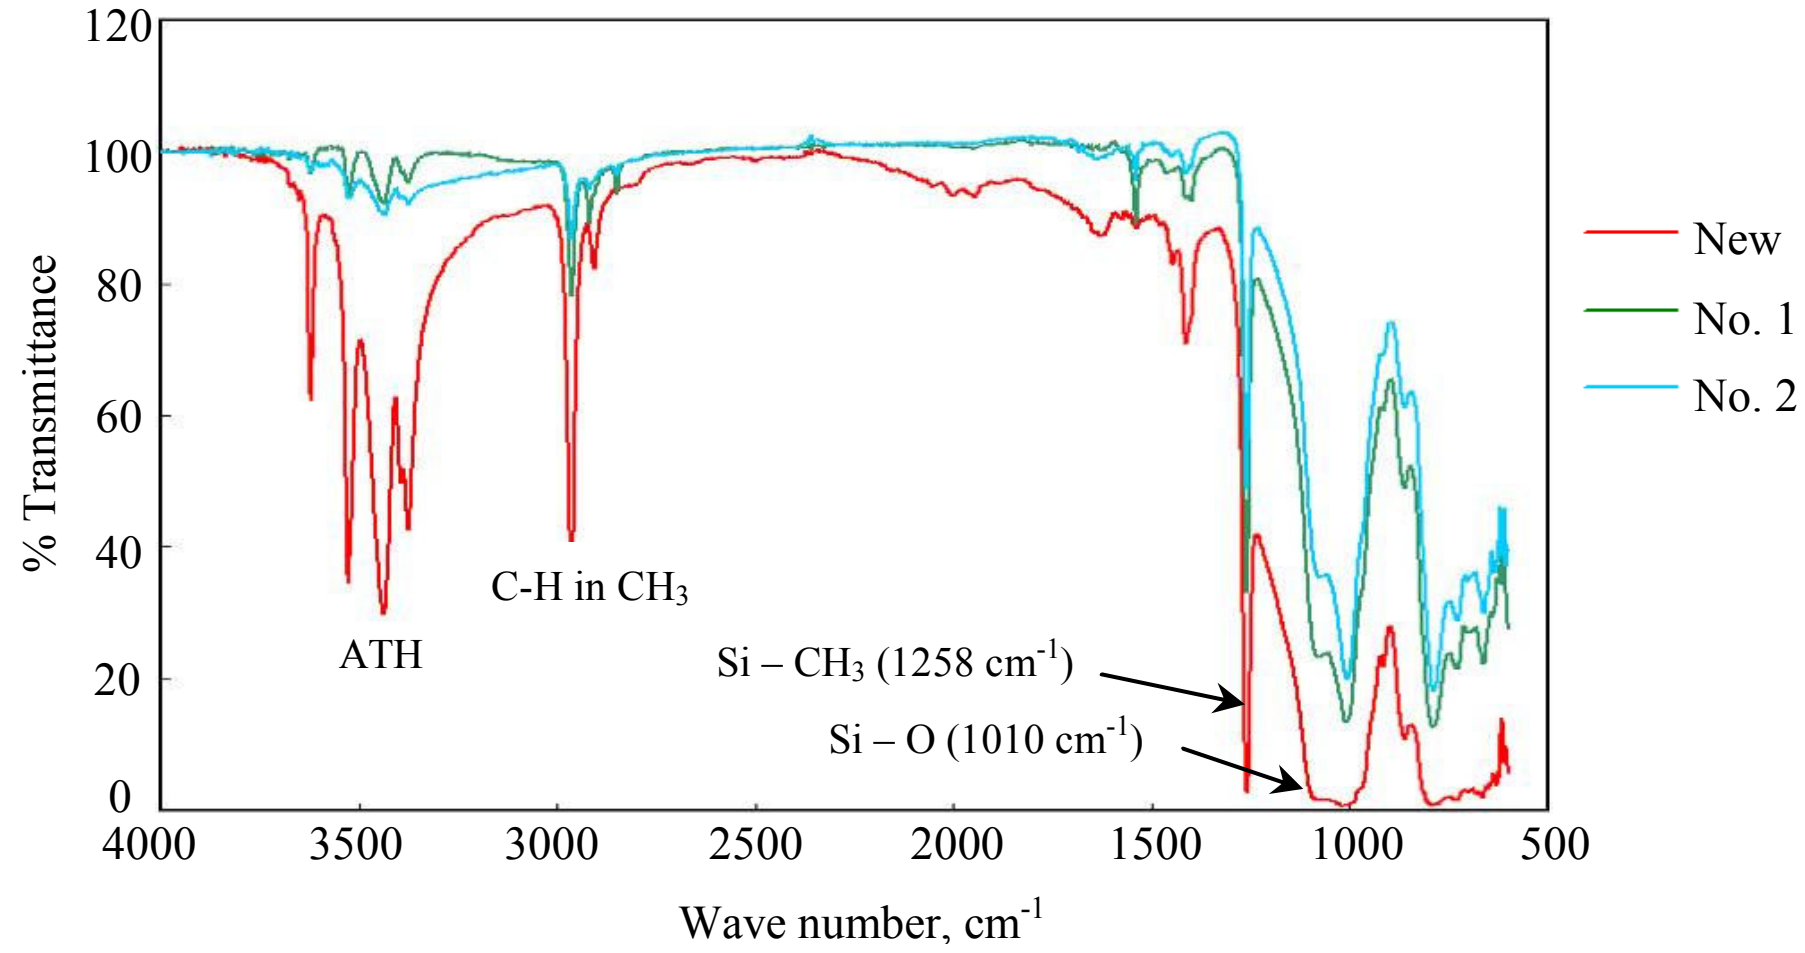
Fig. 9 ATR- FTIR spectrum of Type-A specimen at position 10

ATR-FTIR (attenuated total reflection Fourier transform infrared spectroscopy) is chemical analysis technique for the chemical bonds changing inspection. Side chains bond (Si-CH_3) at wave number 1258 cm^{-1} and back bond (Si-O) at wave number 1010 cm^{-1} of silicone rubber surface were analyzed. Reduction of Si-CH_3 indicates side chain scission. Reduction of Si-O spectrum indicates back bond scission. An example of ATR-FTIR spectrum of trunk surface at position 10 of tested surface comparing with the new specimen surface is illustrated in Fig. 9.After 30,000 test cycles, decreasing of side chain and back bond spectrums were obtained for both types of tested specimens when comparing with the new specimen. Mostly changing of side chain and back bone bonds were measured on trunk surface when comparing with shed surface. ATR-FTIR analysis results for all position of all-type specimens are illustrated in Table IV and Table V.
