The High Temperature Damage of DV – 2 Turbine Blade Made from Ni – Base Superalloy

Abstract—High pressure turbine (HPT) blades of DV – 2 jet engines are made from Ni – based superalloy. This alloy was originally manufactured in the Soviet Union and referred as ŽS6K. For improving alloy's high temperature resistance are blades coated with Al – Si diffusion layer. A regular operation temperature of HPT blades vary from 705°C to 750°C depending on jet engine regime. An overcrossing working temperature range causes degradation of the protective coating as well as base material which microstructure is formed by the gamma matrix and strengthening phase gamma prime (forming small particles in the microstructure). Diffusion processes inside the material during exposition of the material to high temperatures causes mainly coarsening of the gamma prime particles, thus decreasing its strengthening effect. Degradation of the Al – Si coating caused its thickness growth. All the microstructure changes and coating layer thickness growth results in decreasing of the turbine blade operation lifetime.

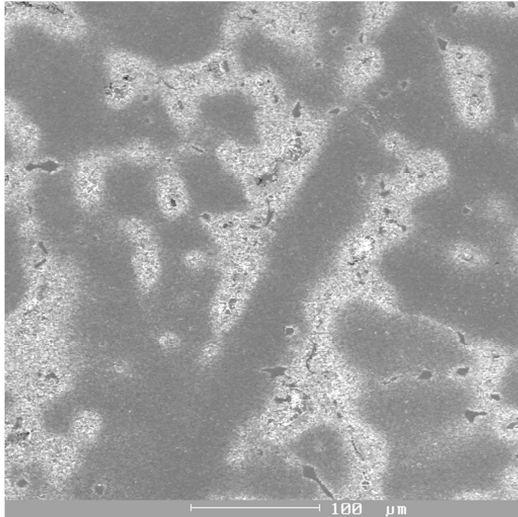
A typical microstructure of ŽS6K Ni – base superalloy as – cast is showed on Figs. 1 and 2. Microstructure of as – cast superalloy contain significant dendritic segregation caused by chemical heterogeneity (Fig. 1 (a)) and particles of primary MC and secondary M₂₃C₆ carbides (Fig. 1 (b)). Primary carbides (Ti, Mo, and W)C are presented as an block shaped particles mainly inside of grains. Secondary carbides are presented as a “Chinese” script shape particles on grain boundaries.

Fig. 1 Microstructure of As – cast Ni – base superalloy ŽS6K: (a) dendritic segregation, (b) primary MC and secondary M_{23}C_6 carbides, etch. Marble, SEM

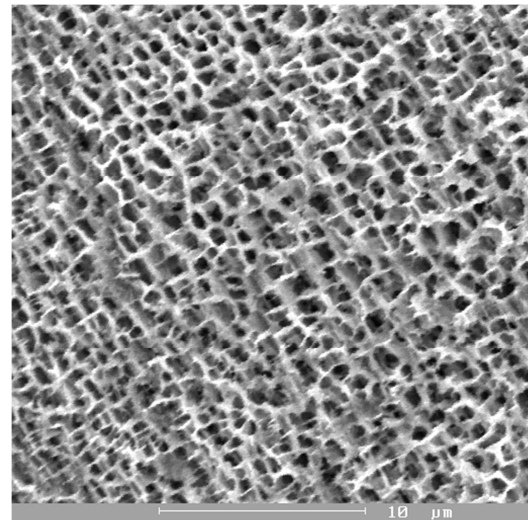
strengthening precipitates, which are a product of artificial age – hardening and has significant influence on mechanical properties and creep rupture life – so called γ' phase (gamma prime, $\text{Ni}_3(\text{Al, and Ti})$ – ordered coherent precipitate phase with $L1_2$ structure), Fig. 2 (a).

Fig. 2 Ni – base superalloy ŽS6K: (a) morphology of γ' precipitate, as - cast, (b) eutectic cell of γ/γ' , etch. Marble, SEM

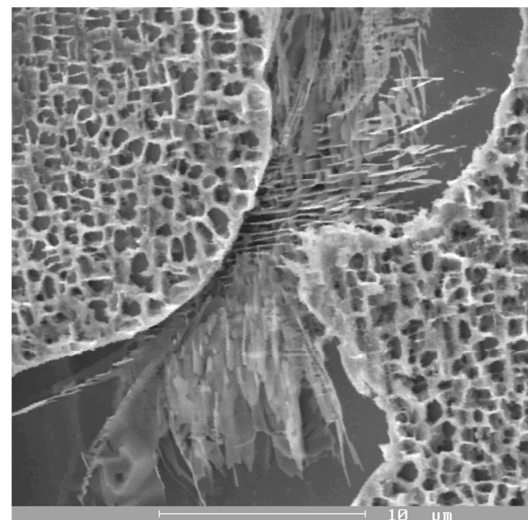
(b)

The γ' precipitates in precipitate strengthened nickel - base superalloys remain coherent up to large precipitate sizes due to the small lattice mismatch between the matrix phase γ and the γ' precipitates. The γ' precipitates are usually present in volume fractions in the range of 20÷60% depending on the alloy, with a typical precipitate size of 0.25 to 0.5 μm for high temperature applications [7]. Both of these phases, γ (gamma) and γ' (gamma prime) are also creating γ/γ' eutectic, Fig. 2 (b).

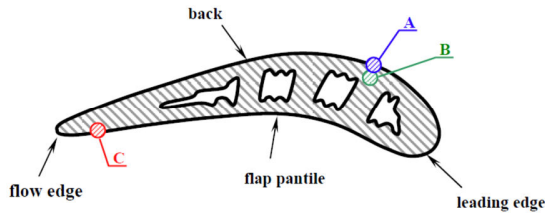
Fig. 3 The cross section of blade and description zones of interests
 A – checking of the uniformity and homogeneity of alitize layer from 1/4 of blade back
 B – evaluation of morphology and amount of γ' - phase and grain boundary right under alitize layer
 C – checking of alitize layer degradation or presence of Cr rich carbides needles.

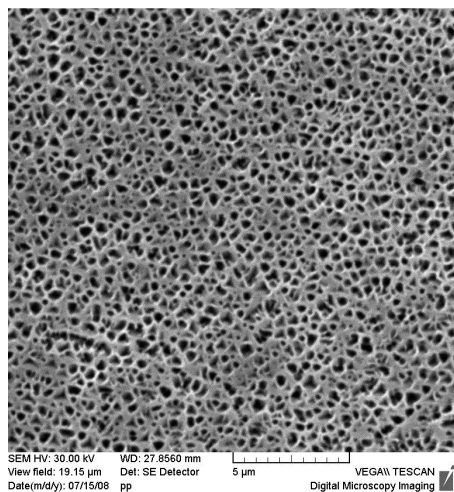
secondary $M_{23}C_6$ carbides formed and lowering creep resistance of base material. The strengthening intermetallic γ' precipitate also degrades by changing its morphology from previous cubic shape like onto coarse spheroidal particles with average size $0.6 \mu\text{m}$, Fig. 6.

Fig. 6 Degradation of γ' precipitate at high temperature ($751^\circ\text{C}/2\text{s}$) loading compared to starting stage microstructure: (a) γ' - phase morphology, initial stage, (b) after $751^\circ\text{C}/2\text{s}$ for 600 hours of loading, etch. Marble, SEM

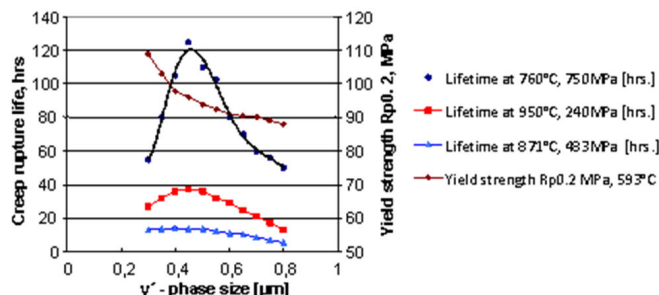
This shape and size changes cause decreasing creep rupture life of alloy, Fig. 7 [8]. As a matter of a fact, creep at high temperatures is driven mainly by diffusion mechanism and deformation rate increases with higher amount of dislocations and their easier slip, which have been previously blocked by tight distribution of cubic morphology of γ' precipitates. Coarsening and spheroiding of γ' precipitates leads to creation of wider channels between γ' particles and dislocations can easier move, so deformation of base material can propagate.

Fig. 7 Influence of γ' - phase size on mechanical properties [8]
