Failure Analysis of Pipe System at a Hydroelectric Power Plant

Ali Göksenli, Barlas Eryürek

Keywords— Failure analysis, hydroelectric plant, water-hammer, crack, welding seam.

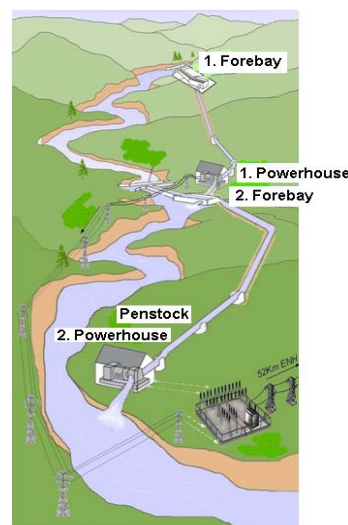
Fig. 1 Layout of the hydraulic power plant

turbine [2], [3]. The turbine turns the generator which is connected to electrical loads whereby electrical power is produced. In the investigated plant, two power systems are placed in succession. Waterfall height is 295.3 m, tunnel length 6419 m, penstock length 390 m, pipe diameter 2 m and flow rate is 11 m³/s (Fig. 1). Failure had occurred at the second powerhouse pipe system.

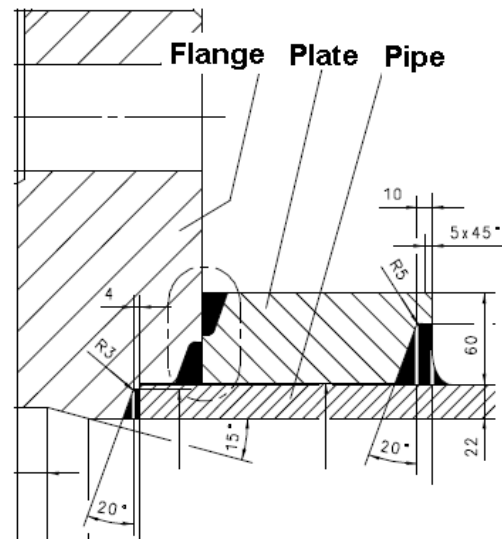
Fig. 5 Technical drawing of the pipe-plate-flange system

The design of the flange-pipe region can be seen in Fig. 5. To strengthen the pipe, a plate is welded at four regions to the pipe and flange. Flange material is steel St 52-3.

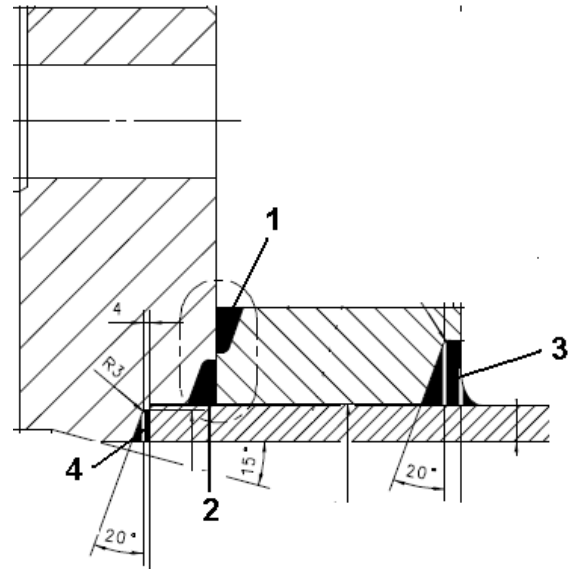
Fig. 7 Assembly drawing of the plate-flange-pipe system

Weld seams 1 and 2 are applied between plate and flange, weld 3 between plate and pipe and weld 4 between pipe and flange as can be seen in Fig. 7. For further detailed weld analysis it is investigated if these mentioned four weld seams are applied correct as can be seen in Fig. 7. During observation an additional weld seam, which was not mentioned in assembly drawing in Fig. 7 was detected, as can be seen in Fig. 8.

After weld seam analysis it is concluded that assembly of the plate-flange-pipe system was not applied correctly. Weld seams 1 and 2 were not applied; only weld grooves of weld 1 and 2 were constituted. The unfilled grooves 1 and 2 acted as inside cracks resulting in a strong notch effect. Stresses raised at this region caused crack propagation to the weld seam 5. By further investigation it is detected that weld groove for weld 3 was prepared incorrect. Groove angle was 70° instead of 20°. This had resulted in an increase of weld thickness from 25 mm to 110 mm, as can be seen in Fig. 10. This has resulted in a decrease of safety of the pipe-plate system, due to the low strength and high brittleness of weld seam according to base material.
