# Condition Monitoring for Controlling the Stability of the Rotating Machinery

**Abstract**—In this paper, the experimental study for the instability of a separator rotor is presented, under dynamic loading response in the harmonic analysis condition. The global measurement and analysis of vibration on the cement separator RC500 is carried, the points of measurement used are radial dots, vertical, horizontal and oblique. The measures of trends and spectral analysis for reconnaissance of the main anomalies, the main defects in the separator and manifestation, the results prove that the defects effect has a negative effect on the stability of the rotor. Experimentally the study of the rotor in transient system allowed to determine the vibratory responses due to the unbalances and various excitations.

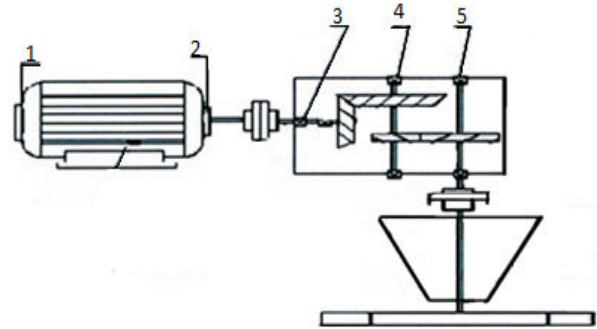
Fig. 3 Measuring points

We noticed that the vibration level by speed measurement in the bearings 02 and No. 03, in the alarm condition, requiring the intervention and the bearings 01 and No. 04 and 05 in alarm status but are acceptable and after the separator Z2 repair we noticed a reduction in the levels velocity and stabilization (correct state) in all bearings the trend curve and the spectrum defined defects in each measuring point.
