# Structural Analysis and Strengthening of the National Youth Foundation Building in Igoumenitsa, Greece

Chrysanthos Maraveas, Argiris Plesias, Garyfalia G. Triantafyllou, Konstantinos Petronikolos

**Abstract**—The current paper presents a structural assessment and proposals for retrofit of the National Youth Foundation Building, an existing reinforced concrete (RC) building in the city of Igoumenitsa, Greece. The building is scheduled to be renovated in order to create a Municipal Cultural Center. The bearing capacity and structural integrity have been investigated in relation to the provisions and requirements of the Greek Retrofitting Code (KAN.EPE.) and European Standards (Eurocodes). The capacity of the existing concrete structure that makes up the two central buildings in the complex (buildings II and IV) has been evaluated both in its present form and after including several proposed architectural interventions. The structural system consists of spatial frames of columns and beams that have been simulated using beam elements. Some RC elements of the buildings have been strengthened in the past by means of concrete jacketing and have had cracks sealed with epoxy injections.

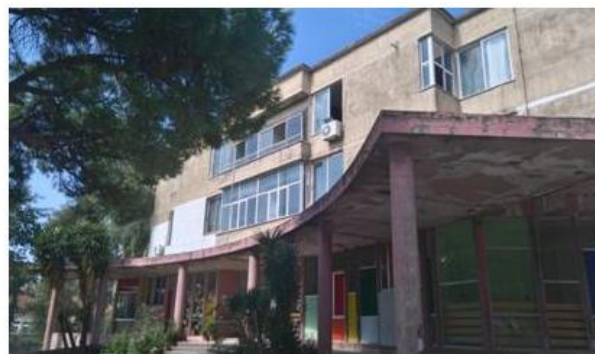
Fig. 1 The National Youth Foundation Building in Igoumenitsa, Greece

All buildings in the newly built complex suffered damage. Specifically: Building I presented:

- Differential subsidence between columns, resulting in rotation and deformation of the building in relation to the central Building II.
- Fractures in the cantilever slabs on the ground floor and the A' floor at support positions.
- Cracking of the lower 10 cm-thick slab of the pilotis ceiling. It is noted that these slabs are of secondary use and act as insulating structural components.
- Fracture of the shared foundation between Buildings I and II and of the corresponding column.

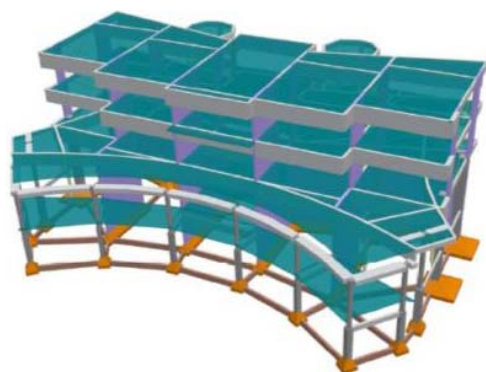
Fig. 4 Illustration of the structural layout of Building II

symmetrical along its North–South axis, as illustrated in Fig. 4. The common methodology of the era was followed, in which concrete slabs were used as surface elements to undertake the vertical actions on each service level of the structure. They carry the vertical loads through a system of beams and then through columns or concrete walls to the ground. The slabs had rectangular cross-sections. Structural meshes of standard dimensions were used a steel reinforcement. This type of reinforcement is unusual in Greek construction and experiences problems in corrosive environments. Corrosion activity in terms of the residual cross-sections of steel meshes is greater than when other strategies are used, due to the small diameter of the rebar employed (4–6 mm). The slabs were 15 cm-thick, which is considered sufficient for their intended purpose (usual length of 4 m). However, Building II contained slabs that often exceeded 6 m in length. Modern regulations indicate that this thickness is marginal for ensuring the required slenderness. The beams involved had small cross-sections and were reinforced with marginal quantities of steel. This often resulted in under-reinforced elements.

Vertical elements (columns and concrete walls) were placed primarily to satisfy architectural requirements with regard to the arrangement of curved sections on the ground floor for the layout of the stairs. These curved walls were not founded on the ground, but rather were settled on curved beams. In addition, there were small columns on the external perimeter of the building (North–South) that act as point supports and mainly affect the static combinations of actions.

walls/level). Due to architectural constraints, these walls did not descend to the ground floor and were not founded. As a result, their contribution to the seismic response of the building was improved in terms of increasing the stiffness on the upper floors (reduced efficiency). In addition, not all columns or walls were strengthened as designed, particularly in the basement.

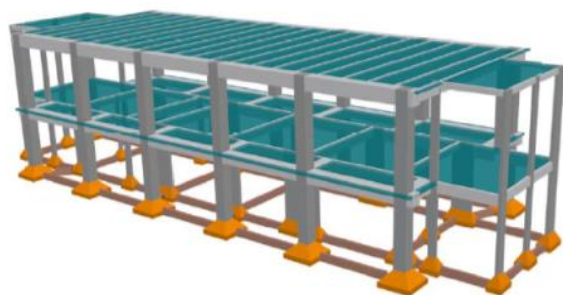
Fig. 5 Illustration of the structural layout of Building IV

Building IV was first designed as a symmetrical RC structure with two symmetrically protruding parts at its eastern and western boundaries, as illustrated in Fig. 5. It is a two-story building with a balcony that acts as a "loft" and that is to be demolished. The layout varies from level to level. Concrete slabs were used as surface elements for transferring vertical actions on each service level of the structure. They carry vertical loads through a system of beams, followed by columns or concrete walls that go to the ground. The slabs have rectangular cross-sections. The slab of the event venue (with a length of approximately 13 m) was a folded concrete slab shell. It was assumed that the vertical elements of the folded concrete slab shell were the beams of the system and the horizontal parts were the small slabs. The behavior of the simulation after the earthquake proved the ineffectiveness of the latter. Structural meshes of the standard dimensions used in Building II had been used as steel reinforcement, producing the problem of cross-section loss in corrosive environments that is mentioned above. The slabs were 15 cm-thick, which is considered sufficient for usual length of 4 m, but for Building IV where slabs often exceeded 6 m in length, this thickness is marginal for ensuring the required slenderness. Beams were reinforced with marginal quantities of steel, which often resulted in under-reinforced elements.

The vertical element structural system consisted of two strong support lines at the floor level that carried the folded concrete slab shell. These support lines consisted of circular columns that behaved unacceptably during the earthquake, failing at their bottoms. These columns were strengthened with concrete jacketing to form an overall cross-section of 75 cm x 75 cm per column. On the ground floor, two additional support lines were constructed with a mixed system of vertical elements (columns and walls) and added to the existing strong columns. Thus, the structural system used to simulate the force imparted by the earthquake was composed of:

The retrofitting techniques of the initial study focused on the installation of strong North–South beams on the ground floor that strengthened the diaphragmatic function of this level even though the connection points with the existing beams did not ensure good function for the nodes. Tensile tendons were installed on the tops of the perimeter columns of the folded concrete slab shell of the ground floor ceiling. Columns were strengthened via concrete jacketing.
