Diagnosis of Intermittent High Vibration Peaks in Industrial Gas Turbine Using Advanced Vibrations Analysis

Abubakar Rashid, Muhammad Saad, Faheem Ahmed

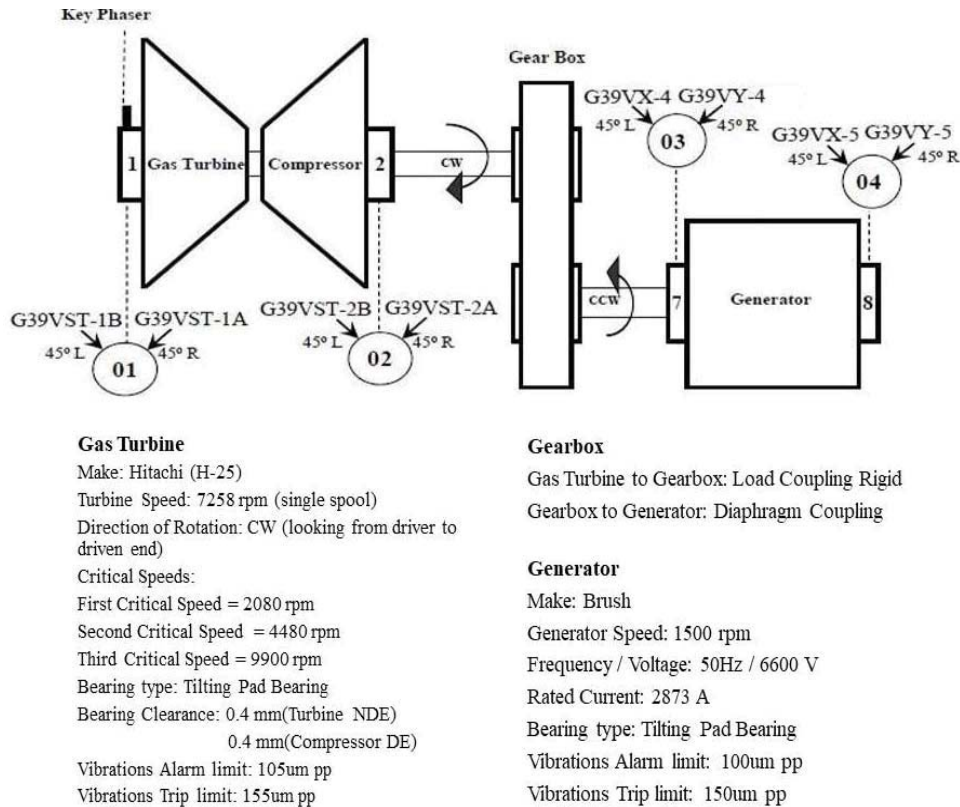
Fig. 3 Details used for route creation in ADRE DSP 408

Vibration peaks was observed during steady state data recorded on 1st November 2018. Vibration peak was recorded at 1435hrs up to 40.09 & 35.54µm pp at Turbine Bearing#01 against normal vibrations of 22 & 24µm pp & at Turbine Bearing#02 up to 64.09 & 58.98µm pp against its normal trend of 43 & 45µm pp. As per vibration trend data, vibration peaks were observed to appear at different times & the peak lasted for duration of approximately 15 minutes (as shown in Fig. 3).

Based on the data gathered from ADRE SXP, there was a vibration increase with high 1X rpm response & 1X phase change [6], [7] is most probably suspected due to intermittent rubbing either in Turbine NDE bearing or bearing seals. Rubbing in the bearing oil (labyrinth) seal may be caused by

build-up of deposits resulting in localized reduction in seal clearance. Carbon deposits may be formed if lubricating oil comes in contact with high temperature causing oil to overheat. This may cause intermittent contact of rotor with deposits resulting in high vibration which tends to become normal upon clearance of deposits; however, vibration cycle may be repeated upon formation of new deposits.
