# Railway Crane Accident: A Comparative Metallographic Test on Pins Fractured during Operation

Thiago Viana

Open Science Index, Mechanical and Mechatronics Engineering Vol:14, No:8, 2020 publications.waset.org/10011350.pdf

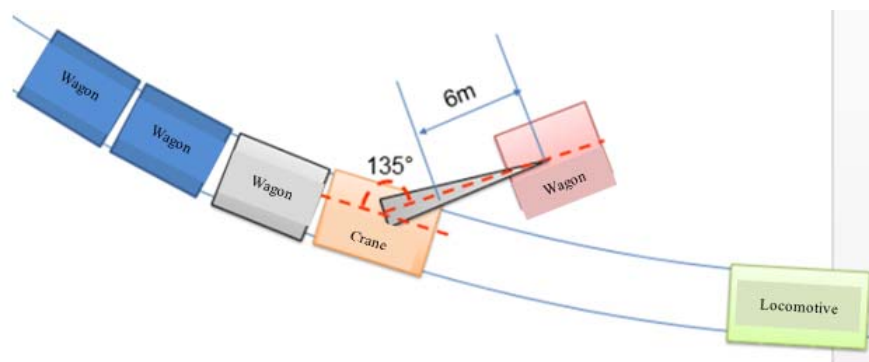
Fig. 2 Schematic diagram of formation of the rescue train during the fracture of the pins and fall of the crane hoist

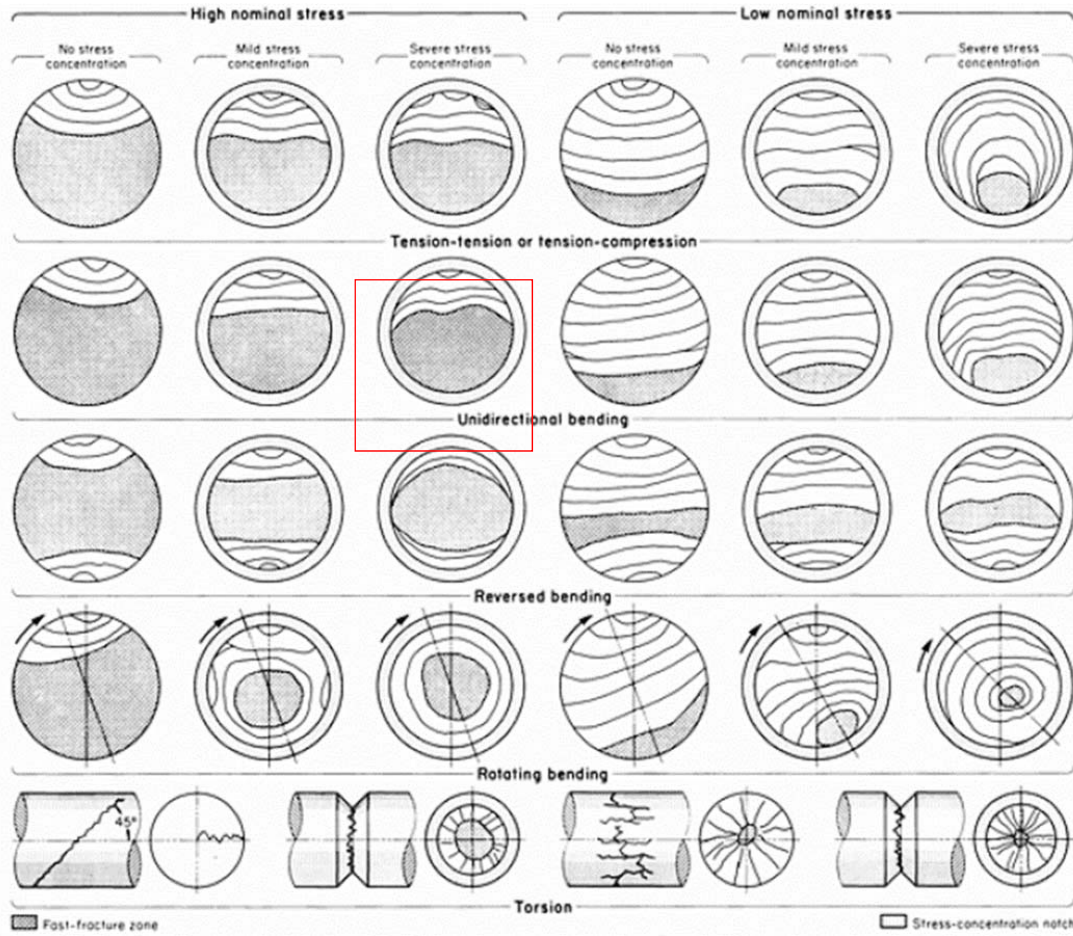
Fig. 4 Schematic diagram to aid in the definition of fatigue fracture type in components with circular cross-section [7]

The schematic drawing highlighted by the red square in Fig. 4 presented in the literature review is similar to the fracture of pin 1. This figure shows that there is a severe stress

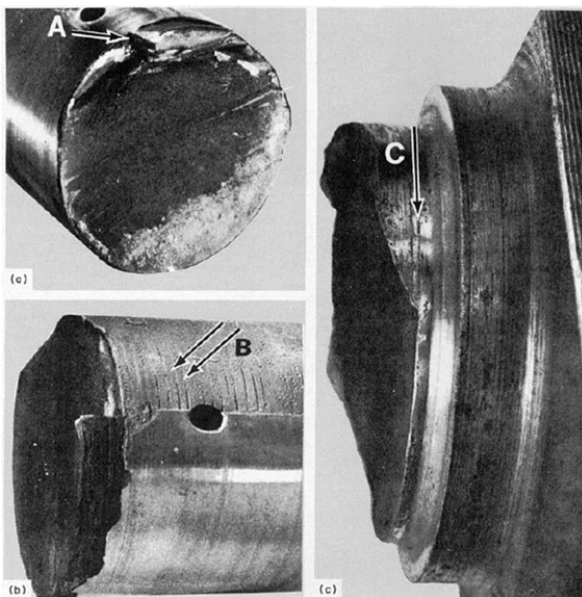
Fig. 5 Presence of scratches/notches/stress concentrators in shaft/pin, being the root cause of the initiation of crack by fatigue [6]
