# Railway Crane Accident: A Comparative Metallographic Test on Pins Fractured during Operation

Thiago Viana

Open Science Index, Mechanical and Mechatronics Engineering Vol:14, No:8, 2020 publications.waset.org/10011350/pdf

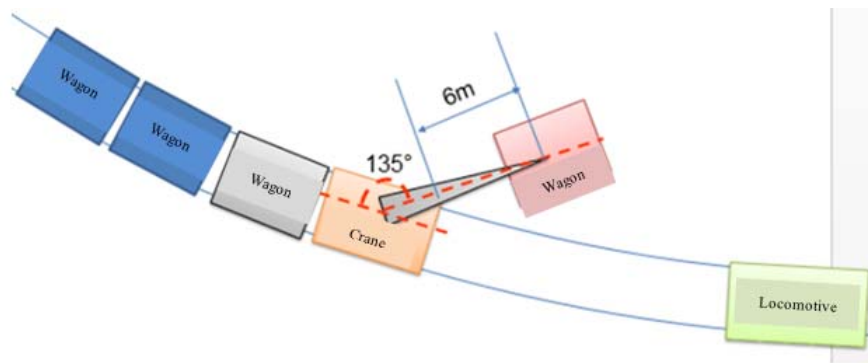
Fig. 2 Schematic diagram of formation of the rescue train during the fracture of the pins and fall of the crane hoist

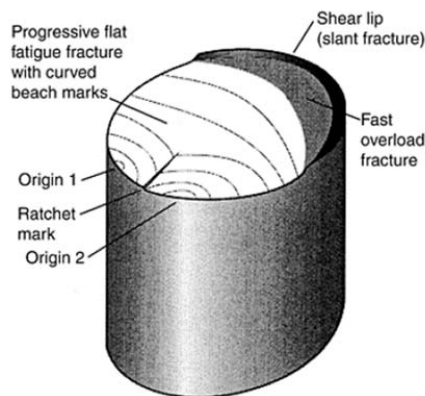
Fatigue failures have one or more crack initiation points, followed by a crack propagation region and a fracture end region (ductile and/or fragile) [6], see Fig. 3.

Fig. 3 Fatigue fracture stages: initiation, crack propagation and final collapse [6]
