Modelling for Roof Failure Analysis in an Underground Cave

M. Belén Prendes-Gero, Celestino González-Nicieza, M. Inmaculada Alvarez-Fernández

Keywords—Forensic analysis, hypothesis modelling, roof failure, seismic monitoring.

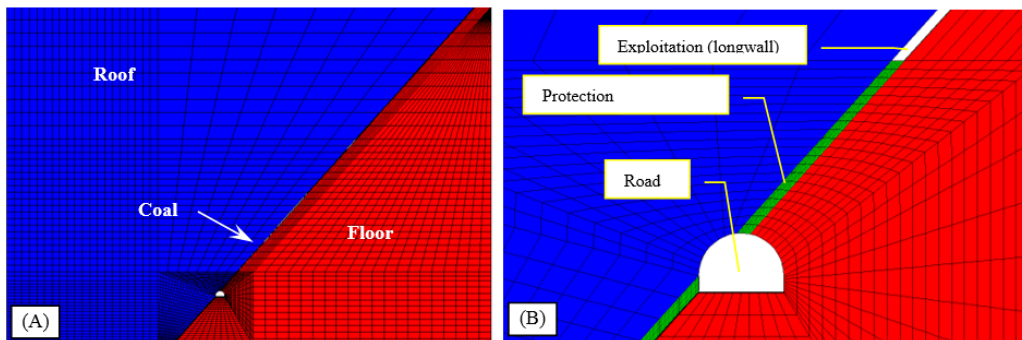
Fig. 4 Model description

The model shown in Fig. 4 has 350 m width and 270 m height. The rest of the ground, until reaching the 700 m depth, was replaced by an equivalent overload. In the figure, it is possible to see the different simulated materials: the layer of coal (in green), the roof of the layer (sandstones, in blue), the wall of the layer (shales, in red), and the simulated works of the exploitation: the tailgate and the workshop of the

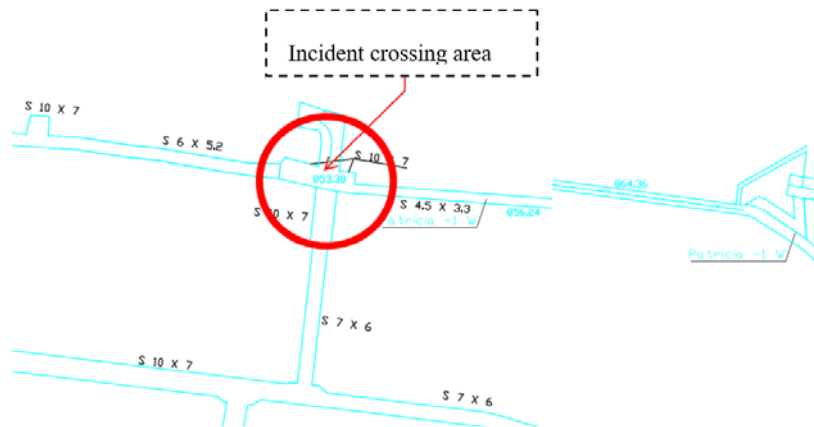
Fig. 5 Dimensions of the galleries in the collapsed area

- 1) Case 1: The tailgate has the most common dimensions in this type of infrastructure, that is to say, 6 m of width and 5.2 m of height.
- 2) Case 2: The tailgate has a bigger cross section, 10 m of width and 7 m of height. These dimensions are the dimensions of the collapsed place (Fig. 5).
