Fatigue Failure Analysis in AISI 304 Stainless Wind Turbine Shafts

M. F. V. Montezuma, E. P. Deus, M. C. Carvalho

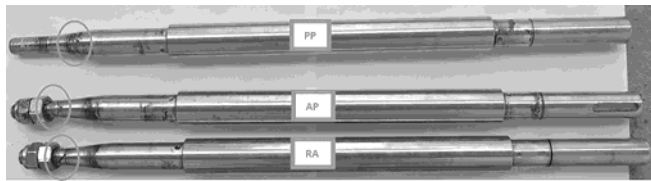
Figs. 2 and 3 show the parts as received, the motivating shafts of the analysis, and the failure region, differentiated according to the manufacturer.

Fig. 2 Wind turbine shafts - Model A1700

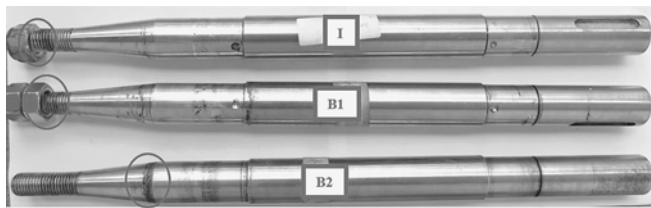
Fig. 3 Wind turbine shafts – Model A3300
