Behavior of RC Buildings to Tsunami Action

Carlos H. Cuadra

Abstract—The present report describes the characteristics of damages and behavior of reinforced concrete buildings during the tsunami action. The discussion is based on the field damage survey in selected cities located on the coast of the zone affected by the Great East Japan Earthquake on March 11, 2011. This earthquake is the most powerful know earthquake that has hit Japan with a magnitude 9.0 and with epicenter located at 129 km of Sendai city (off the coast). The earthquake triggered a destructive tsunami with run up height of up to 40 meters that mainly affect cities located on the Pacific Ocean coast of the Tohoku region (north-east region of Japan). Reinforced concrete buildings in general resist the tsunami without collapse however the non-structural elements like panels and ceilings were severely damaged. The analysis of damages has permitted to understand the behavior of RC buildings under tsunami attack, and has also permitted to establish recommendations for their use to take refuge from tsunami in places where natural topography makes impossible to reach hilltops or other safer places.

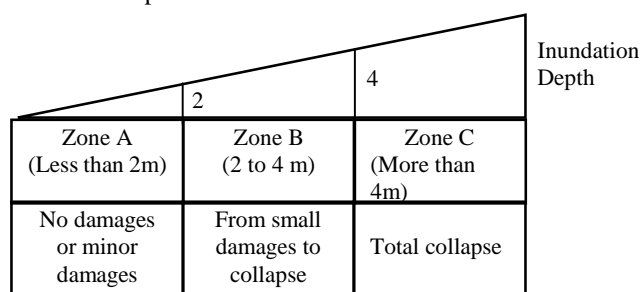
Fig. 6 Inundation depth and damages on wooden houses

recognized that in general the wooden houses collapse or present damages due to the tsunami action when the inundation depth is larger than 2 meters. As is presented in Fig. 6, the damages on wooden houses are divided into three zones according to the inundation depth. Zone A correspond to a places where the inundation depth is smaller than 2 meters and structural damages are not observed, that is the wooden houses are safe in this case. Zone B correspond to a zone where the inundation zone ranges from 2 to 4 meters, and depending on the structural shape, condition of the structural elements, etc, the houses can suffer from light damages to severe damages. From the field observation it can be said that when the water level cover the first floor of the wooden house the structures collapse not only due to the lateral force of the water but also due to the water pressure on the ceiling of the first floor causing floating of the upper floors. Zone C correspond to a zone where the inundation depth is large that 4 meters and total collapse of the structure is expected to occur.
