Causes of Rotor Distortions and Applicable Common Straightening Methods for Turbine Rotors and Shafts

Esmaeil Poursaeidi, Mostafa Kamalzadeh Yazdi

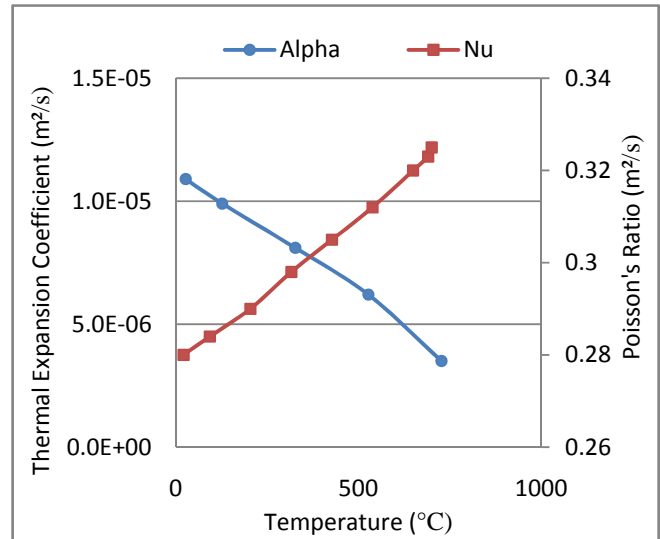
various models. Thermal expansion coefficient and poisson's ratio were modeled as shown in Fig. 5 Also other parameters such as thermal conductivity, specific heat, mass density and elastic modules were defined considering rotor material properties at different temperatures. Initial temperature assumed as a uniform temperature of 21°C .

Fig. 5 Nonlinear material properties of the rotor

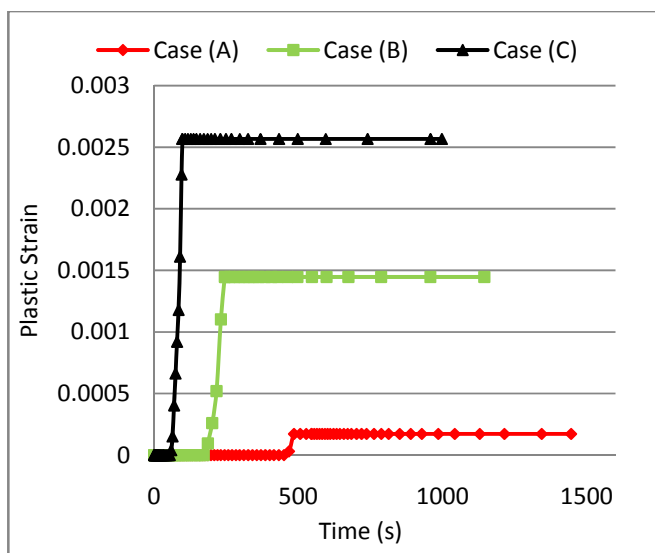
Fig. 7 Magnitude of plastic strain during hot spotting
