# Artificial Accelerated Ageing Test of Silicone Rubber Housing Material for Lightning Arrester

W. Payakcho, J. Grasaesom, S. Thong-om and B. Marungsri\*

**Abstract**— This paper presents the experimental results of silicone rubber housing material for 24kV lightning arrester under artificial accelerated ageing test based on IEC 61109 specifications. Specimens having inclined and alternated shed made of HTV silicone rubber with ATH content and having leakage distance 625 mm were tested continuously 1000 hrs in artificial salt fog chamber. After 1000 hrs of salt fog ageing test, obviously surface erosion was observed on trunk between the upper large shed and the lower small shed near the energized end. Decreasing in hydrophobicity and increasing in hardness were measured on tested specimen comparing with new specimen. Chemical analysis by ATR-FTIR confirmed the observation results.

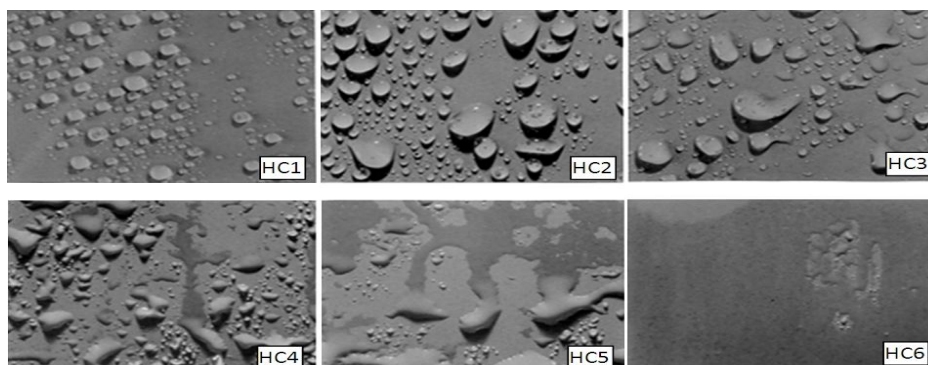
Fig. 7 Characteristics of the sample surface HC1-HC6 [11].

Loss of hydrophobicity on specimen surface after 1000 hrs ageing test was evaluated by STRI guide [11], as show in Fig. 7. Decreasing in hydrophobicity on surface of tested specimen near energized end was obtained from the measuring results. The measurement results are shown in Table IV.
