Image Distortion Correction Method of 2-MHz Side Scan Sonar for Underwater Structure Inspection

Abstract—The 2-MHz Side Scan SONAR (SSS) attached to the boat for inspection of underwater structures is affected by shaking. It is difficult to determine the exact scale of damage of structure. In this study, a motion sensor is attached to the inside of the 2-MHz SSS to get roll, pitch, and yaw direction data, and developed the image stabilization tool to correct the sonar image. We checked that reliable data can be obtained with an average error rate of 1.99% between the measured value and the actual distance through experiment. It is possible to get the accurate sonar data to inspect damage in underwater structure.

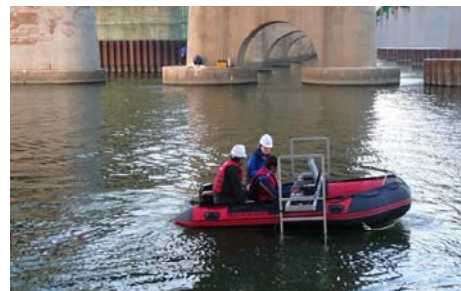
Fig. 2 Underwater structure survey using SSS

that occurs during the operation, and to visualize the filtered image through the image stabilization algorithm. Figs. 1 and 2 show the underwater exploration of the SSS.

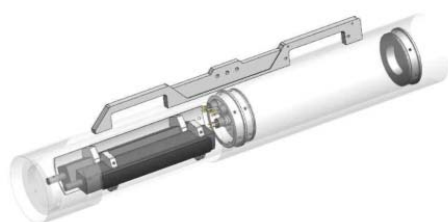
Fig. 3 Design of 2-MHz SSS Body

the field. The developed 2-MHz SSS is shown in Figs. 3 and 4.

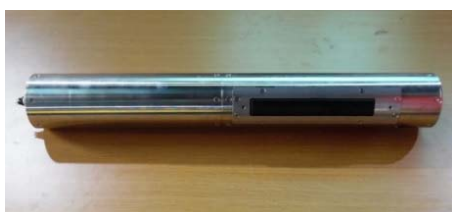
Fig. 4 2-MHz SSS

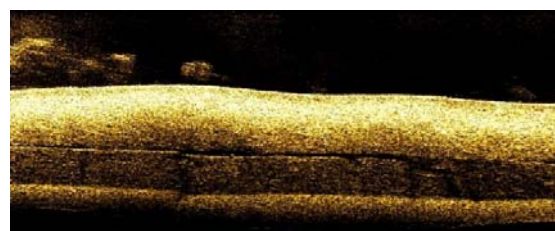
Fig. 8 2-MHz Sonar data after correction

The block joint of the gravity type quaywall structure was scanned using the developed 2-MHz sonar as shown in Fig. 7. As mentioned above, since the boat and the sonar are all acting together, it is seen that the shape of the gravity type block is distorted because of the shaking caused by the rolling phenomenon of the boat by the wave and the operation of inexperienced boat drivers. The roll, pitch and yaw directions obtained from the motion sensor were analyzed, and the data were subjected to image stabilization. As a result, the corrected data were obtained as shown in Fig. 8. It is confirmed that the

joint shape of the block is corrected to a straight line shape.

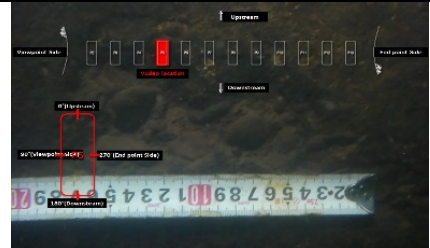
TABLE III
COMPARISON OF SONAR DATA AND DAMAGE THROUGH MOTION SENSOR

Damage occurred P5- 270° (End point side)	Difference length (L=0.21m) Depth of water :3.0m	#3. Difference length (L=0.20m) Depth of water :3.0m	
				The whole average 1.99%

Fig. 6 shows the towfish with the motion sensor and the field survey logarithm. Table III is one of the samples and shows the sonar data corrected by the motion sensor and the damage comparison method.
