Analyses of Wear Mechanisms Occurring During Machining of the Titanium Alloy Ti-6Al-2Sn-4Zr-6Mo

Keywords—Alloy 6246, machining, tool wear, optical microscopy, SEM, EDX analysis

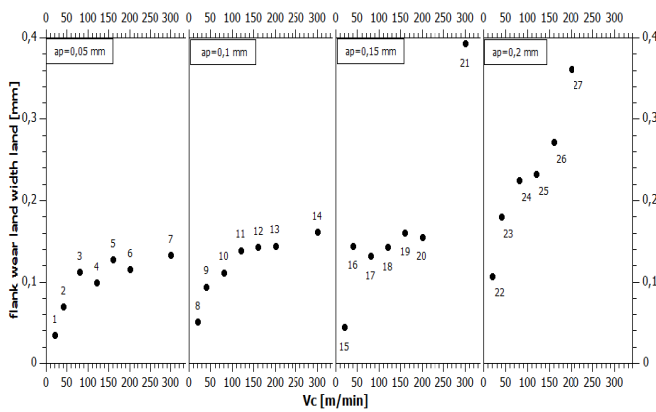
This graph shows that with increasing v_c the flank wear land width increases. For $a_p = 0.05\text{mm}$, 0.1mm and 0.15mm VB is independent of the cutting depth whereas a sharp increase of VB is visible in case $a_p = 0.2\text{mm}$. It has to be stated that chip ignition occurred at 300m/min and 0.15mm causing significant damage of the tool represented by steep rise of the flank wear land width.

Fig. 1 Specific flank wear land width

Typical forms of tool wear were observed on all samples, namely notch wear on the flank face was observed. In addition, abrasion was measured by an increasing flank wear land width (VB). On the rake face, crater wear, micro cracks and built-up edges (adhesion of Ti-6246 on top of the coating) have been found. Regarding tool life, VB is an important factor as large values would lead to the introduction of additional heat into the finished workpiece. This could lead to Oxygen diffusion into the workpiece and, hence, to α -casing. [1] The results of the flank wear land width analyses for each worn tool are summarized in Fig 1.

Flank wear land width increased with increasing cutting depths and cutting speeds. This can be understood by the larger amount of energy introduced by the cutting action leading to higher temperatures in the cutting zone and, hence, to thermal weakening of the tool (as most of the heat produced will be dissipated into the tool due to Titanium's low heat conductivity). In addition, crater wear and build up edge were observed on the tools after all cutting experiments performed. Increasing temperatures in the cutting zone (as a result of the energy dissipation) ease chemical reactions between Ti-6246 and the tool leading to smearing and welding. These effects could be minimized by the use of cooling liquids during the cutting process. The roughness on rake face was increased with increasing cutting depths and with increasing cutting speeds. Due to the relatively low Young's modulus of Ti-6246 in combination with the high strength, large amounts of elastic energy are stored in the surface of the workpiece leading to vibrations and chatter. This results in lower surface quality and increased surface roughness.

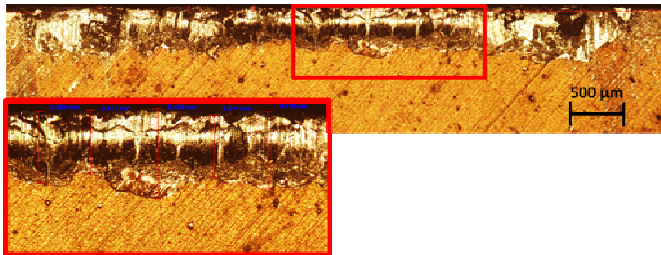
In a second step, we investigated the crater wear and built-up edge formation. The crater wear on the rake face increased with the increasing a_p and the largest crater wear was found after machining at $v_c = 40\text{m/min}$ and 80m/min . Fig.2 shows a detailed image of the rake face of the worn tool ($a_p = 0.15\text{mm}$, $v_c = 40\text{m/min}$) showing severe crater wear.

Fig. 2 Details of the rake face of the worn tool ($a_p = 0.15\text{mm}$, $v_c = 40\text{m/min}$)

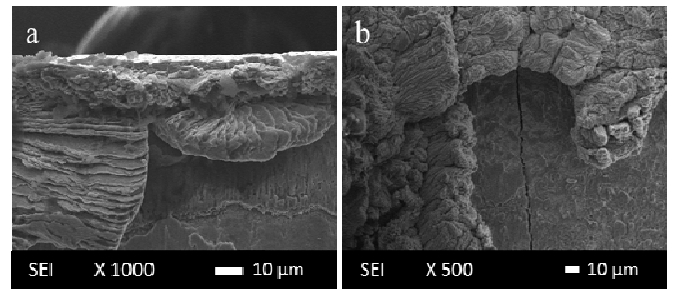
In addition, micro crack formation has been observed on two tools, see Fig. 4b. The related cutting conditions were: $a_p = 0.2\text{mm}$, $v_c = 160\text{m/min}$ and $a_p = 0.2\text{mm}$, $v_c = 200\text{m/min}$.

Fig. 4 SEM images of different wear mechanisms. a built-up edge formation, b micro crack formation

The built-up edges (material adhesion to the cutting insert) were found on all tools after the cutting experiments. Fig. 3 shows a photo of the flank face of a worn tool with a built-up edge created on the rake face. Details of built-up edge are shown on fig.4a. Severe built-up edge formation was observed on tools machined in the following conditions: a_p : 0.05mm and 0.1mm at v_c between 80m/min and 200m/min and at a_p 0.15mm and 0.2mm in the complete cutting speed regime investigated here.

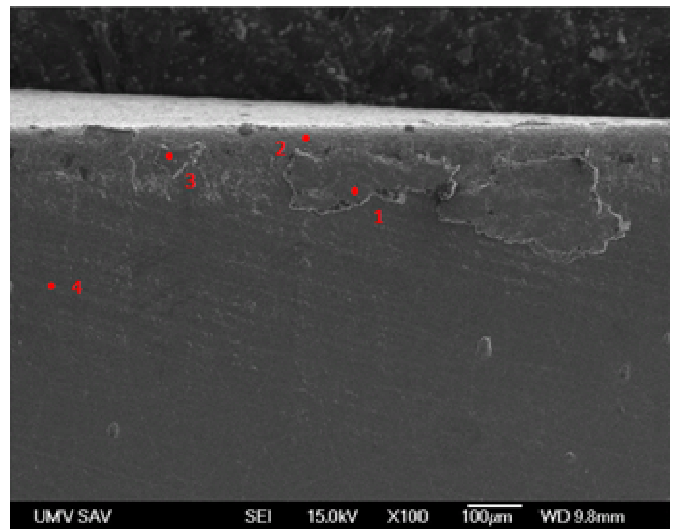
The EDX point analysis of a built-up edge ($a_p = 0.05\text{mm}$, $v_c = 20\text{m/min}$) is shown on Figs. 5 and 6. The related chemical composition is listed in Table 1. As can be seen from Table 1, the EDX data confirmed that the unworn area (point 4) included titanium (approx. 42 at.%), nitrogen (approx. 46 at.%) and aluminum (approx. 11 at.%), the worn area included elements from the workpiece material. Points 1 and 3 represent the zones of built-up edges formation which consisted of Aluminum, Molybdenum and Zirconium and twice more Titanium compared to the unworn areas.

Fig. 5 The EDX point analysis of the worn tool

$v_c = 20\text{m/min}$, $a_p = 0.05\text{mm}$	Point 1 (at.%)	Point 2 (at.%)	Point 3 (at.%)	Point 4 (at.%)
C	-	22.52	-	-
O	-	37.43	-	-
N	-	-	-	42.42
Ti	85.18	29.48	83.93	46.39

Al	11.22	10.57	9.19	11.19
Zr	-	-	3.14	-
Mo	3.60	-	3.74	-

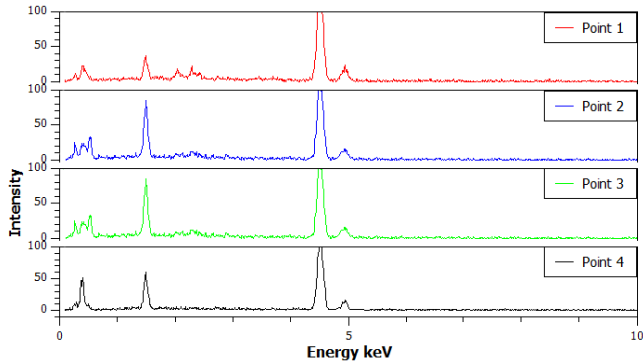
Fig. 6 EDX spectra of the points marked in Figure 6

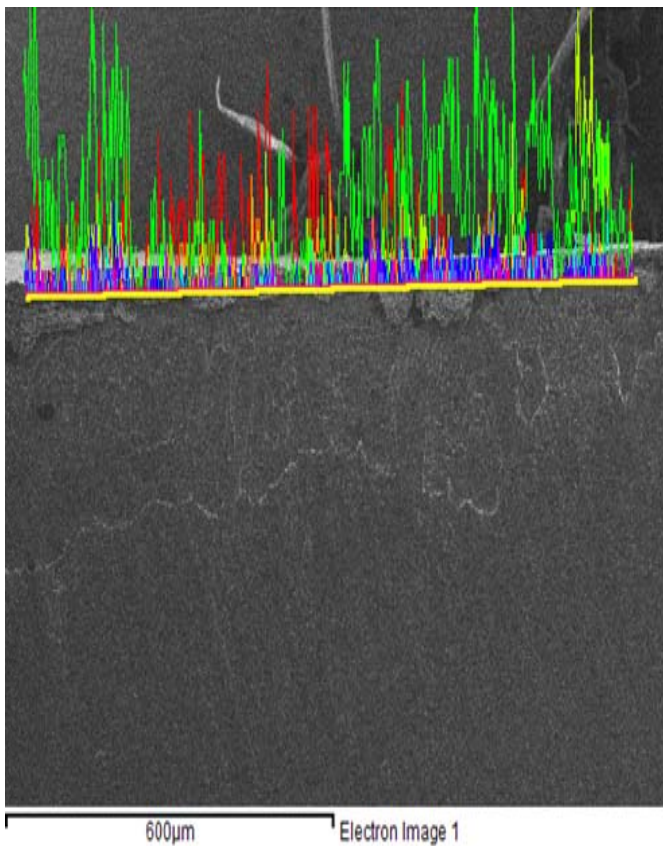
Fig. 7 The EDX linear analysis area

Zones of crater wear (rake face of the worn tool, cutting conditions: $a_p = 0.1\text{mm}$, $v_c = 80\text{m/min}$) were also investigated by EDX. The related EDX line analyses are presented in Figs. 7 and 8. The analysis showed that all elements are almost homogeneously distributed along the worn surface of the tool. Zirconium, Molybdenum, Tin, Titanium and Aluminum represented the Ti-6246 workpiece material. The presence of tungsten and nitrogen indicates a destruction of coating.

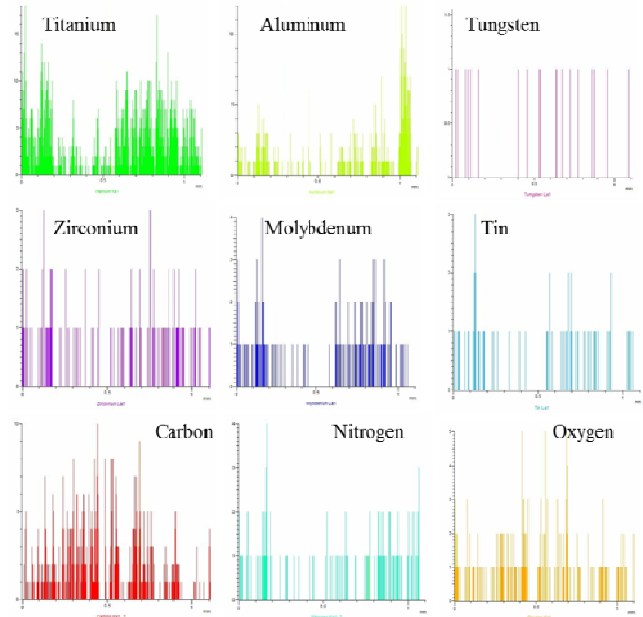
Fig. 8 The EDX line analysis of the worn tool

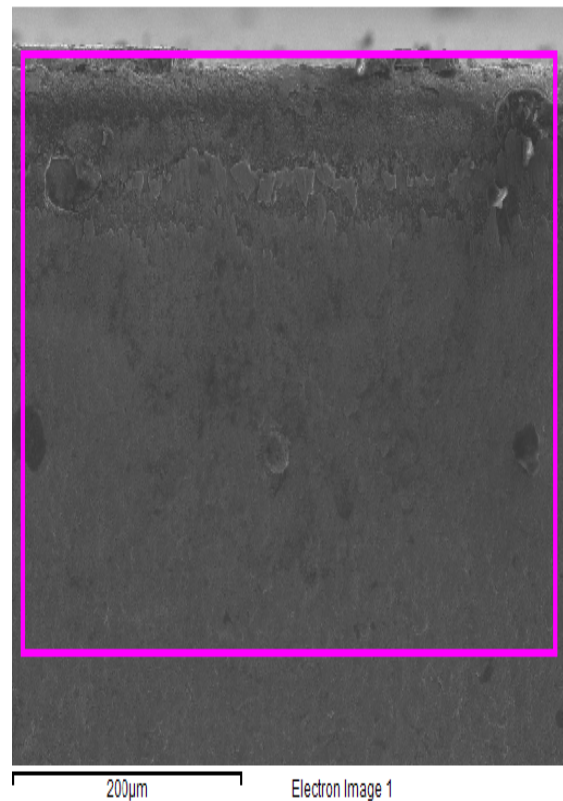
Fig. 9 The EDX mapping area

A chemical elements map of worn part of tool ($a_p = 0.05\text{mm}$, $v_c = 20\text{m/min}$) is shown on Figs. 9 and 10. The distribution of the elements tungsten and aluminum again signalizes a destruction of tool coating and a built-up edge formation. Other elements as Molybdenum, Zirconium and Tin were originating from workpiece material.

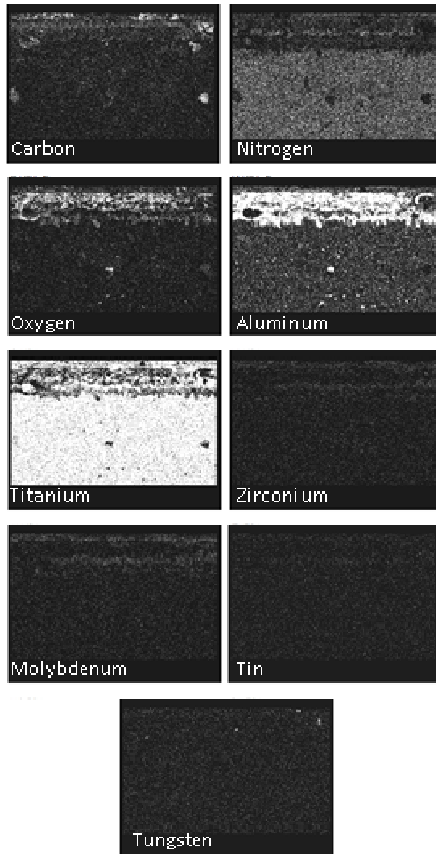
Fig. 10A chemical elements map

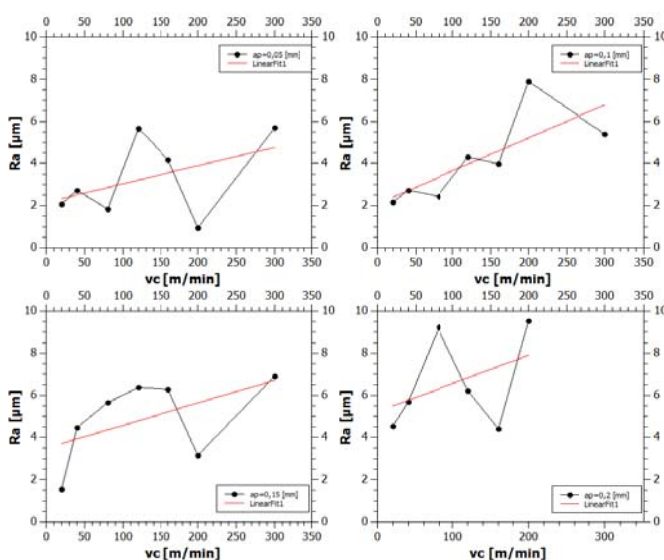
The roughness was measured by a confocal microscope at a distance of $20\mu\text{m}$ from the edge of tool. As it is very difficult to analyze surfaces with high portion of sharp edges (larger than 70°), the results presented here are only to be taken as rough approximations. Fig. 11 shows the results of the roughness measurements. It is clearly visible that the surface roughness increases with increasing cutting speed for all cutting depths.

Fig. 11 Indicators of roughness
