Artificial Accelerated Ageing Test of Silicone Rubber Housing Material for Lightning Arrester

Abstract— This paper presents the experimental results of silicone rubber housing material for 24kV lightning arrester under artificial accelerated ageing test based on IEC 61109 specifications. Specimens having inclined and alternated shed made of HTV silicone rubber with ATH content and having leakage distance 625 mm were tested continuously 1000 hrs in artificial salt fog chamber. After 1000 hrs of salt fog ageing test, obviously surface erosion was observed on trunk between the upper large shed and the lower small shed near the energized end. Decreasing in hydrophobicity and increasing in hardness were measured on tested specimen comparing with new specimen. Chemical analysis by ATR-FTIR confirmed the observation results.

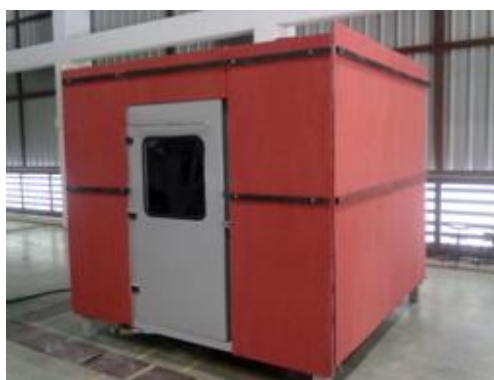
Fig. 3 Illustration of test chamber.

(a) Test chamber

(b) Specimen installation

All specimens were placed in the test chamber having volume 9.6 m^3 ($2 \times 2 \times 2.4 \text{ m}^3$). Test chamber made from stainless steel sheet in order to prevent corrosion from salt fog. Salt fog was generated by using ultrasonic humidifier. Test arrangements are shown in Fig. 2 and test chamber is shown in Fig. 3, respectively.
