Retrofitting of Beam-Column Joint Using CFRP and Steel Plate

Abstract—This paper presents the retrofitting of beam-column joint using CFRP (Carbon Fiber Reinforced Polymer) and steel plate. This specimen was tested until failure up to 1.0% drift. This joint suffered severe damages and diagonal cracks at upper crack at upper column before retrofitted. CFRP were wrapped at corbel, bottom and top of the column. Steel plates with bonding were attached to the two beams and the jointing system. This retrofitted specimen is tested again under lateral cyclic loading up to 1.75% drift. Visual observations show that the cracks started at joint when 0.5% drift applied at top of column. Damage of retrofitted beam-column joint occurred inside the CFRP and it cannot be seen from outside. Analysis of elastic stiffness, lateral strength, ductility, hysteresis loops and equivalent viscous damping shows that these values are higher than before retrofitting. Therefore, it is recommended to use this type of retrofitting method for beam-column joint with corbel which suffers severe damage after the earthquake.

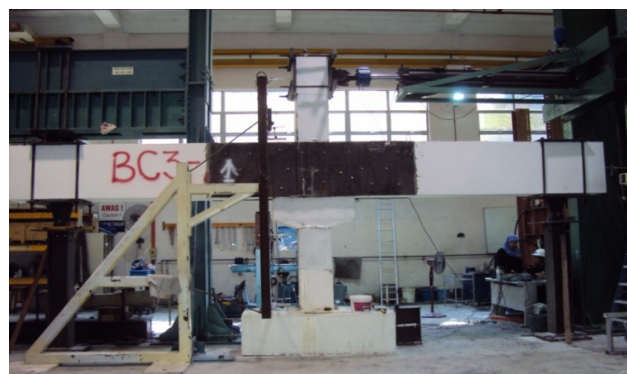
The retrofitting and strengthening of beam-column joint take place using CFRP and steel plate. The first step of retrofitting and strengthening the beam-column joint is to treat and close the gaps of cracks. This is to ensure that the cracks are properly treated prior to retesting of specimen under lateral cyclic loading. The diagonal crack at top column was treated with epoxy to cover up the structural cracks. The wrapping of CFRP sheets on prime coat epoxy resin takes place once the epoxy injection grouting dried. The top column is retrofitted with three layers of CFRP sheets while the bottom column and corbel were retrofitted with two layers of CFRP sheets. The transverse beam near the joint region was strengthened using 2500mm x 750mm x 8mm steel plate on both side of the joint.

Fig. 2 The specimen BC-23ER is ready for testing

After the crack was repaired, the steel plate was then bolted to both side of the joint region using 23 stainless steel M16 anchor. Before the plate is attached to the specimen, fifteen holes with size of 16mm were drilled on the beam surface. After that, the plates were bonded to the beam-column joint and bolted with the anchor bolts. Fig. 2 shows the specimen BC-23ER after retrofitted with CFRP and steel plate bonding which is ready for testing.

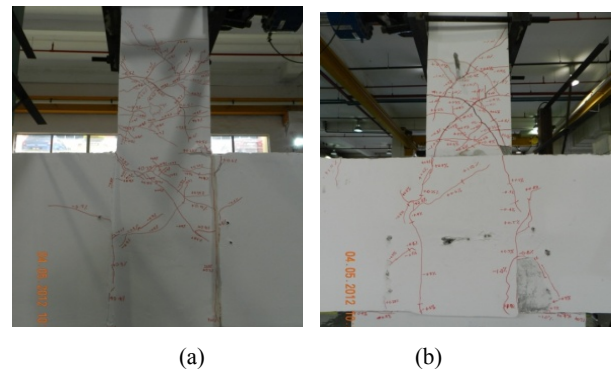
Fig. 5 shows the diagonal shear crack at top column after $\pm 1.0\%$ drift before retrofitting. During retesting, there are no visible hairline cracks or tearing of the CFRP sheet on the beam and column at 0.01% drift to 0.5% drift. The formation of crack can only be seen along the interface of the column to beam at 0.6% drift. At 1.5%, minor spalling of concrete started to shown at the corner of the side of the column. When the drift is increased up to 1.75% drift, the column failed and tears the CFRP layers showing the large crack and spalling of concrete under the layers to tear completely. At this point, the specimen experienced a complete disintegration at the top column. The test revealed that the reinforcement bar has bended which causes the failing of the top column as shown in Fig. 6.

Fig. 5 Diagonal shear crack at top column after $\pm 1.0\%$ drift before retrofitting; (a) front view and; (b) back view

The first crack found on the control specimen occurred at $\pm 0.1\%$ drift at corbel-column interfaces under lateral cyclic loading. At $\pm 0.5\%$ drift, many hairline cracks were observed starting from top of column and beam-column joint. Diagonal cracks started to shown at cast-in-place area at beam-column joint as well as flexural cracks on beam at 0.5% drift. At $\pm 1.0\%$ drift, an extension of the diagonal crack with 5mm width formed which later result in diagonal shear crack. The diagonal shear crack was formed due to the strong beam-weak column design known as soft storey mechanism.
