Ageing Deterioration of High-Density Polyethylene Cable Spacer under Salt Water Dip Wheel Test

Abstract—This paper presents the experimental results of high-density polyethylene cable spacers for 22 kV distribution systems under salt water dip wheel test based on IEC 62217. The strength of anti-tracking and anti-erosion of cable spacer surface was studied in this study. During the test, dry band arc and corona discharge were observed on cable spacer surface. After 30,000 cycles of salt water dip wheel test, obviously surface erosion and tracking were observed especially on the ground end. Chemical analysis results by fourier transforms infrared spectroscopy showed chemical changed from oxidation and carbonization reaction on tested cable spacer. Increasing of C=O and C=C bonds confirmed occurrence of these reactions.

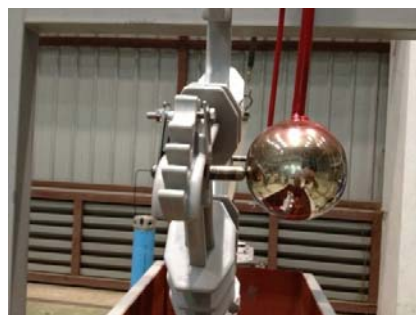
Four items of cable spacers were installed on the wheel as shown in Fig. 2. Only two phases near ground end were energized. Voltage was energized via stainless rods and stainless sphere as shown in Fig. 3

Fig. 3 Voltage Energized via Stainless Rod and Stainless Sphere

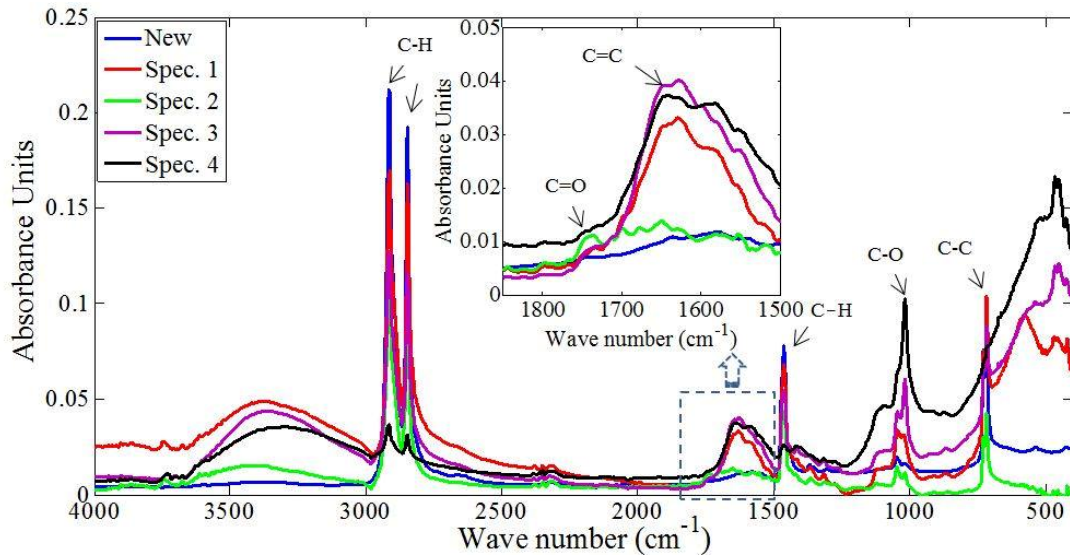
Appearance of C=O bond at wave number 1,745 cm^{-1} and C=C bond at wave number 1,630 cm^{-1} indicates the occurrence of Oxidation and Carbonization, respectively. As illustrated in Fig. 7, reduction in C-H bond and C-C bond were observed on all tested specimens when comparing with new specimen. In contrast, increasing in C=O bond and C=C bond were observed on all tested specimens. Ratio of C=O bond and C-C bond is illustrated in Fig. 8. And ratio of C=C bond and C-C bond is illustrated in Fig. 9

Fig. 7 ATR-FTIR analysis result [Position 1]

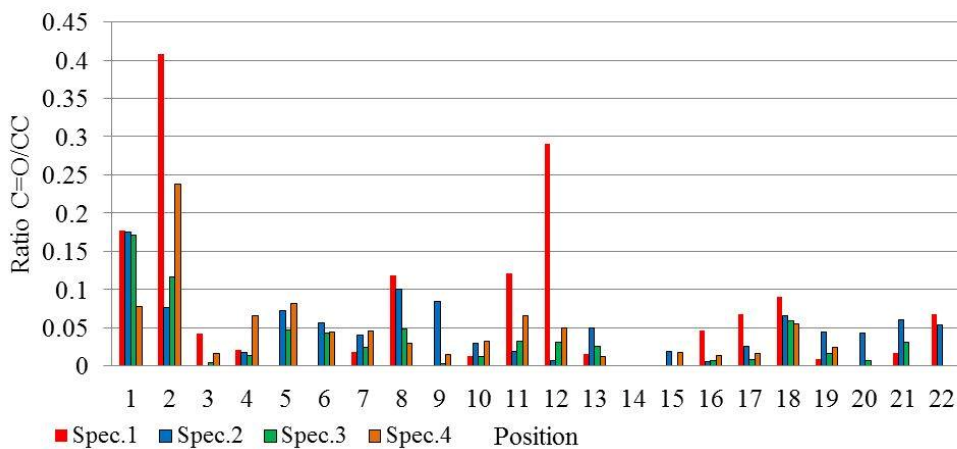
Fig. 8 Ratio of C=O/C-C
