Finite Element Analysis of Low-Velocity Impact Damage on Stiffened Composite Panels

Abstract—To understand the factors which affect impact damage on composite structures, particularly the effects of impact position and ribs. In this paper, a finite element model (FEM) of low-velocity impact damage on the composite structure was established via the nonlinear finite element method, combined with the user-defined materials subroutine (VUMAT) of the ABAQUS software. The structural elements chosen for the investigation comprised a series of stiffened composite panels, representative of real aircraft structure. By impacting the panels at different positions relative to the ribs, the effect of relative position of ribs was found out. Then the simulation results and the experiments data were compared. Finally, the factors which affect impact damage on the structures were discussed. The paper was helpful for the design of stiffened composite structures.

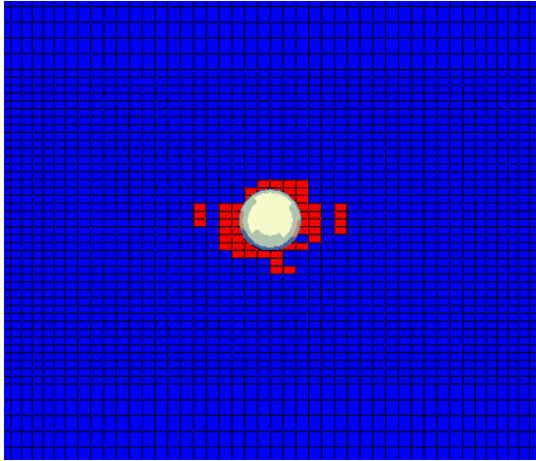
The damage area is 998 mm^2 , and it is 20% smaller than experiment value.

Fig. 5 Damage area on site A from top view

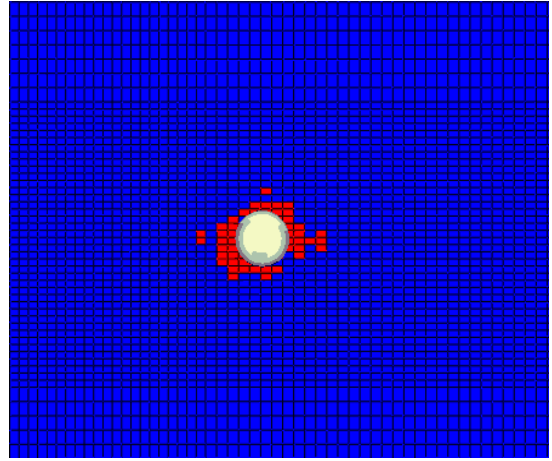
Fig. 8 Damage area on site B from top view

The damage area is 678 mm^2 , and it is 18% smaller than experiment value .

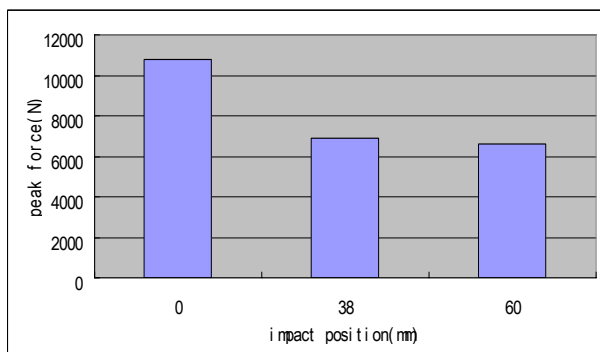
Fig. 13 Peak force on the three impact sites

The locations of the impacts were in centre bay between the stringers, in a bay close to a stringer, and above the stringer centreline. From Figs. 13 and 14, we can figure out that the more it is apart from stringer, the less peak force is; the more it is apart from stringer, the more damage area is. For impacts in the bay, a compliant bay led to increased absorption of the incident energy through elastic structural response. However, for impacts in the foot, a compliant bay led to increased absorption of the incident energy through damage to the substructure. For impacts over the stringer centreline, much of the incident energy was absorbed through elastic deformation of the substructure. So the result in my paper is acceptable.

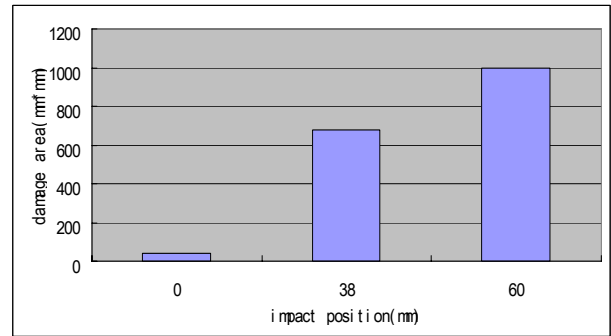
Fig. 14 Damage area on the three impact sites
