Comparison of Double Unit Tunnel Form Building before and after Repair and Retrofit under in-Plane Cyclic Loading

Abstract—This paper present the experimental work of double unit tunnel form building (TFB) subjected to in-plane lateral cyclic loading. A one third scale of 3-storey double unit of TFB is tested until its strength degradation. Then, the TFB is repaired and retrofitted using additional shear wall, steel angle and CFRP sheet. The crack patterns, lateral strength, stiffness, ductility and equivalent viscous damping (EVD) were analyzed and compared before and after repair and retrofit. The result indicates that the lateral strength increases by 22% in pushing and 27% in pulling direction. Moreover, the stiffness and ductility obtained before and after retrofit increase tremendously by 87.87% and 39.66%, respectively. Meanwhile, the energy absorption measured by equivalent viscous damping obtained after retrofit increase by 12.34% in pulling direction. It can be concluded that the proposed retrofit method is capable to increase the lateral strength capacity, stiffness and energy absorption of double unit TFB.

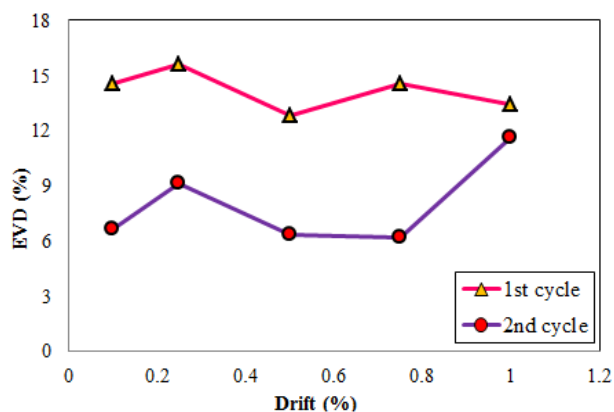
Fig. 3 Equivalent viscous damping (a) before retrofitting and (b) after retrofitting

Fig. 3 shows the comparison of equivalent viscous damping (EVD) before and after retrofitting for both cycles. The EVD for the first cycle before retrofitting seems to be decreased as the drift increase. EVD first cycle after retrofitting seems to be increased as the drift increased. The percentage increment between before and after repair for the first cycle is not much differing. However, the EVD for the second cycle, before and after repair seems to have similar pattern. It is increased as the drift increase, but EVD after repair increased 12.34% from before repair. In fact, even though EVD after repair started at lower value as compared with before repair, but it manages to increase much more higher than before repair.
