# FEM and Experimental Modal Analysis of Computer Mount

Vishwajit M. Ghatge, David Looper

**Abstract**—Over the last few decades, oilfield service rolling equipment has significantly increased in weight, primarily because of emissions regulations, which require larger/heavier engines, larger cooling systems, and emissions after-treatment systems, in some cases, etc. Larger engines cause more vibration and shock loads, leading to failure of electronics and control systems.

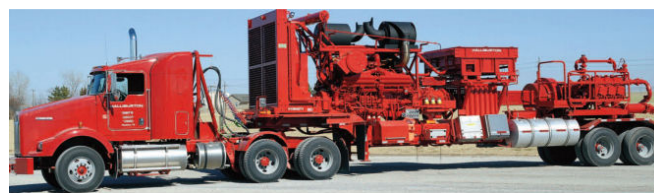
**O**IL and gas stimulation equipment consists of pump trailers, blenders, proppant handling systems, etc., which are designed to achieve maximum reliability with minimal maintenance, even in extremely harsh oilfield environments [1]. A typical fracturing pump trailer is shown in Fig. 1. To

Fig. 1 Typical fracturing pump trailer

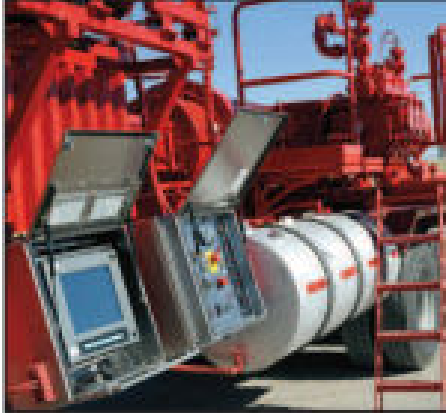
still suitable for this new computer, until the newest version was introduced, which is 10 lbm heavier. Some failures of internal parts have been reported when exposed to vibration in the field resulting from the two brackets colliding under off-road conditions, which causes a high shock input to the computer parts. The location of the Daisy Data Display computer is shown in Fig. 2.

Fig. 2 Location of Daisy Data Displays computer on trailer

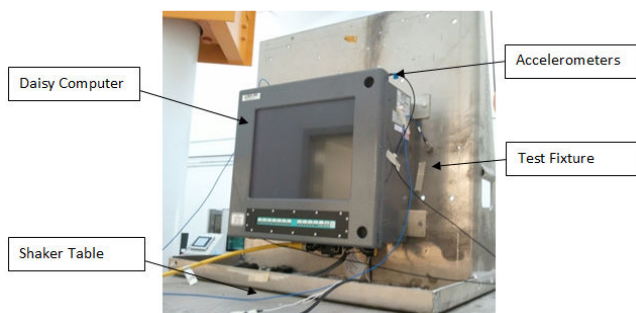
The Daisy Data Displays computer was experimentally tested by hard-mounting it to the test fixture, as per the manufacturer's suggestions and guidelines, to duplicate the manufacturer's testing. Fig. 3 shows the test setup, in which the Daisy Data Displays computer was hard-mounted to the test fixture and the fixture was hard-mounted on the shaker table.

Fig. 3 Test setup for Daisy Data Displays computer
